REPORT OF INVESTIGATION

**Fatal Underground Mine Explosion
April 5, 2010**

**Upper Big Branch Mine-South, Performance Coal Company
Montcoal, Raleigh County, West Virginia, ID No. 46-08436**

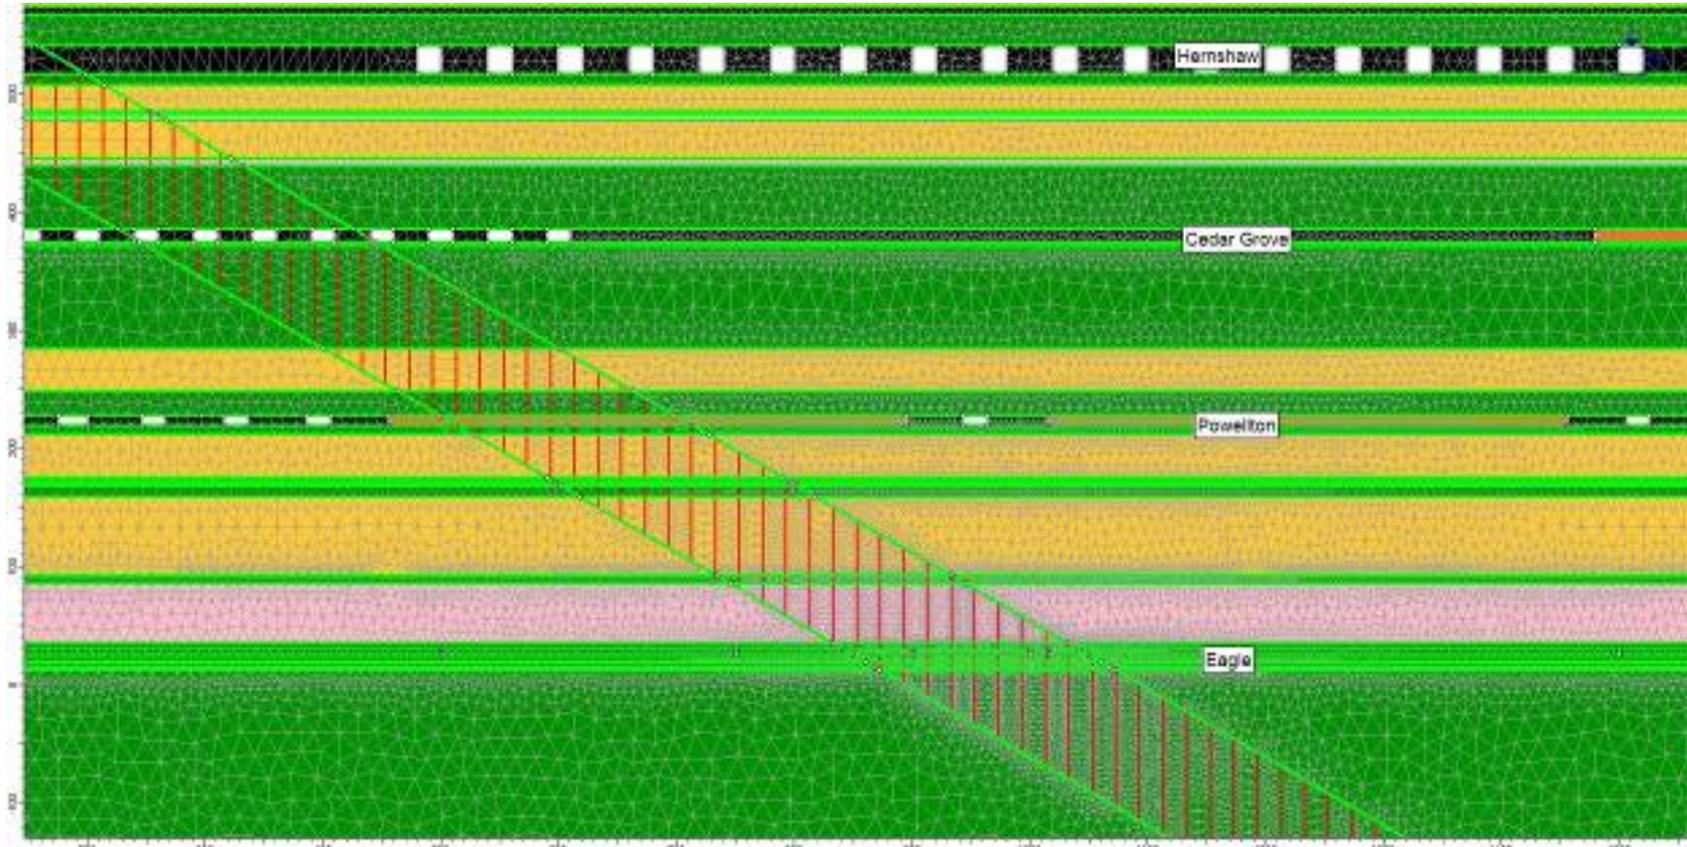
Investigators simulated the fault zone with a 100-foot thick zone, consisting of vertical joints, that dips 30° across the stratigraphic sequence (rock layers), resulting in an intercept width of 200 feet for each layer of strata (Figure 19). This configuration matches closely the geological observations, i.e. intact rock hosting widely spaced joints or other geological structures within the shallowly dipping fault zone. Simulated vertical joints were spaced 20 feet apart within the 30° dipping zone and given a friction angle of 28°, with no tensile strength or cohesion. Joint ends were specified as being open at excavation boundaries.

Figure 19. Stratigraphy in Rocscience showing incorporation of 30° dipping fault zone that is comprised of vertical joints spaced 20 feet apart for 1 North Panel cross section.

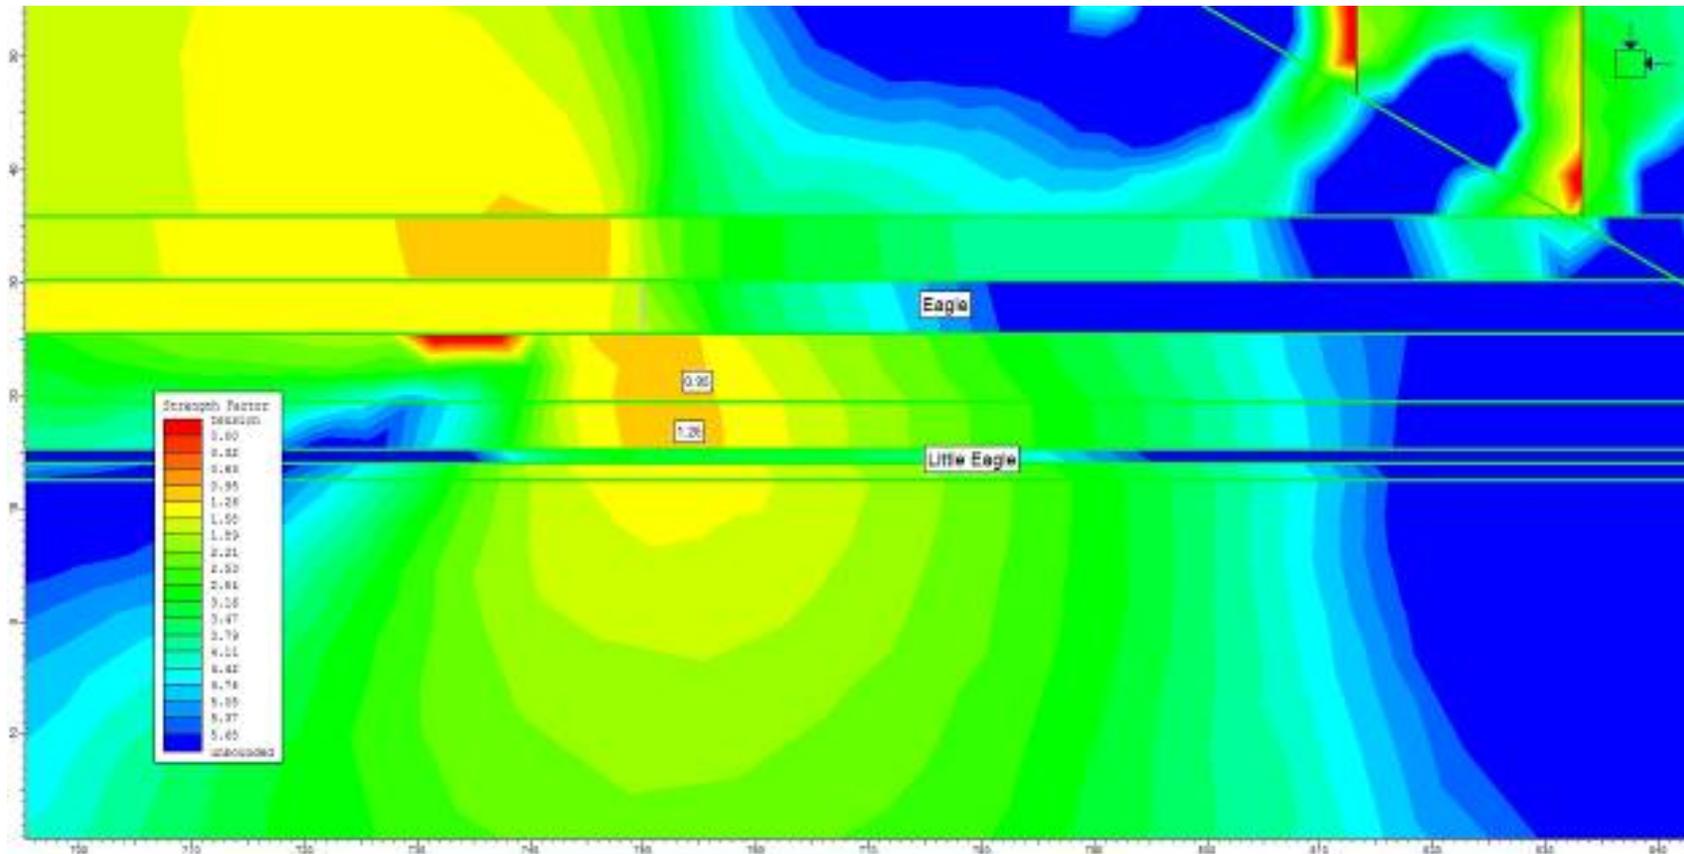
Areas outside the fault zone did not incorporate joints, and when the simulated longwall face position was 250 feet in by the April 5, 2010 position, strength factors less than one extend only a calculated five feet into the floor, approximately halfway to the Little Eagle seam (Figure 20 and 21). When the longwall face had reached its April 5, 2010 position, such that the 30°- dipping fault zone was cantilevered over the face, zones of tension extend a predicted 25 feet into the floor along joint zones, and a zone of strength factors less than one extends 15 feet into the floor. This fully encompasses the Little Eagle seam and intervening interburden to the Eagle seam, with the zone extending beneath the Little Eagle seam for a short depth.

Figure 20. Distribution of strength factors when 1 North Panel longwall face is 250 feet inby the April 5, 2010 face position, outside the projected fault zone. Strength factors less than one are calculated to extend only five feet into the floor beneath the face.

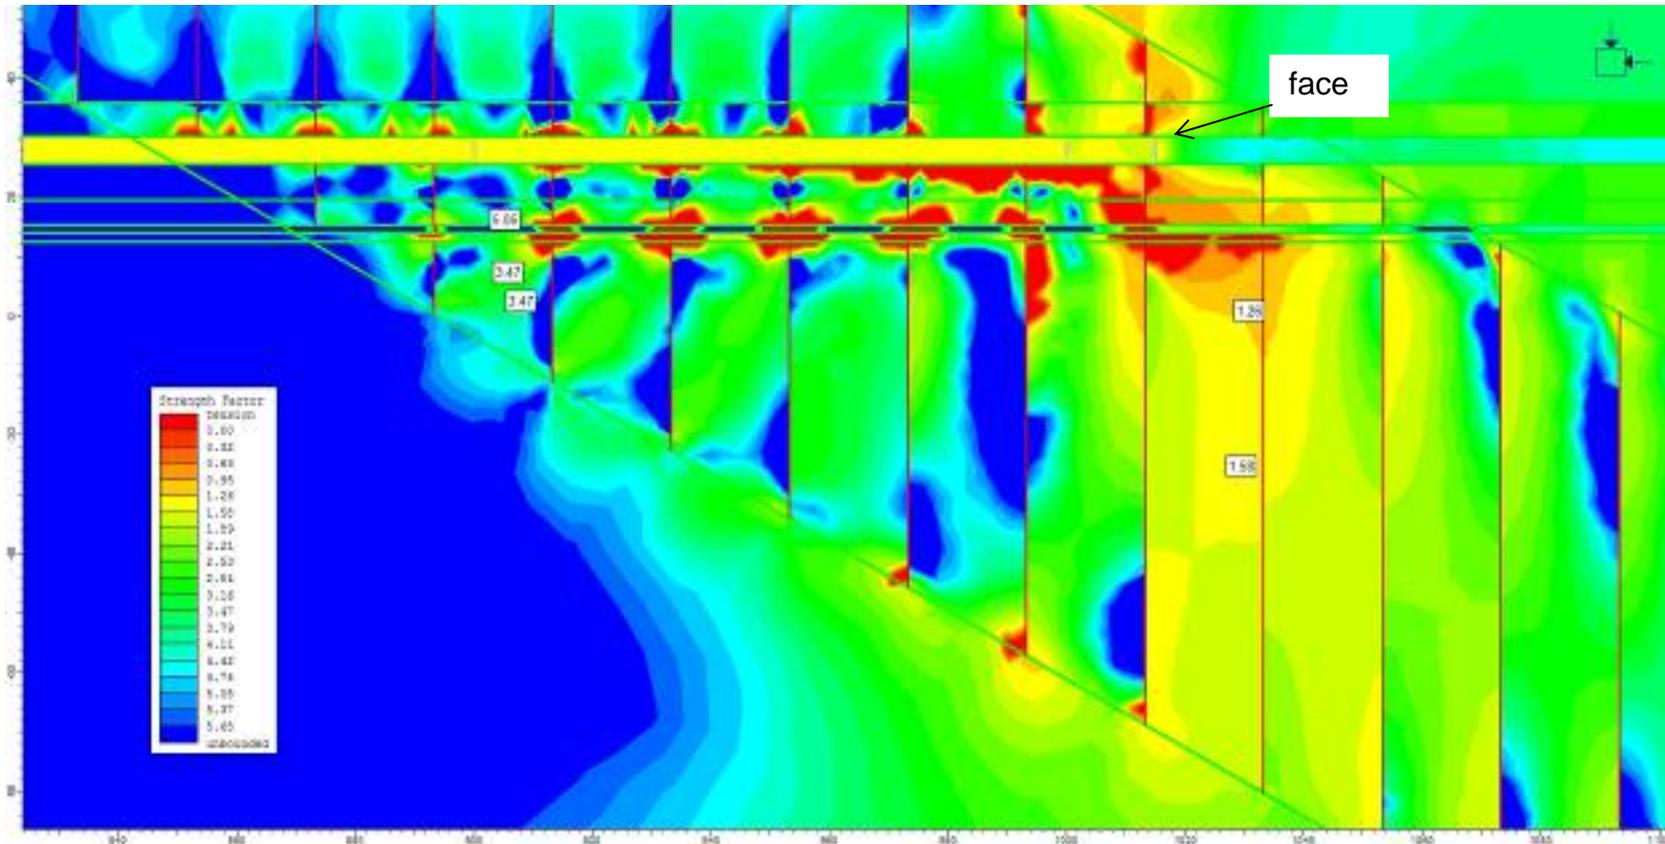
Thus, investigators concluded that the most likely explanation for the failure mechanism associated with the gas inflow at shields 160-171 is that mining into the fault zone beneath the two rows of remnant barriers at over 1,000 feet of depth resulted in a unique overlap of factors that caused the development of tension zones along pre-existing geologic structures for a calculated 25 feet into the floor.

Figure 21. Distribution of strength factors when the 1 North Panel longwall face is at its April 5, 2010 position. Zones of tension are developed along joints below the Little Eagle seam, with large swath of strength factors less than one extending 25 feet into the floor, which encompasses the Little Eagle seam and underlying strata.

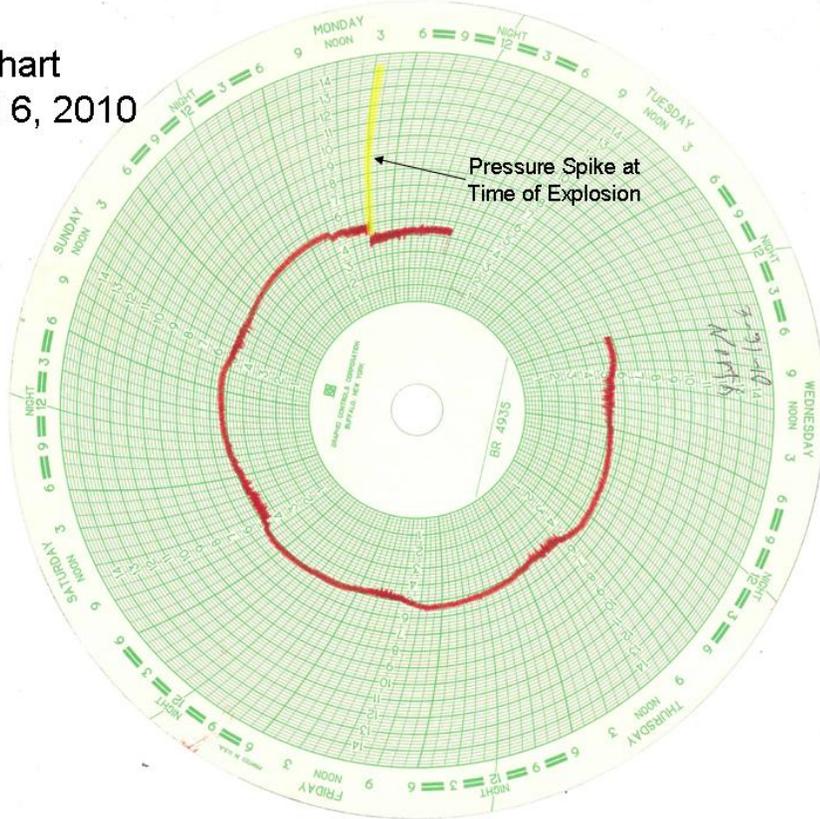
North Fan Chart
March 31 – April 6, 2010

UBB was ventilated with two blowing fans and one exhausting main mine fan. The North Portal blowing fan was a Joy, Model Number 12065D, Serial No. MF4110, ten-foot axial vane fan. The fan was operated with a 1,000-horsepower, 4160 volt, 900 revolutions per minute (rpm) motor. Figure 24 is a copy of the North fan chart which was on the fan pressure recorder when the explosion occurred and shows the fan was operating at about 4.8 inches of water gauge (in. w.g.).

Figure 24. Chart for North Fan, showing pressure spike at time of explosion.

Although the fan charts shown in Figures 24 to 26 were not aligned correctly on the pressure recorder to correspond with actual time, each fan chart shows the pressure spike from the explosion. The North fan recorded a spike of over 9 in. w.g. over its normal pressure of 4.8 in. w.g. The South fan recorded a spike of 2 in. w.g. over its normal pressure of 1.4 in. w.g. The Bandytown fan spike went downward off the chart because this fan was exhausting and the pressure spike was positive. The magnitude of the spike cannot be determined but it was greater than the fan operating pressure. Several small variations in fan pressure were noted on the Bandytown fan chart following the explosion, although persons who were underground during that time reported no additional explosions.

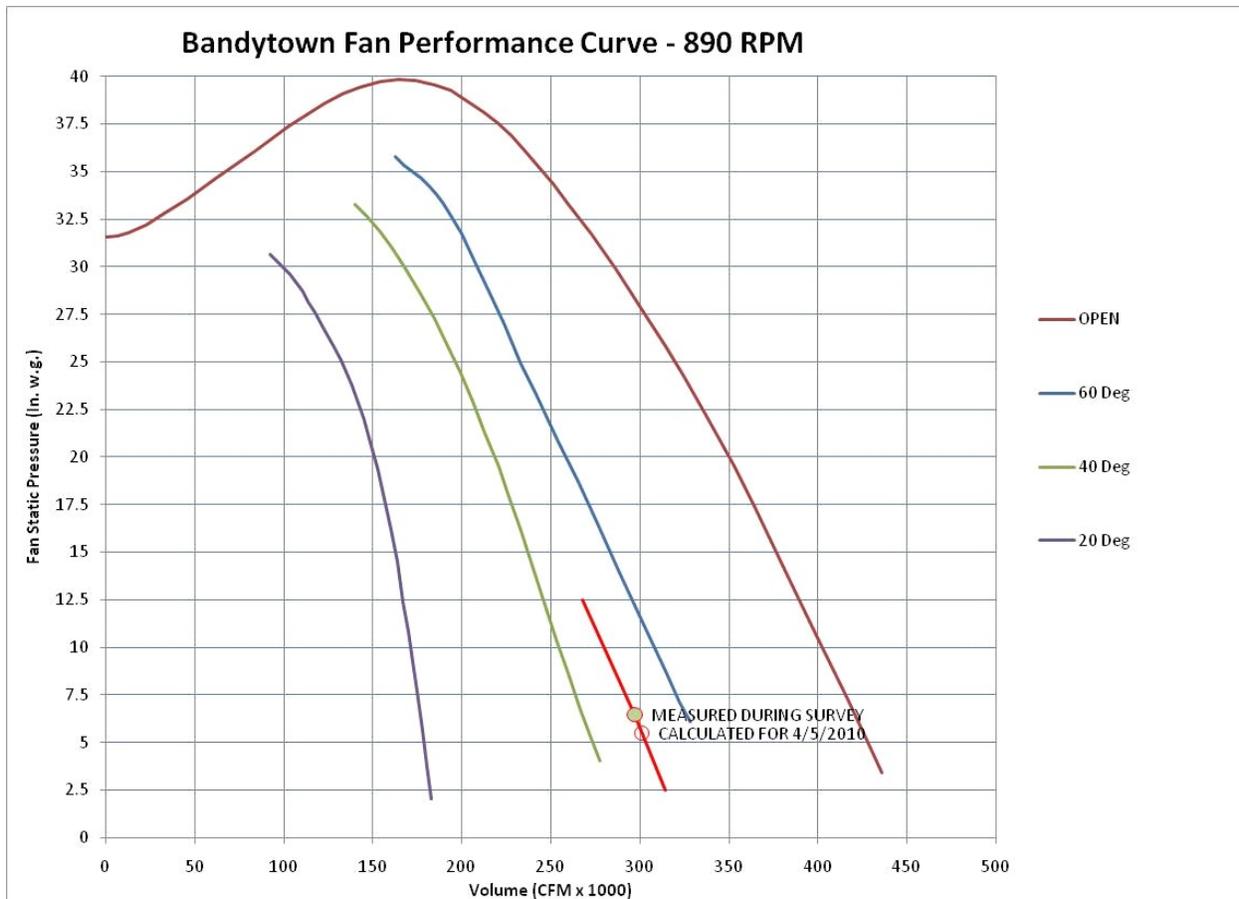
The in-mine survey determined an air quantity of approximately 297,000 cfm reported to Bandytown fan. Records indicated that the fan had not been altered since the explosion and was not affected by the explosion. The operating point for the fan was determined from the underground measurements, and the pressure indicated on the fan chart during the pre-survey (6.45 in. w.g.). The pressure taken from the fan recording chart during the survey was compared with the fan pressure recorded on the chart prior to the explosion (Figure 26). The operating point was plotted on a fan performance curve for Bandytown fan. A curve was drawn through the operating point and the pre-explosion pressure was used to determine the quantity at the fan prior to the explosion. The fan performance curve is shown in Figure 27.

Figure 27. Graph of air volume versus fan static pressure, defining the Bandytown fan's performance curve.

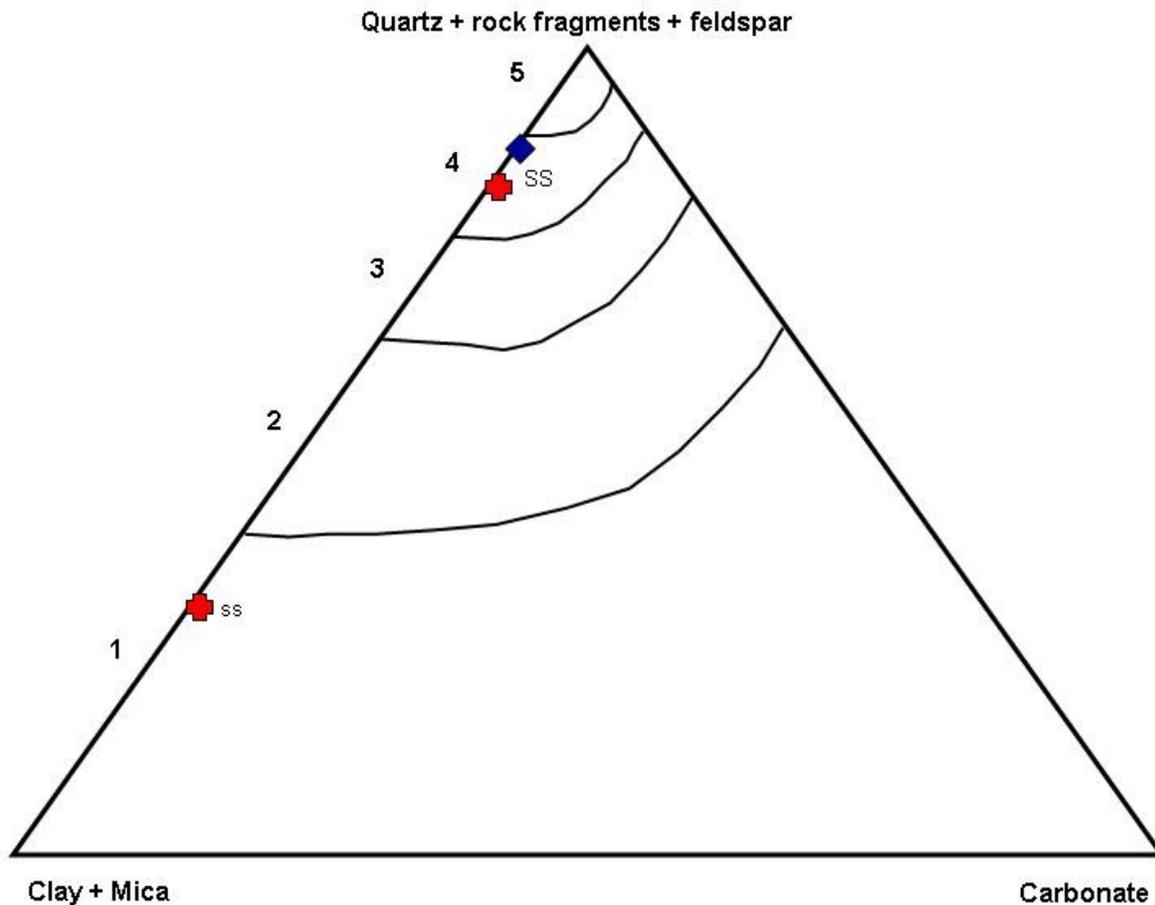
The sandstone that the longwall shearer was cutting into on April 5 had a high potential for frictional ignition. The layers of coarse siltstone, which contain high mica content, plot in Category 1, indicating a low potential for frictional ignition. In contrast, the sandstone plots in Category 4 indicating a high potential for frictional ignition. The floor sandstone very nearly plots in the Category 5 zone, because of its high quartz content. Compared to the sample collected from the roof, the floor sample contains much greater quartz, and is characterized by a much greater degree of grain interlocking. Rocks with an incendivity index of 4-5 were shown in tests to have a high potential for frictional ignition, for rock-on-rock and metal-on-rock ignitions.

Figure 28. Diagram showing relation of UBB roof (red crosses) and floor (blue diamond) sandstone (SS) and siltstone (ss) to contour lines of incendivity index.

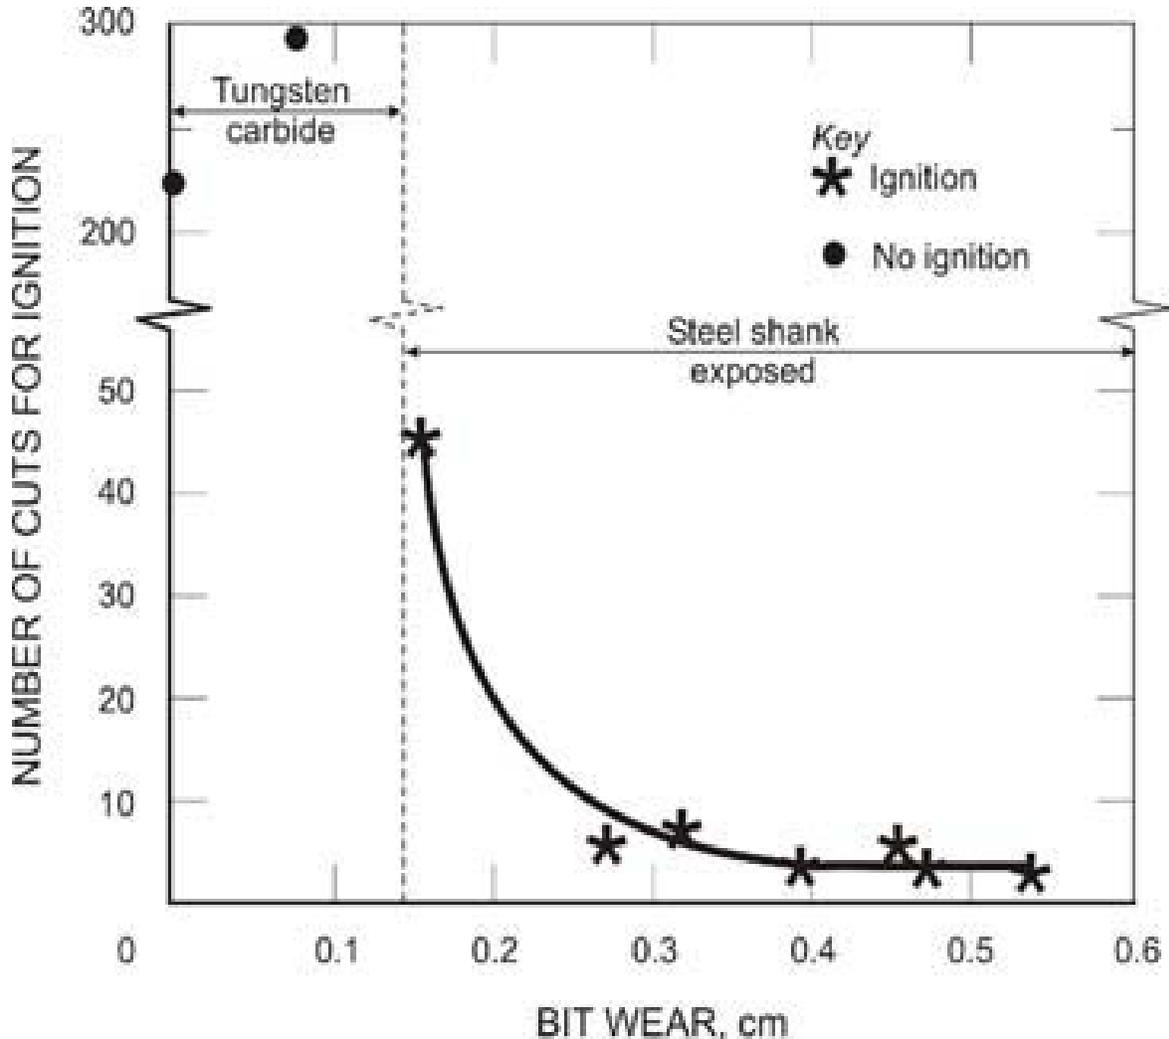
In addition, experiments have revealed that bit surface area is significantly related to the incendive potential of a hot streak. Large wear flats on the cutting bits are more likely to cause an ignition, especially when the carbide tip has worn off and as little as 3 mm of the steel shank has been abraded away (Figure 29).

Figure 29. Relation between bit wear, in centimeters, and the number of cuts required to induce a frictional ignition, from Kissell et al. (2007).

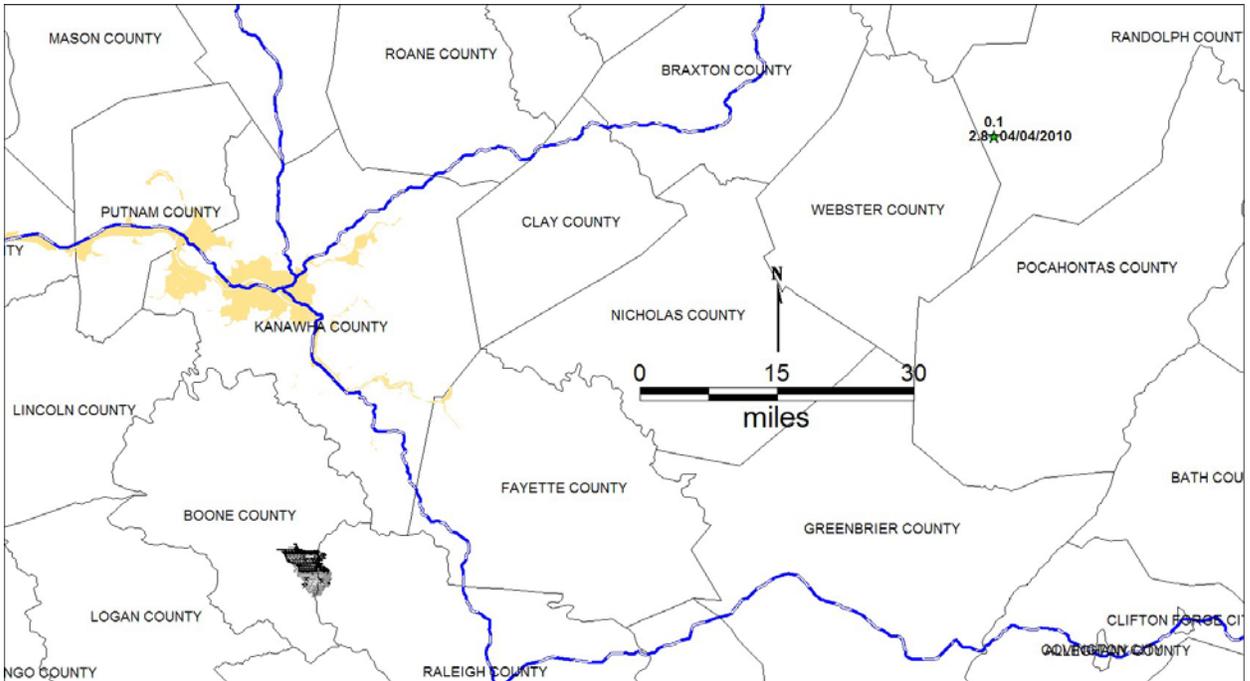
The second seismic event occurred on April 4, 2010 in Braxton County, approximately 60 miles from the face of the 1 North Panel, UBB (Figure M-1). Despite the seemingly close temporal relation between the April 4 seismic event (05:19:14), and the April 5 explosion (15:02), the 60 mile interval and 34-hour time difference does not support any recognizable relationship between the two events. After the April 5, 2010 explosion, seismic events continued to be recorded in the Upshur/Randolph County area. A 2.5 magnitude seismic event was reported on August 21, 2010, with the hypocenter exactly coinciding with a gas well that is exploiting the Devonian-aged Marcellus Shale (API # 47-09703326), with a neighboring well also reported as developed to the Marcellus Shale (API # 47-09703622) (Figure M-2). Following the April 5, 2010 explosion, several seismic events were recorded in central West Virginia. A search of seismic events within 200 km of UBB indicated that six seismic events were recorded in 2010 along the crest of the Gassaway Anticline (Figure M-3). Because several of those events were reported as occurring at 0 km depth, the localized seismic activity is interpreted to be associated in some fashion with the recent increase in gas drilling in the state, and does not appear to have any recognizable association with UBB.

Figure M-1. Location of Randolph County 2.8 M “seismic event,” in relation to UBB, that occurred on April 4, 2010. The event was essentially at the surface, only 0.1 km deep and located over 60 miles away.

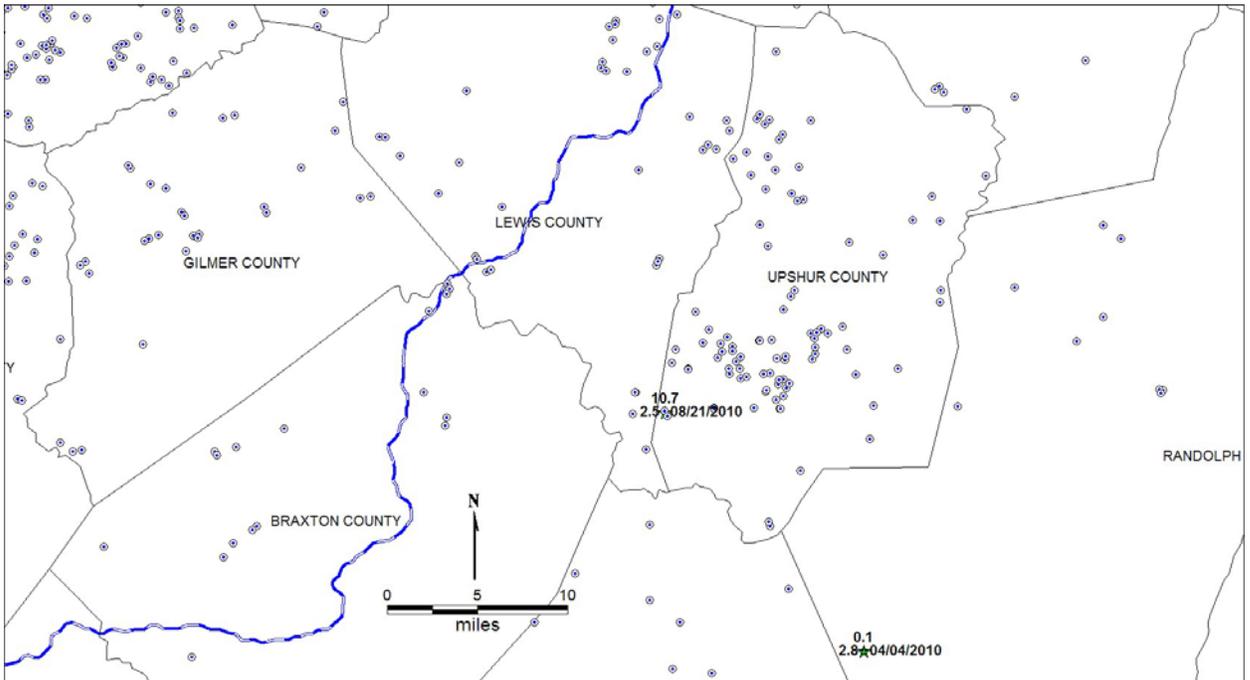
Figure M-2. Locations of seismic events in the vicinity of Upshur County shown in relation to the locations of gas wells developed to the Marcellus Shale. Event on August 21, 2010 plots directly on top of a gas well location, suggesting that increased drilling activity, possibly associated with fluid injection, is related to the increase in recorded seismic events.

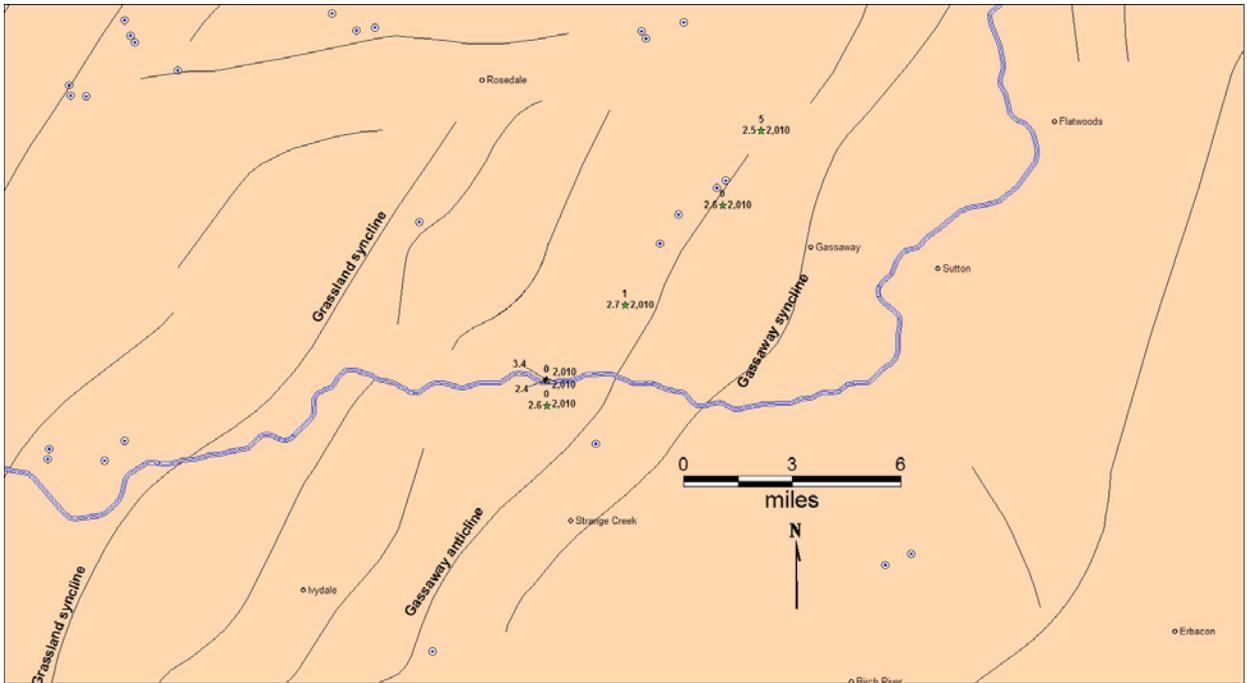
Figure M-3. Map of seismic events recorded by the USGS in 2010 in West Virginia are located along the axis of the Gassaway Anticline, dominantly occurring essentially at the ground surface. Location along anticline axis is suggestive of gas drilling-related activity. Blue circles represent the locations of gas wells drilled to the Marcellus Shale.

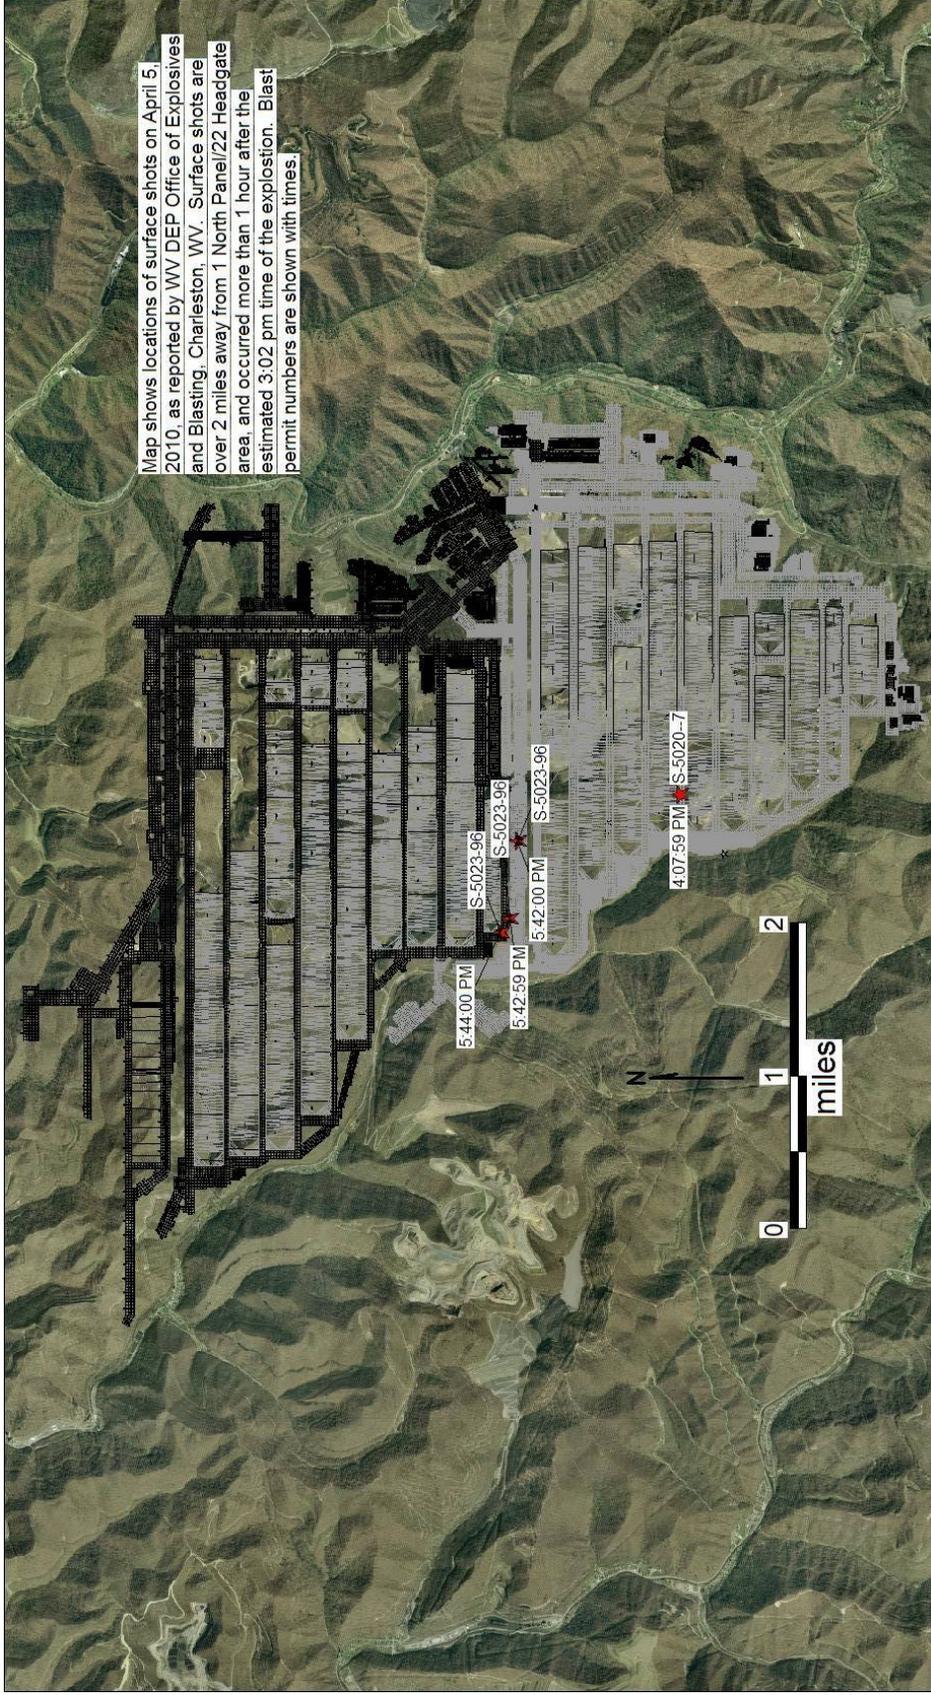
Although the US Geological Survey does not report events that are less than 1.0 Magnitude, the possibility of an association with surface blasting was assessed by portraying UBB workings in relation to surface mines on georeferenced air photos. The nearest surface operation is located nearly two miles from the vicinity of HG 22 and/or the 1 North Panel face. Surface shots conducted on April 5, 2010, the day of the explosion, were recorded by seismographs monitored by the West Virginia Department of Environmental Protection's (WVDEP) Office of Explosives and Blasting. The locations of surface blasts were plotted in a Geographic Information System (GIS) using coordinates provided by the WVDEP Office of Explosives and Blasting, along with the times of surface blasting. Four surface blasts were recorded approximately 2 ½ miles from the face of the 1 North Panel, but the earliest was over one hour after the 3:02 p.m. time of the explosion. The WVDEP was requested to provide the locations and times of all surface blasts for the week prior to the explosion, within a five mile radius of the 1 North Panel face. Discussions with David Vande Linde (Office of Explosives and Blasting) conducted on April 29-30, 2010, revealed that seismographs were located at Lindytown and Synergy, and agreed with the time data provided by the company, although located 1,500-2,000 feet away from the blast (Figure N-1). Mr. Vande Linde indicated that at that distance, the seismic magnitudes resulting from the surface shots were 0.01-0.06 Magnitude, representing very small events.

Figure N-1. UBB in relation to surface blasting events on April 5, 2010. Surface shots all occurred at least one hour after the 3:02 p.m. time of the explosion, and were located more than two miles south of the 1 North panel.

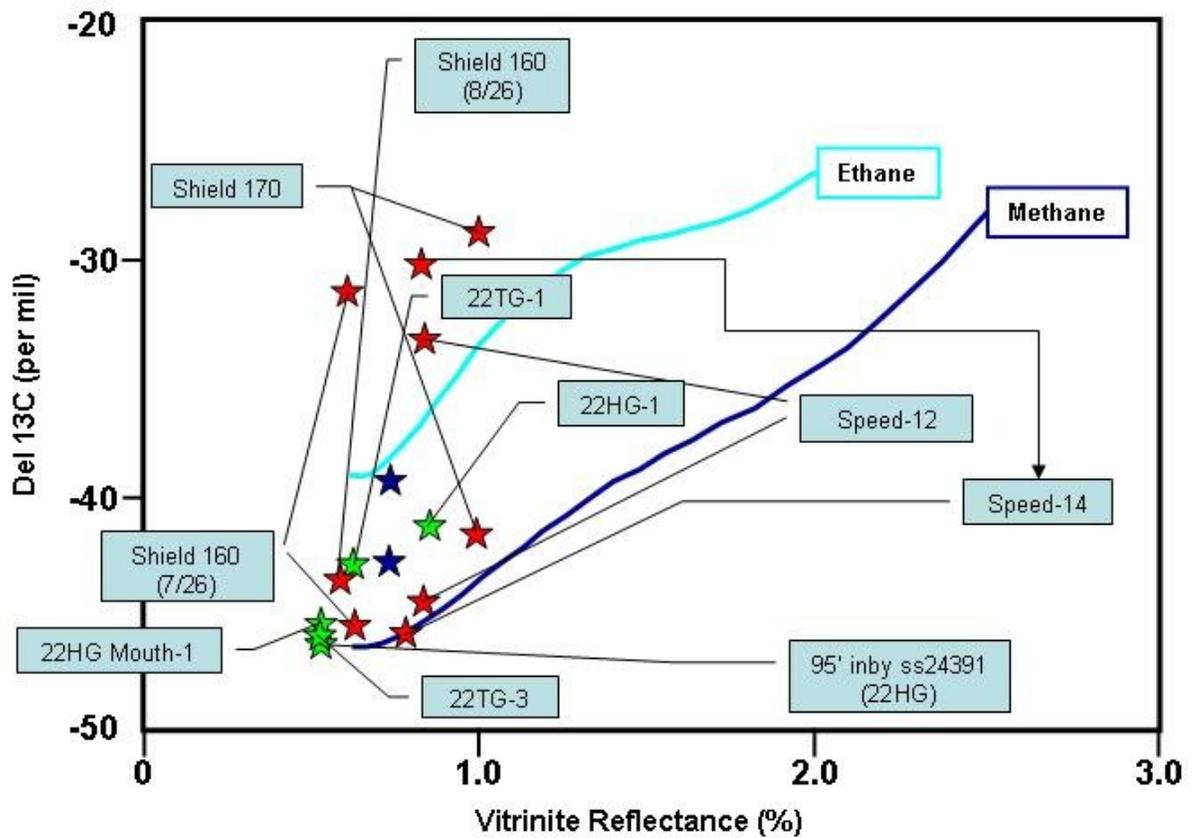
Figure O-1. Plot of collected gas samples for $\delta^{13}\text{C}$ for methane (‰) and ethane versus vitrinite reflectance, after Berner and Faber (1996), indicating derivation from Type II kerogen, such as expected for organic shale. Vitrinite reflectance is unknown for Marcellus Shale beneath UBB, but values of 0.8% and 0.6% for samples collected from the American Eagle Mine and UBB, respectively, are based on Figure 46. Published data for area coal seams in the southern Appalachian Basin suggest that vitrinite reflectance may be as high as 0.9%. For both samples, values lie along the curve defined for methane, but diverge significantly from the curve defined for ethane. Red stars indicate samples that contain C_{2+} hydrocarbons; green stars indicate samples with little or no C_{2+} hydrocarbons. Blue stars indicate composition of natural gas produced from the Marcellus Shale.

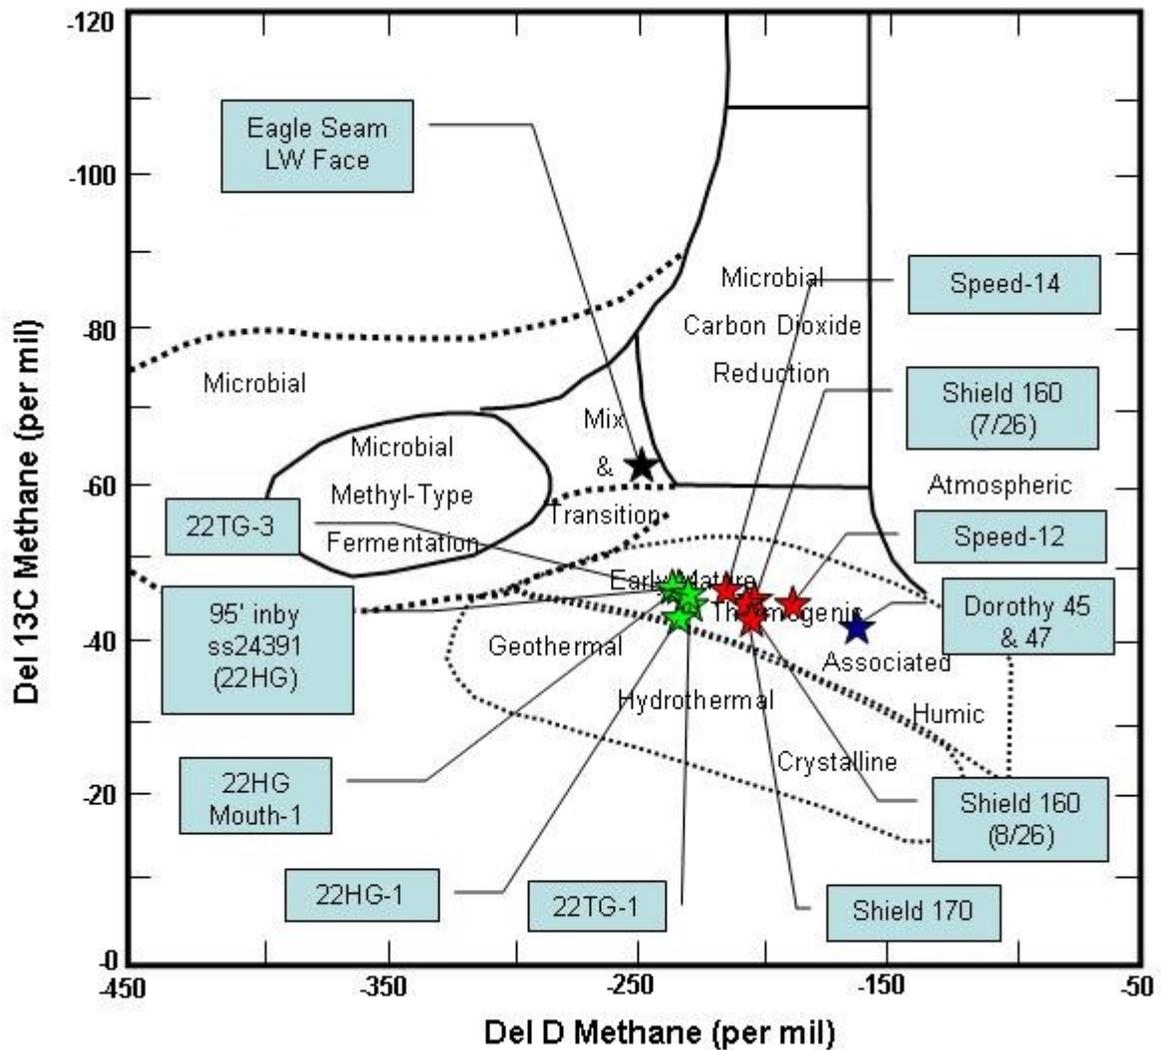
Figure O-2. Discrimination diagram from Whiticar (1996) showing gas fields based on plotting $\delta^{13}\text{C}$ for methane (‰) versus δD for methane (‰). Red stars indicate samples that contain C_{2+} hydrocarbons; green stars indicate samples with little or no C_{2+} hydrocarbons. Blue star indicates samples that were obtained from the Dorothy 45 and Dorothy 47 wells, which produce natural gas from the Marcellus Shale.

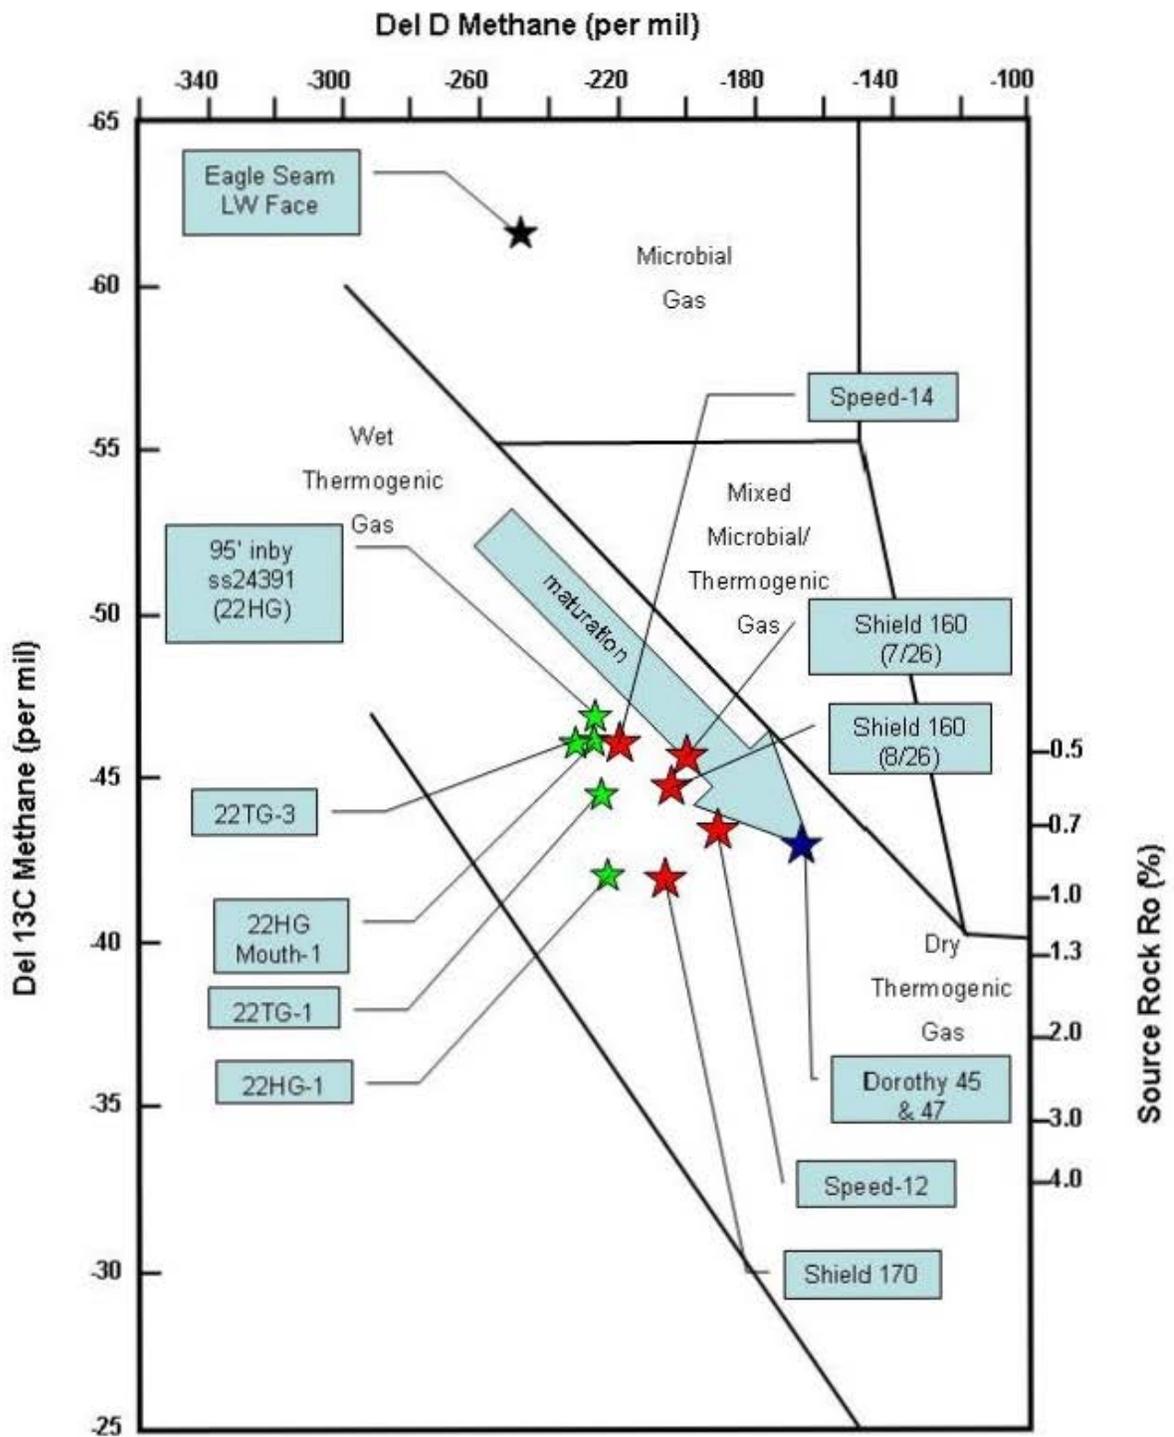
Figure O-3. Discrimination diagram after Jenden et al. (1993) showing fields of microbial and thermogenic gas based on plotting values of $\delta^{13}\text{C}$ for methane (‰) and δD for methane (‰). Values for vitrinite reflectance are shown for comparison. Red stars indicate samples that contain C₂₊ hydrocarbons; green stars indicate samples with little or no C₂₊ hydrocarbons. Blue star indicates samples that were obtained from the Dorothy 45 and Dorothy 47 wells, which produce natural gas from the Marcellus Shale.

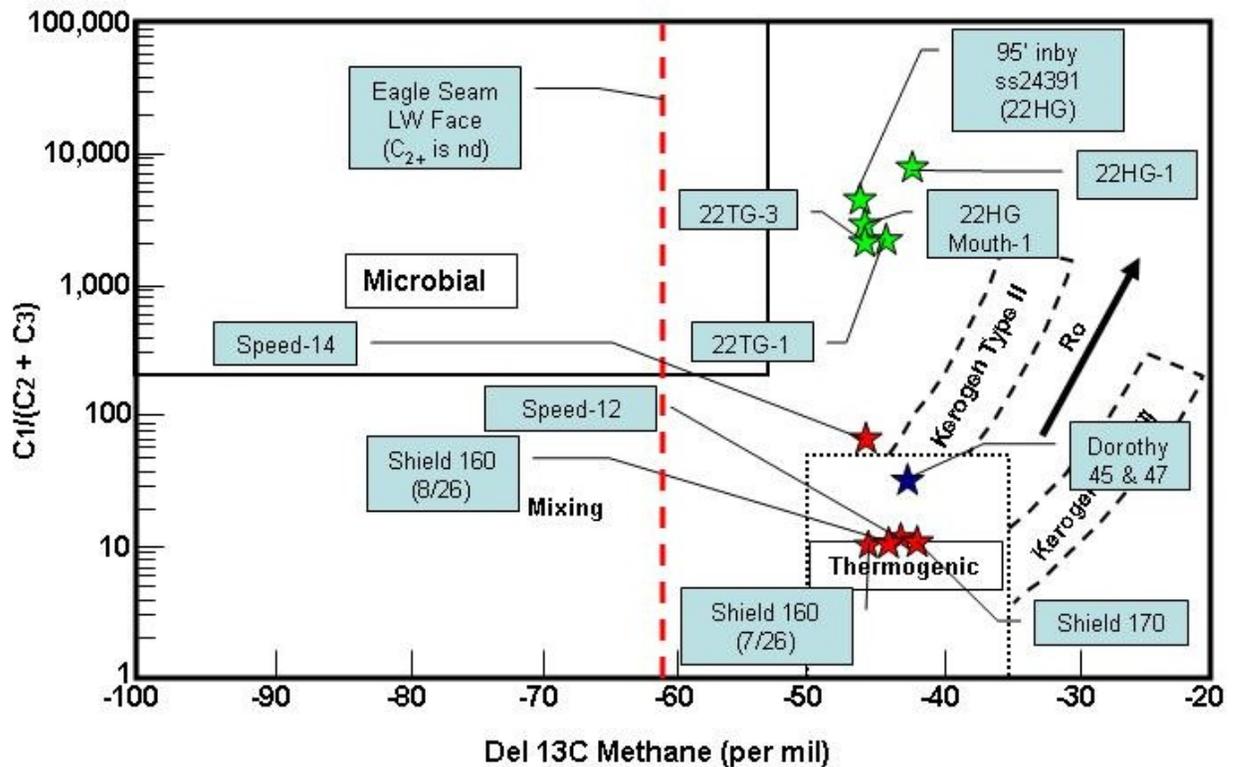
Figure O-4. Discrimination diagram showing fields of gas from microbial and thermogenic sources, based on comparison of C_1 , C_2 , and C_3 hydrocarbons (ratio of methane to combined ethane and propane), compared to $\delta^{13}C$ for methane (‰). Diagram modified from Whiticar, 1996). Red stars indicate samples that contain C_{2+} hydrocarbons; green stars indicate samples with little or no C_{2+} hydrocarbons. Blue star represents samples obtained from the Dorothy 45 and Dorothy 47 wells, which produce natural gas from the Marcellus Shale.

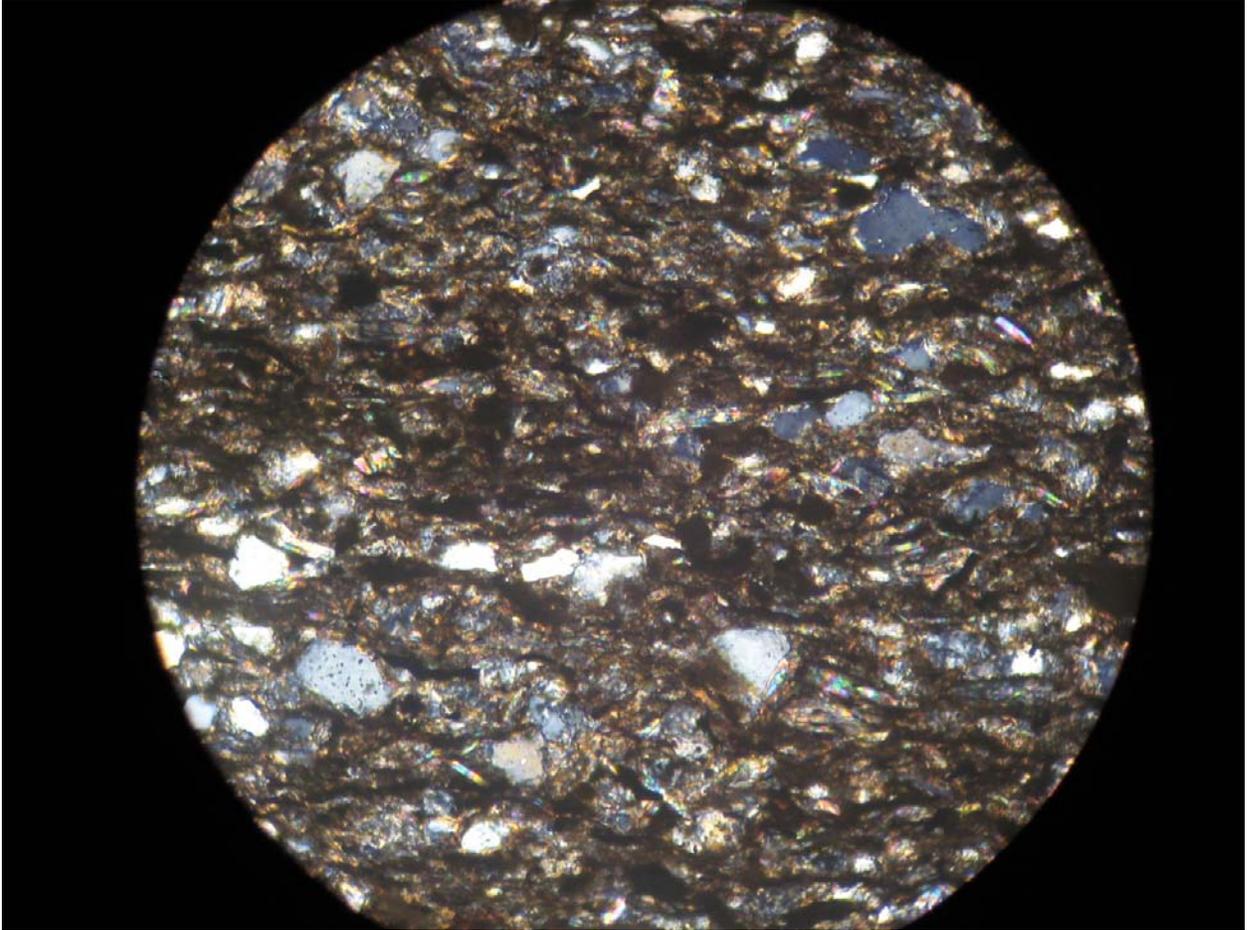
Figure Q-1. Angular grains of quartz (white, yellow) and plagioclase (gray, with dusty sericite alteration) are generally surrounded by a matrix of biotite (dark brown), muscovite (brightly speckled), and illite or very fine-grained muscovite in this sample of coarse siltstone from the 1 North Panel face roof. Field of view 1 mm at 100X.
