REPORT OF INVESTIGATION

**Fatal Underground Mine Explosion
April 5, 2010**

**Upper Big Branch Mine-South, Performance Coal Company
Montcoal, Raleigh County, West Virginia, ID No. 46-08436**

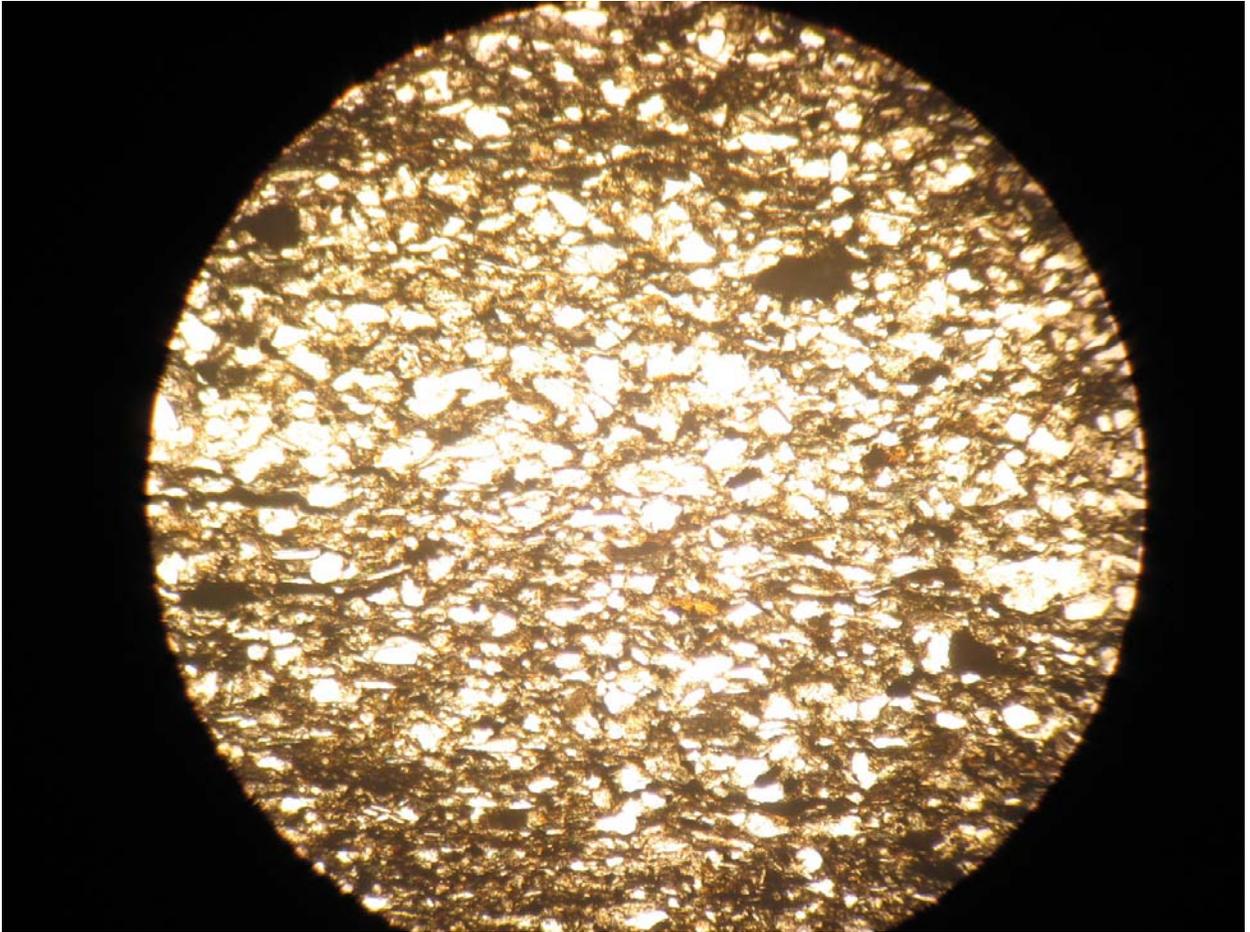
Figure Q-2. The roof rock, viewed in plane polarized light, reveals how changes in the concentration of biotite mica impart the effect of color banding in the coarse siltstone collected from the 1 North Panel face roof. Field of view 1 mm at 100X.

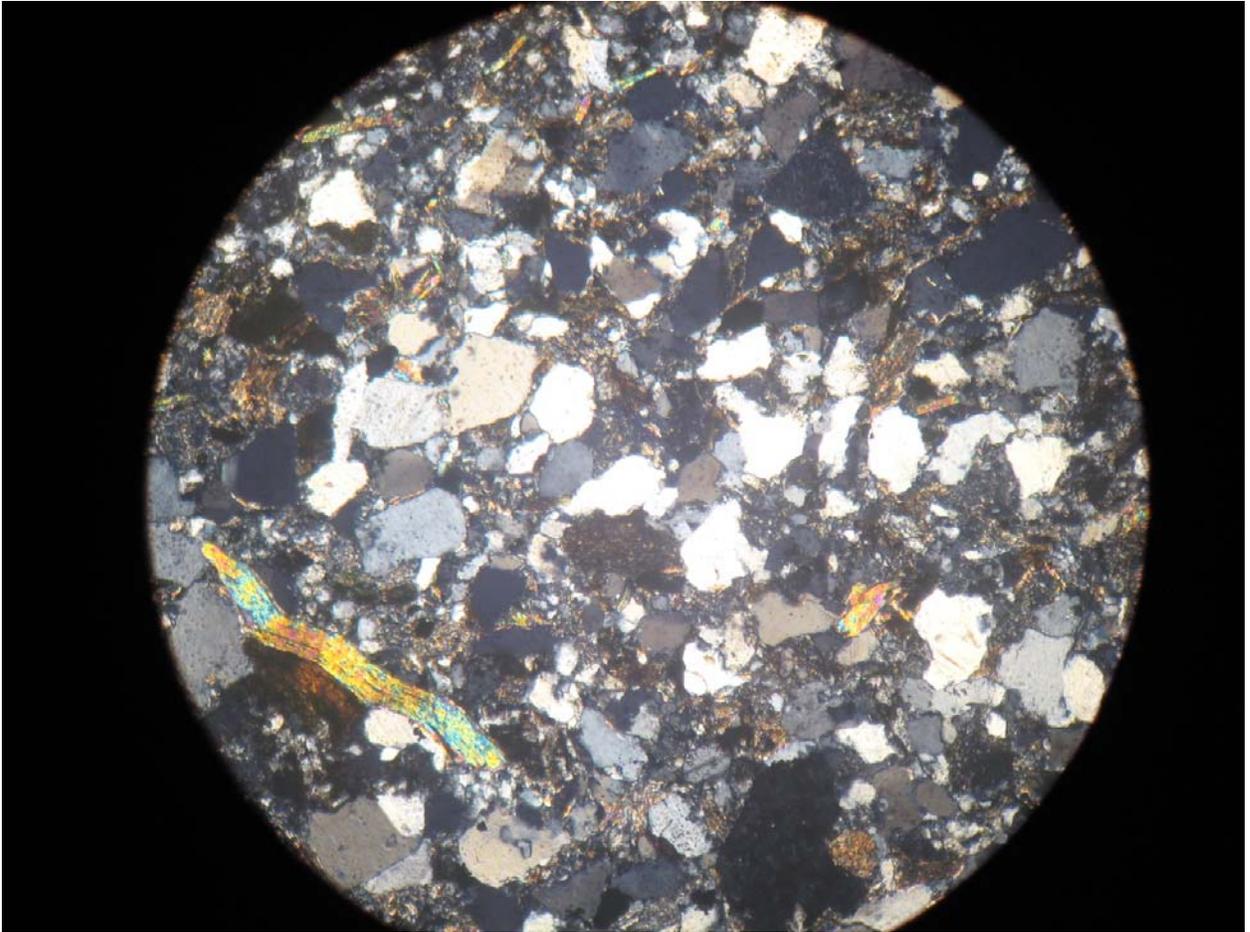
The sandstone, characterized as feldspathic arenite/wacke or arkose, is comprised of angular grains of quartz, plagioclase, and minor microcline that touch along tangential or concavo-convex boundaries, with individual grains or clusters of grains surrounded by a matrix of illite or very fine-grained muscovite (Figure Q-3). Angular, commonly jagged grains of quartz, ranging in size from 0.07-0.6 mm in diameter and constituting 43% of the rock, touch along tangential or concavo-convex boundaries. Angular grains of plagioclase, ranging in size from 0.07-0.4 mm in diameter and constituting 34% of the rock, touch along tangential and concavo-convex boundaries, and are commonly intermixed between larger quartz grains, and exhibit light to moderate sericite alteration. Angular grains of microcline, ranging in size from 0.2-0.3 mm in diameter and constituting 6% of the rock, are sparsely distributed, surrounded by angular grains of quartz and plagioclase. Ragged lathes of muscovite (5% lathe content, 17% including sericite, 0.04-1.1 mm diameter) are sporadically distributed, with individual lathes isolated by surrounding quartz and feldspars (Figure Q-4).

Figure Q-3. Layer of feldspathic arenite interbedded with coarse siltstone from the roof of 1 North Panel face is characterized by angular grains of quartz (white), plagioclase (gray, with dusty sericite alteration), and rare microcline (plaid black and gray) that touch along tangential and concavo-convex boundaries that leave few interstices for illite/muscovite matrix material. Field of view 2.4 mm at 40X.

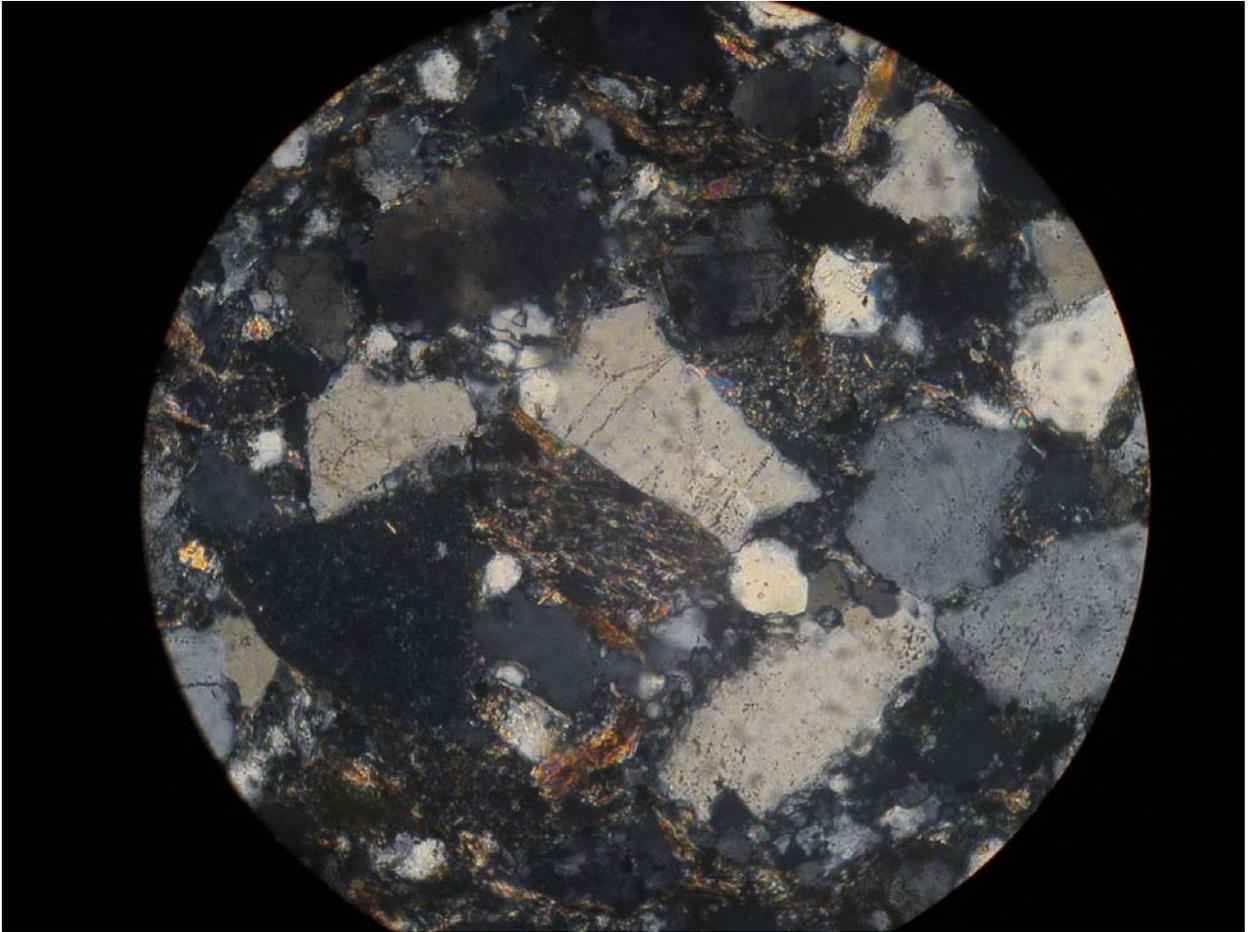
Figure Q-4. Angular grains of quartz (white, shadowed) and plagioclase (gray, with dusty sericite alteration) touch along straight, tangential, and concavo-convex boundaries that leave few interstices for illite/muscovite matrix. Field of view 1 mm at 100X.

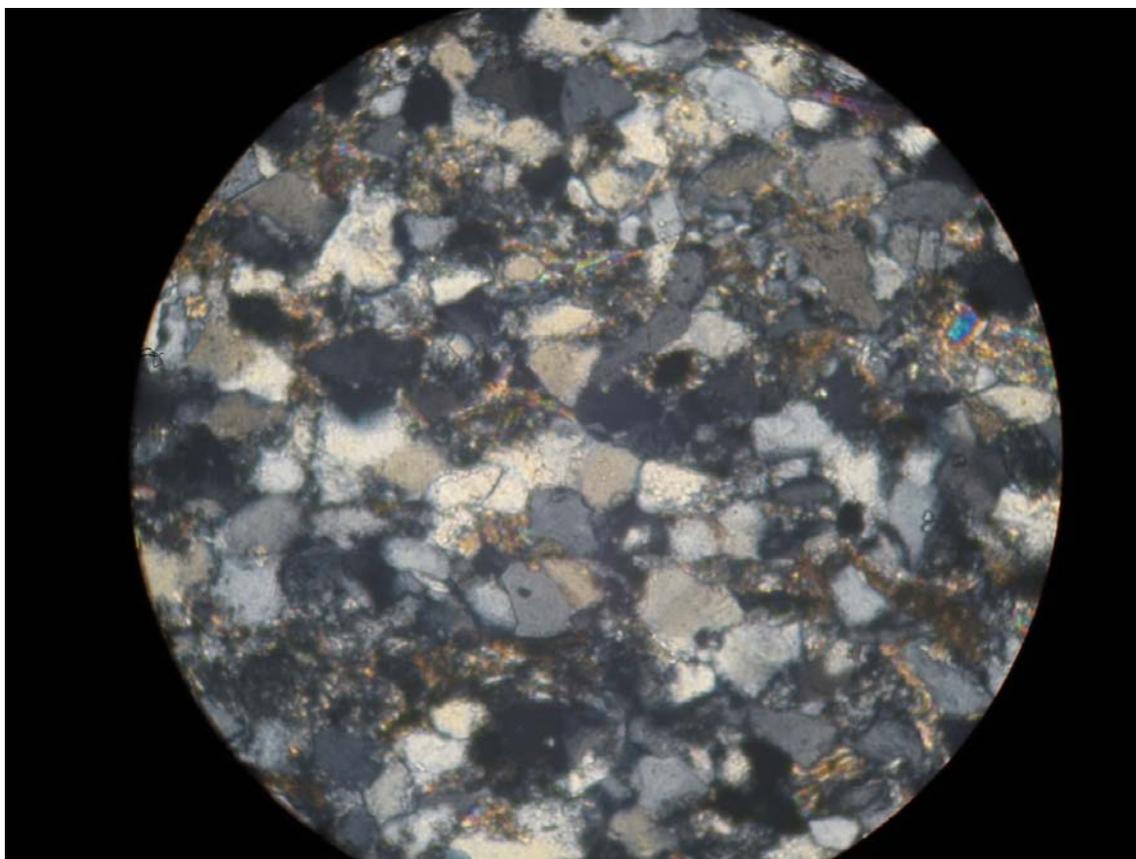
Figure Q-7. In fine-grained feldspathic arenite/subarkose sandstone from floor, angular grains of quartz (yellow, gray) and plagioclase (wavy shades of gray) interlock along straight, concavo-convex, and sutured boundaries, with only minor amounts of mica or sericite in small, rare interstices. Cluster of quartz grains at center of view interlock along sutured boundaries that meet at roughly 120° angles, indicating compaction recrystallization. Field of view 1 mm at 100X.

Compared to the sample collected from the roof, the floor sample contains a much greater quartz content, and is characterized by a much greater degree of grain interlocking, with a significant number of concavo-convex and sutured boundaries. Several areas exhibit sutured boundaries along quartz grains that meet at 120° angles, indicating a degree of diagenetic compaction recrystallization. Similarly, mica flakes are wrapped around obdurate quartz grains due to intense compaction. Due to the higher quartz content in the floor sandstone, it has a higher average Mohs Hardness value of 6.31, compared to a value of 5.83 for the sandstone in the roof, or 3.64 for the dark gray siltstone in the roof. Furthermore, the floor sandstone appears to be more fine-grained, with maximum grain sizes of 0.2 mm compared to grain sizes of 0.4-0.6 mm in the roof sandstone. The grain size distribution also seems more uniform in the floor sandstone.

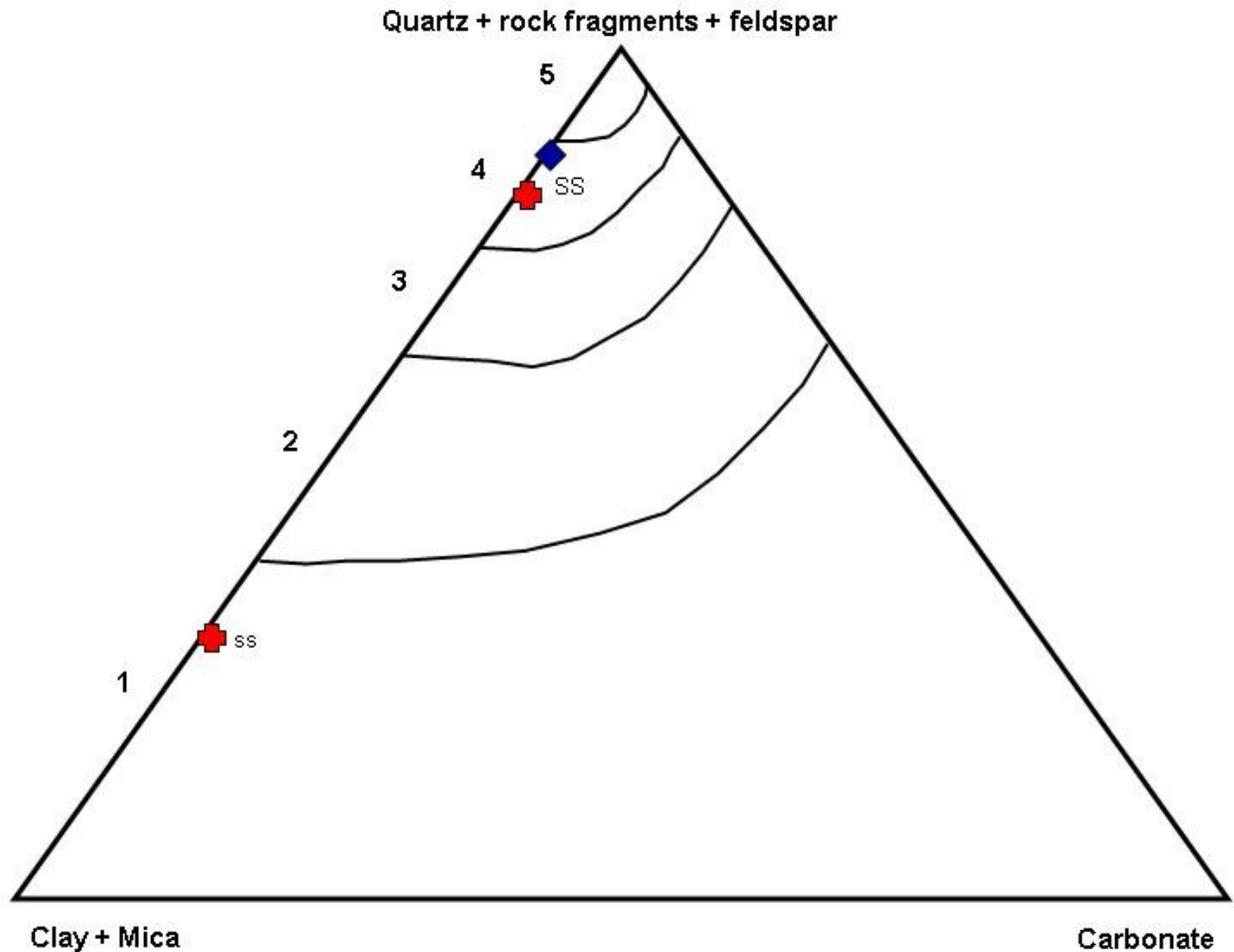
Based on the mineral contents determined by thin section petrography, the samples were plotted on the ternary diagram developed by Ward et al. (2001) for comparison with the incendivity index developed for rocks in Australian coal mines (Figure Q-8). The layers of coarse siltstone, which contain a high mica content, plot in Category 1, indicating a low potential for frictional ignition. In contrast, the sandstone plots in Category 4, indicating a high potential for frictional ignition. The floor sandstone very nearly plots in

the Category 5 zone, due to its high quartz content. It should be noted that the incendivity index applies to rock-on-rock and metal-on-rock ignitions. Thus, sandstone falling in the gob behind the shields, or sandstone being struck by bits on the shearer would both represent potential ignition sources.

Figure Q-8. Ternary diagram after Ward et al. (2001) showing relation of Upper Big Branch roof (red crosses) and floor (blue diamond) sandstone (SS) and siltstone (ss) to contour lines of incendivity index. Rocks with an incendivity index of 4-5 were shown in tests to have a high potential for frictional ignition. Although sandstone from roof and floor have similar incendivity indices, the floor sample is composed dominantly of quartz.

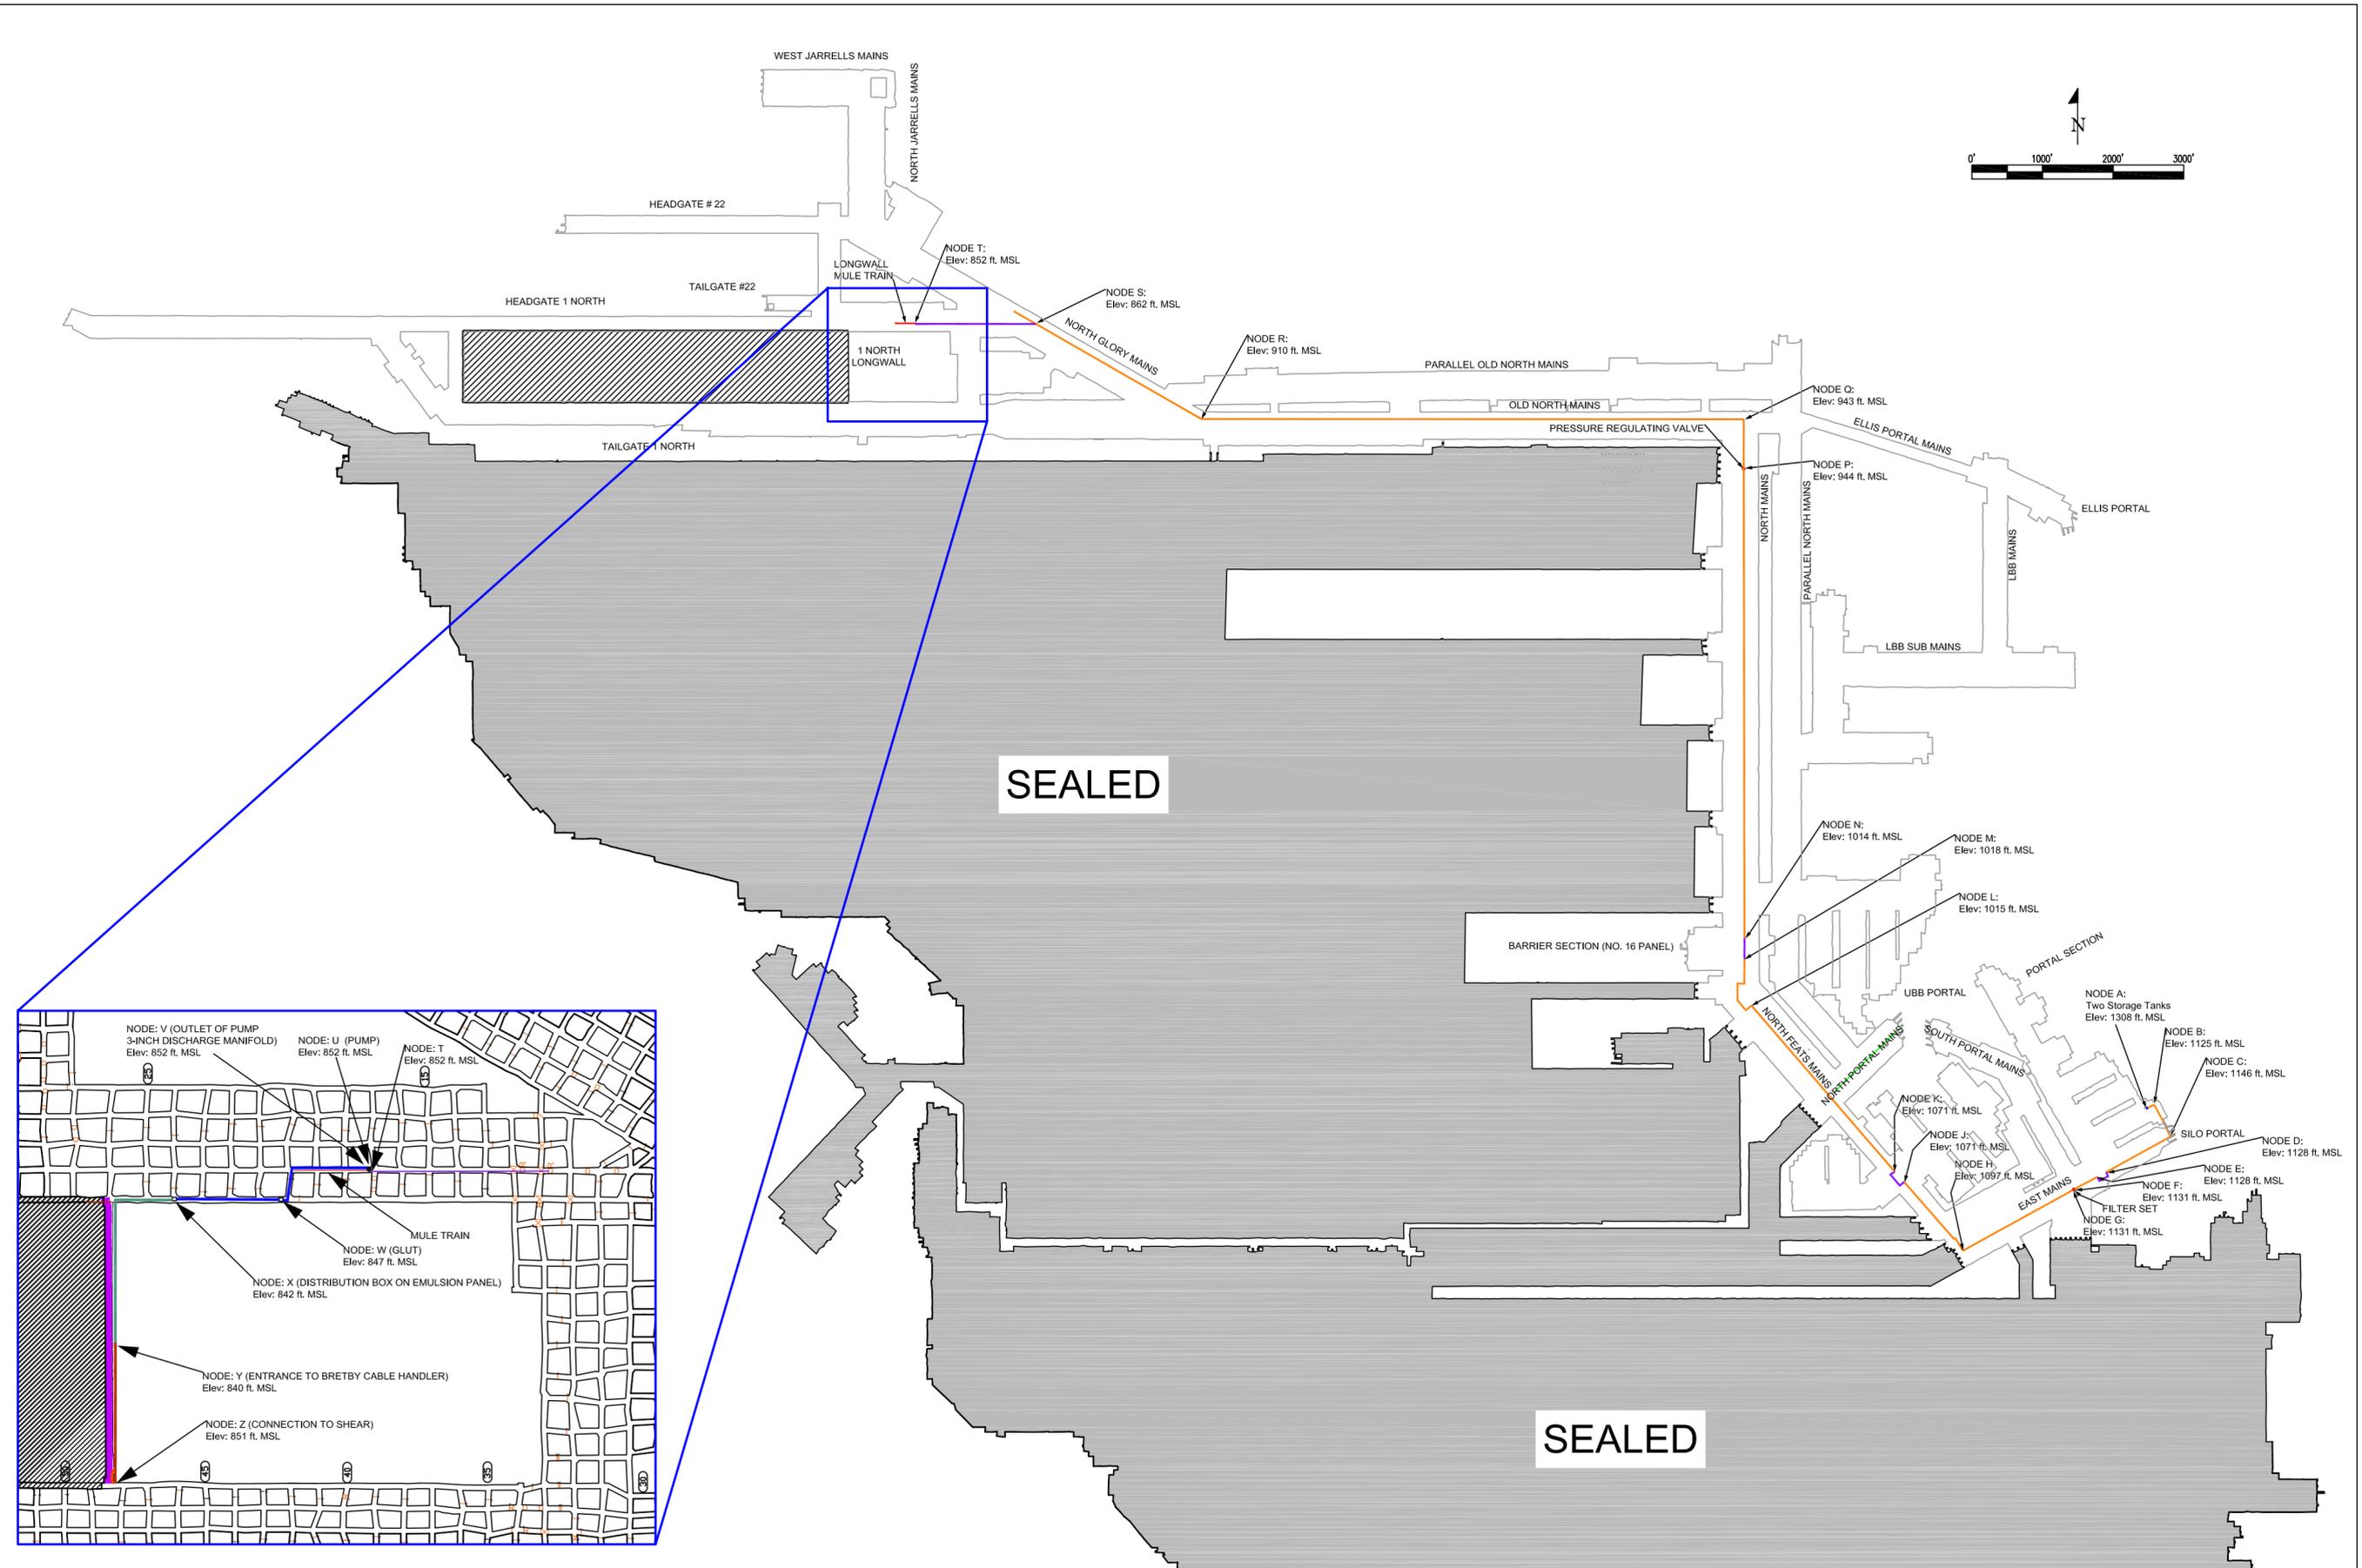
FIGURE R-1
 Location of Waterline Supplying the
 Mule Train
 Upper Big Branch Mine – South
 Performance Coal Company
 MSHA ID No. 46-08436

The exact location of this node is assumed. The connection point to the East Mains water line in this area could not be found due to a large build up of rib sloughage and rock dust which buried this part of the water line. The elevation is approximately 1146 ft MSL.

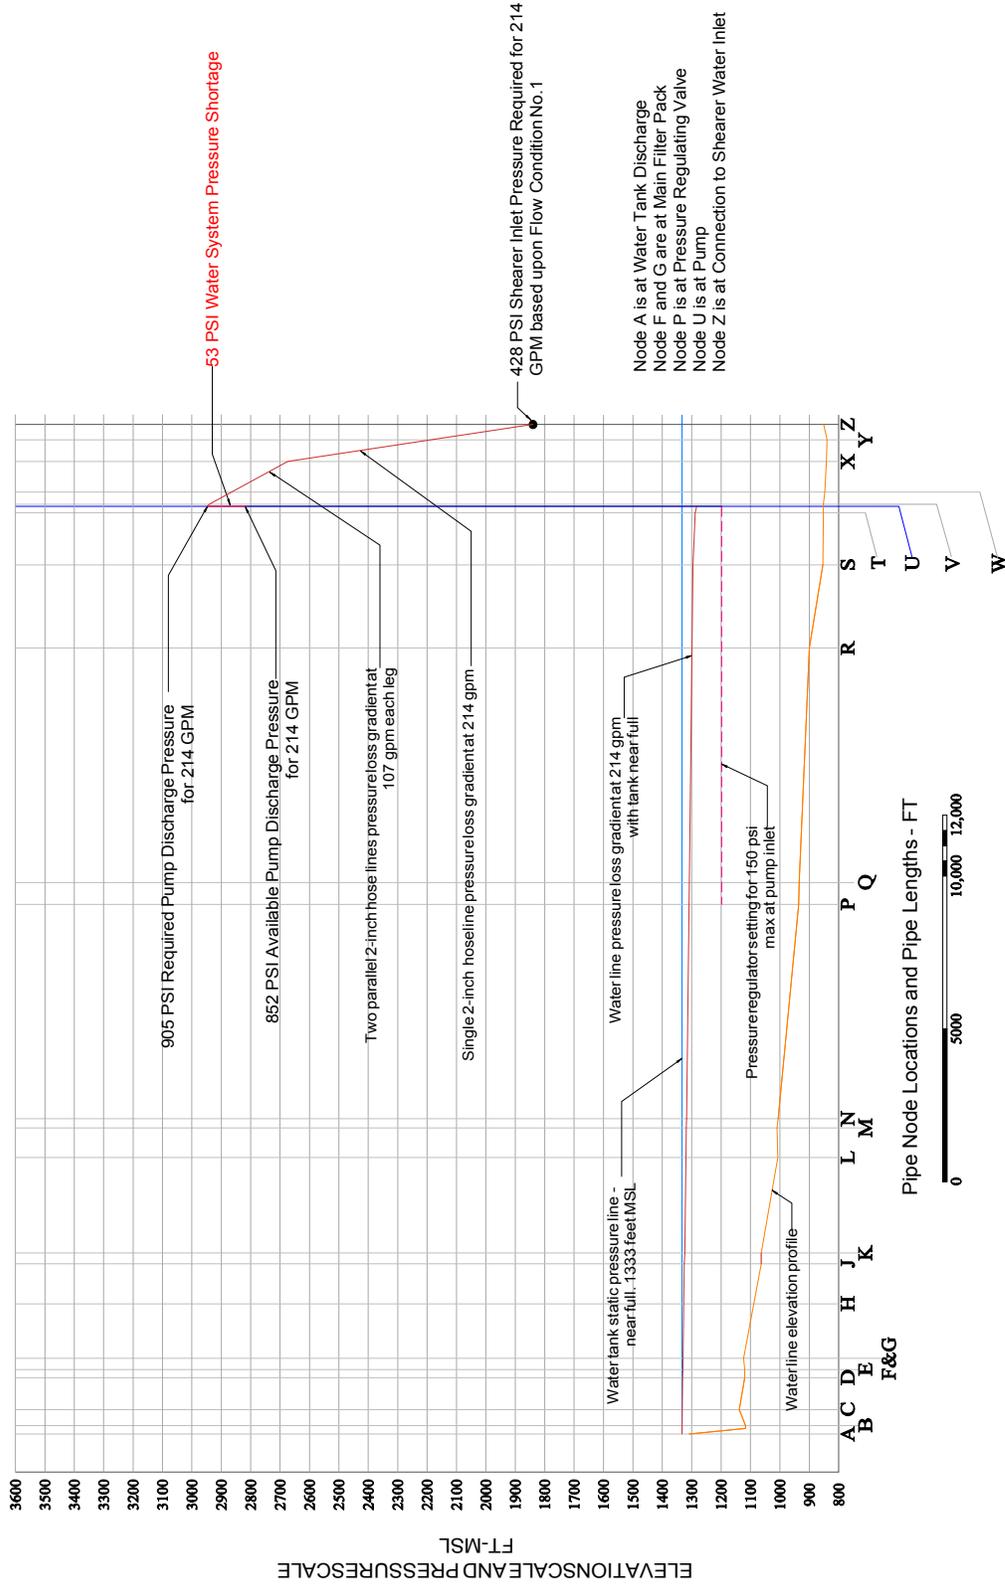
Step 4: Compare the pressure required in Step 3 to the available pressure determined in Step 2. If the required pressure exceeds the available pressure, the water system is deemed inadequate. For the analysis conducted herein, the required pressure exceeded the available pressure for all the flow scenarios that were considered.

FIGURE R-2 UBB WATER SUPPLY TO LONGWALL HYDRAULIC PROFILE
 Flow Scenario 1
 Shearer Flow 214 GPM
 Total Flow 214 GPM

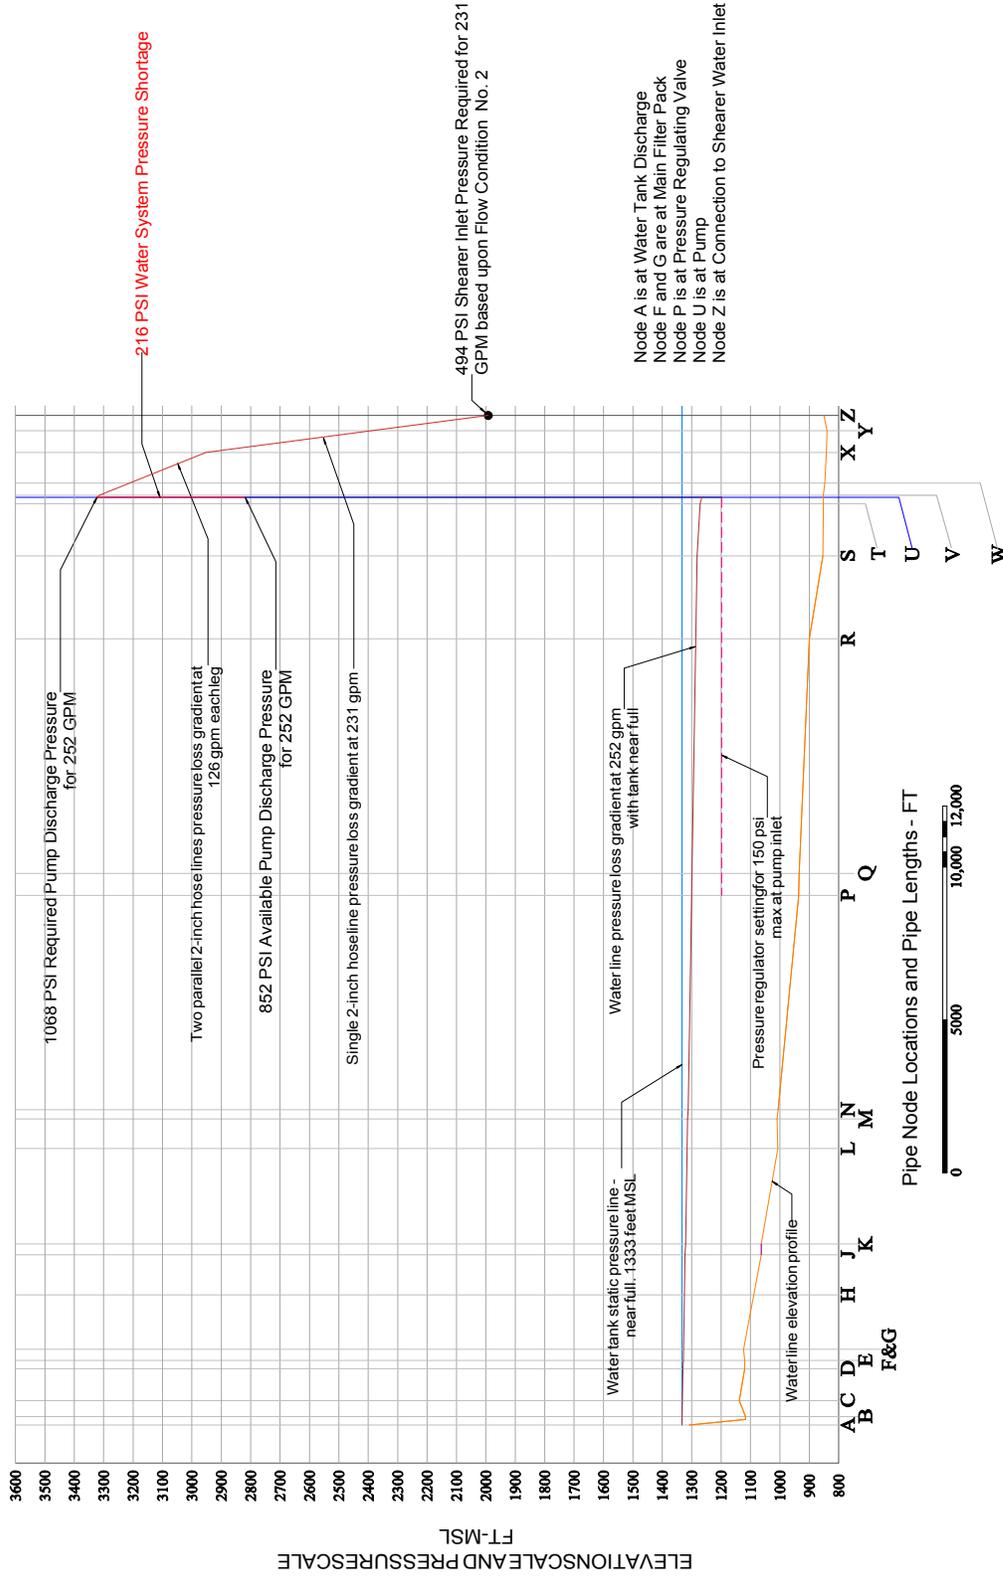
FIGURE R-3 UBB WATER SUPPLY TO LONGWALL HYDRAULIC PROFILE
 Flow Scenario 2
 Shearer Flow 231 GPM
 Total Flow 252 GPM

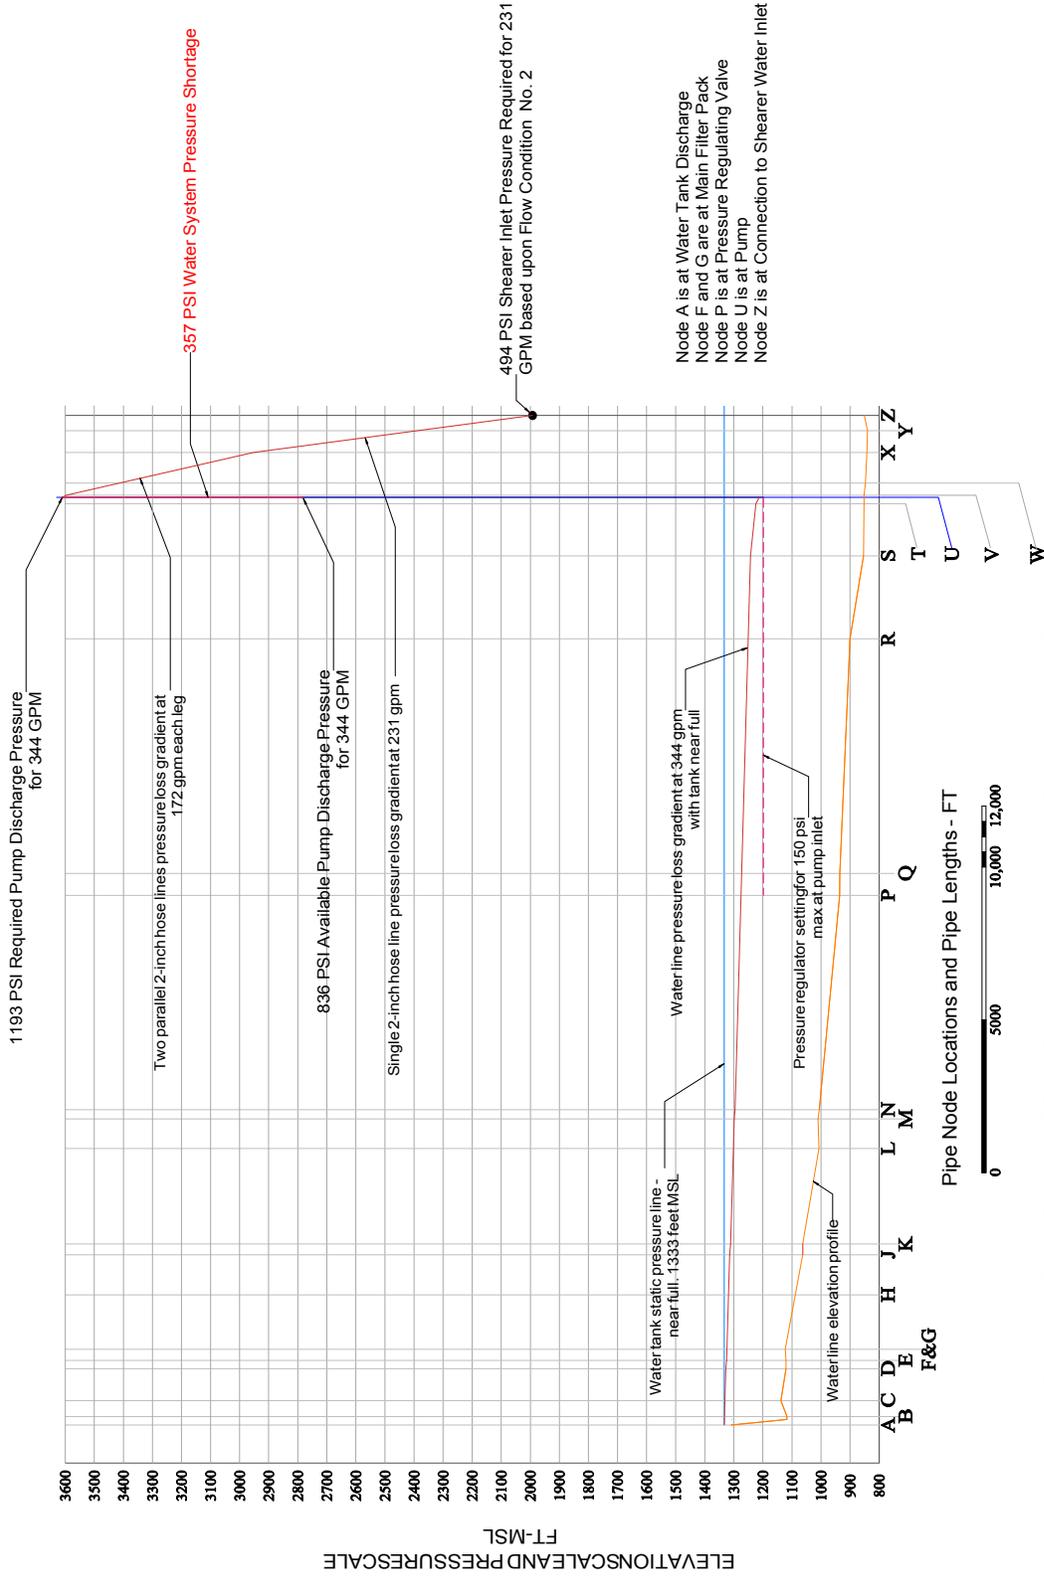
FIGURE R-4 UBB WATER SUPPLY TO LONGWALL HYDRAULIC PROFILE
 Flow Scenario 3
 Shearer Flow 231 GPM
 Total Flow 344 GPM

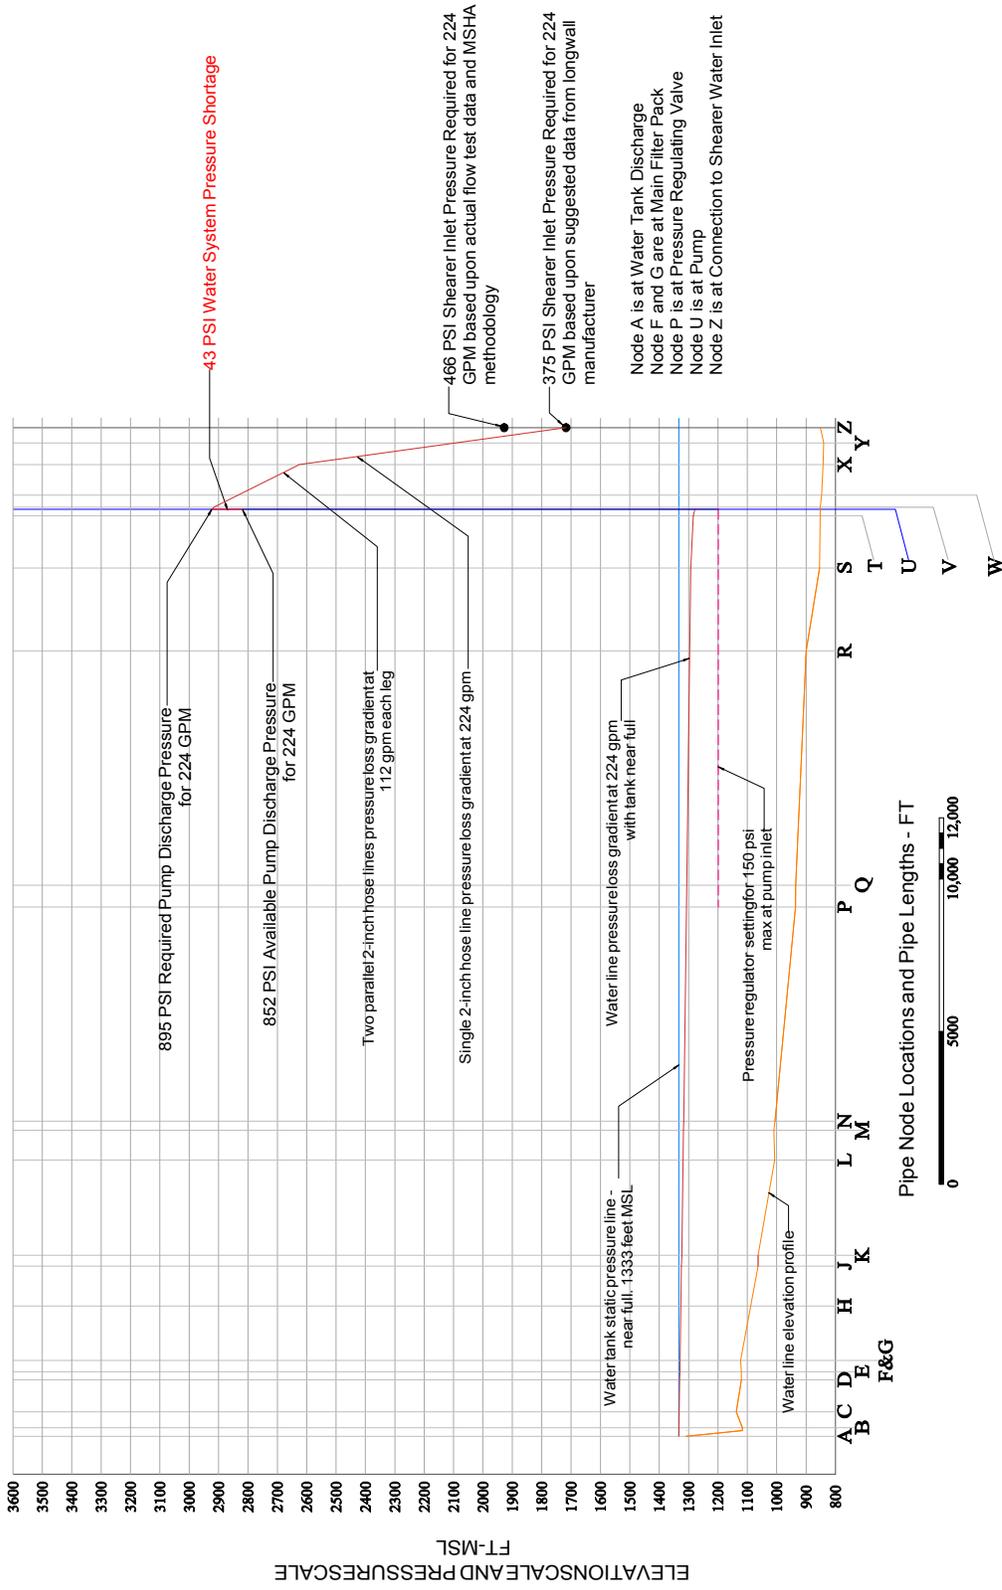
FIGURE R-5 UBB WATER SUPPLY TO LONGWALL HYDRAULIC PROFILE
 Flow Scenario 4
 Shearer Flow 224 GPM
 Total Flow 224 GPM

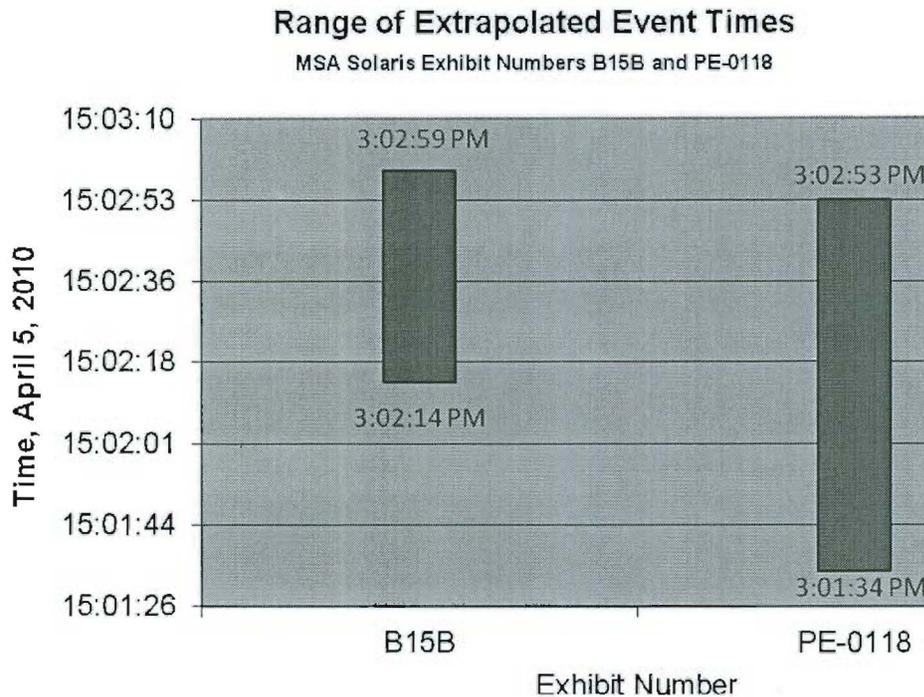
the drift was constant from April 5, 2010 until MSHA began taking time measurements, the actual expected time and date for the over-range events is as shown on the graph below.

The difference in the median of these two ranges is most likely due to the differences in the environment of the two detectors. Exhibit Number B15B was received on June 24, 2010, and kept in the climate-controlled MSHA building. Exhibit Number PE-0118 was not received until July 19, 2010. The environment before that date is not known, but has been anecdotally described as non-climate controlled.

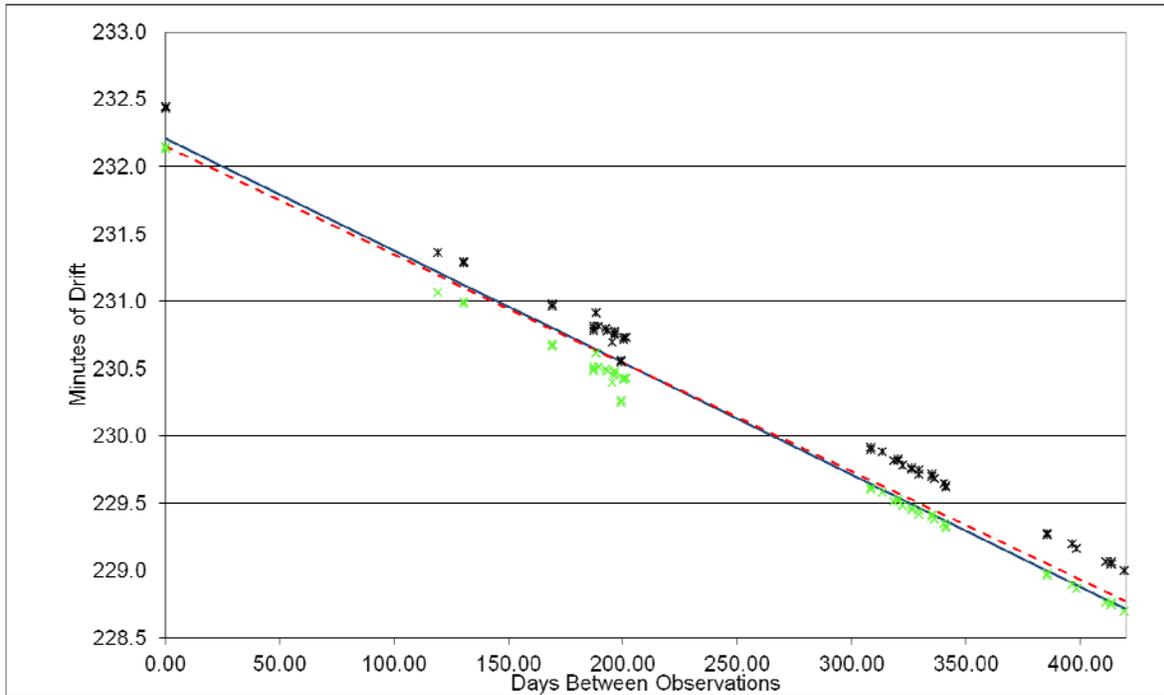
Figure 1. Calculated Minimum and Maximum Clock Drift Rates, Exhibit No. PE-0164

The smallest tolerance on the time observed on the MSHA network and www.time.gov that would allow a straight line to fit all points, as shown on Figure 1 below, was the minimum allowable tolerance of ± 9 seconds. This tolerance was then applied to the reference time, resulting in the points on Figure 1; the points represented by asterisks were the largest possible deviation, and those represented by X were the smallest possible deviation.

The maximum and minimum slopes were 0.49971 and 0.4824 seconds per day. This means, if the drift was constant from April 5, 2010 until measurements started on July 23, 2010, the actual expected time and date for the last "STS Right Handheld ESTOP" event which was recorded at 6:52:39 PM on April 5, 2010 was between 2:59:32 PM and 2:59:38 PM on April 5, 2010.

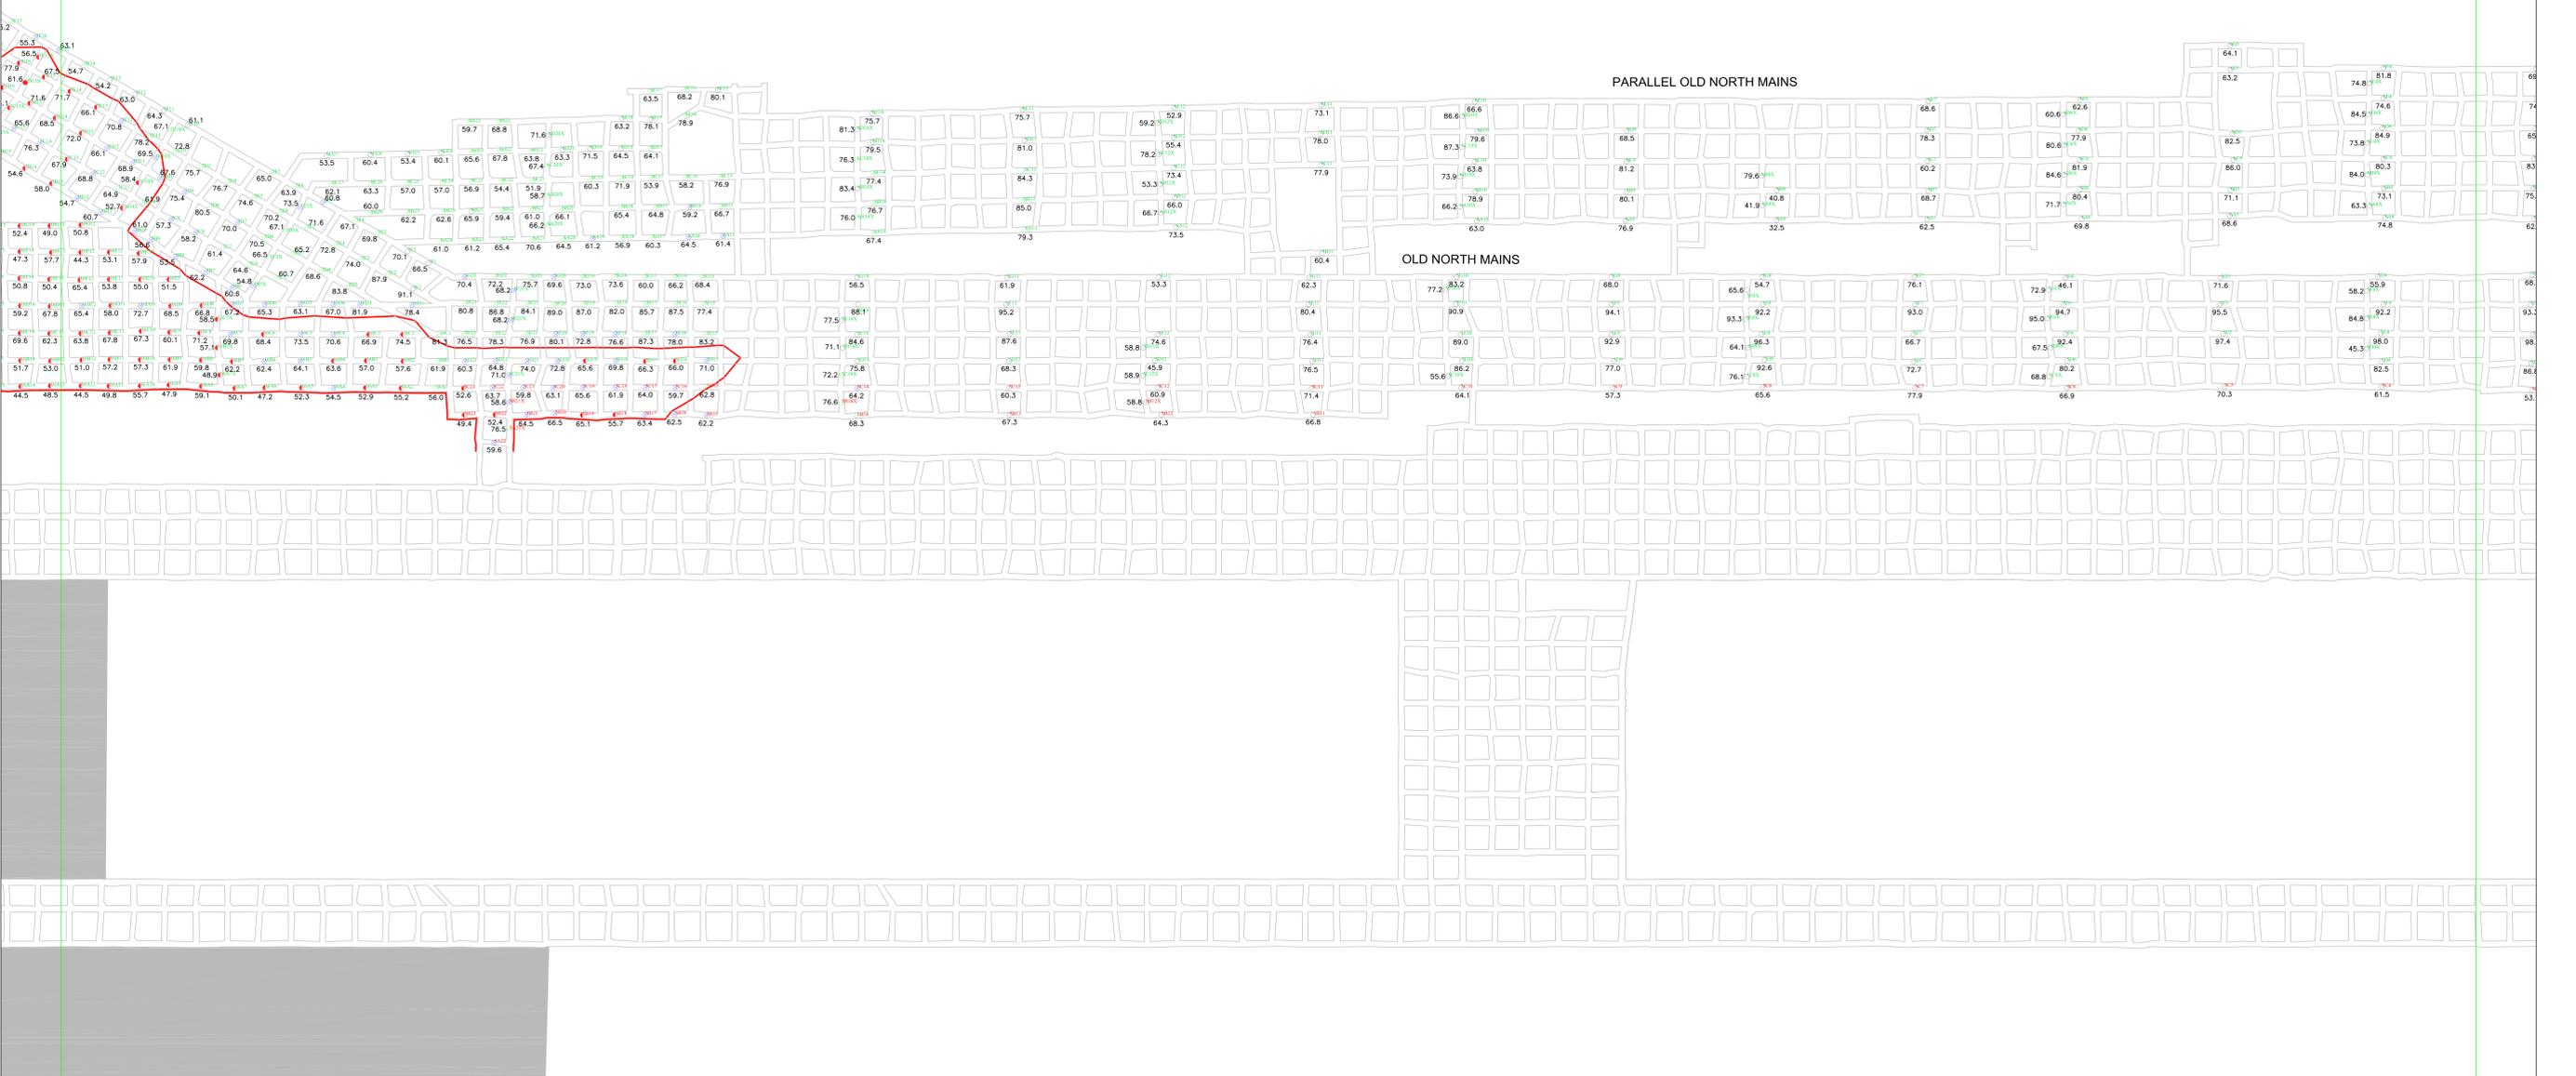
APPENDIX Z-2
 Mine Map Showing Extent of Flame,
 Incombustible Content, and Coke
 Upper Big Branch Mine – South
 Performance Coal Company
 MSHA ID No. 46-08436

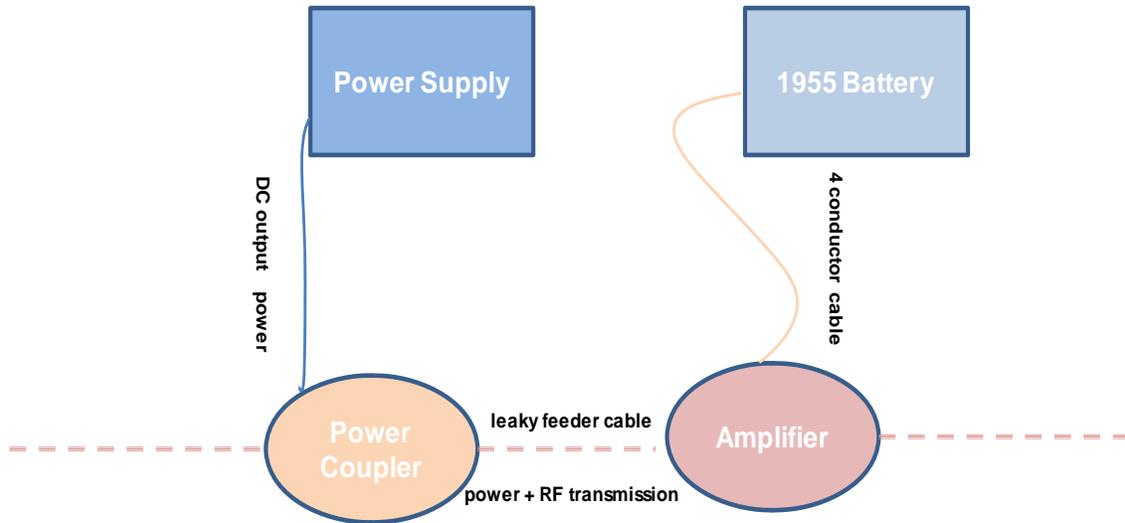
Figure 1 Sketch of Part of the Power Path for the Leaky Feeder System

- 2.9.2. Each amplifier in the leaky feeder system has its own 1955 battery backup unit. Amplifiers receive power over the leaky feeder cable from power couplers which are in line with a power supply. The 1955 battery is charged from DC voltage that travels over the leaky feeder cable, through the amplifier circuit, and through the four conductor cable to the 1955 battery charge circuit as shown in Figure 1.

- 2.9.3. The amplifier circuit includes a non-replaceable (soldered to the printed circuit board) fuse. Reports from field installations indicate that this fuse is susceptible to opening, reportedly due to voltage spikes from the line power source. Even when a 1955 battery is fully charged, an open fuse renders the amplifier inoperable, so communications inby the inoperable amplifier are severed. Although the operation of the tracking readers would be unaffected by the open fuse in the amplifier because they could continue to function on their own standby power source, they would not be able to transmit tracking data to the surface because the open fuse in the amplifier disrupts the operation of the leaky feeder system.
