REPORT OF INVESTIGATION

**Fatal Underground Mine Explosion
April 5, 2010**

**Upper Big Branch Mine-South, Performance Coal Company
Montcoal, Raleigh County, West Virginia, ID No. 46-08436**

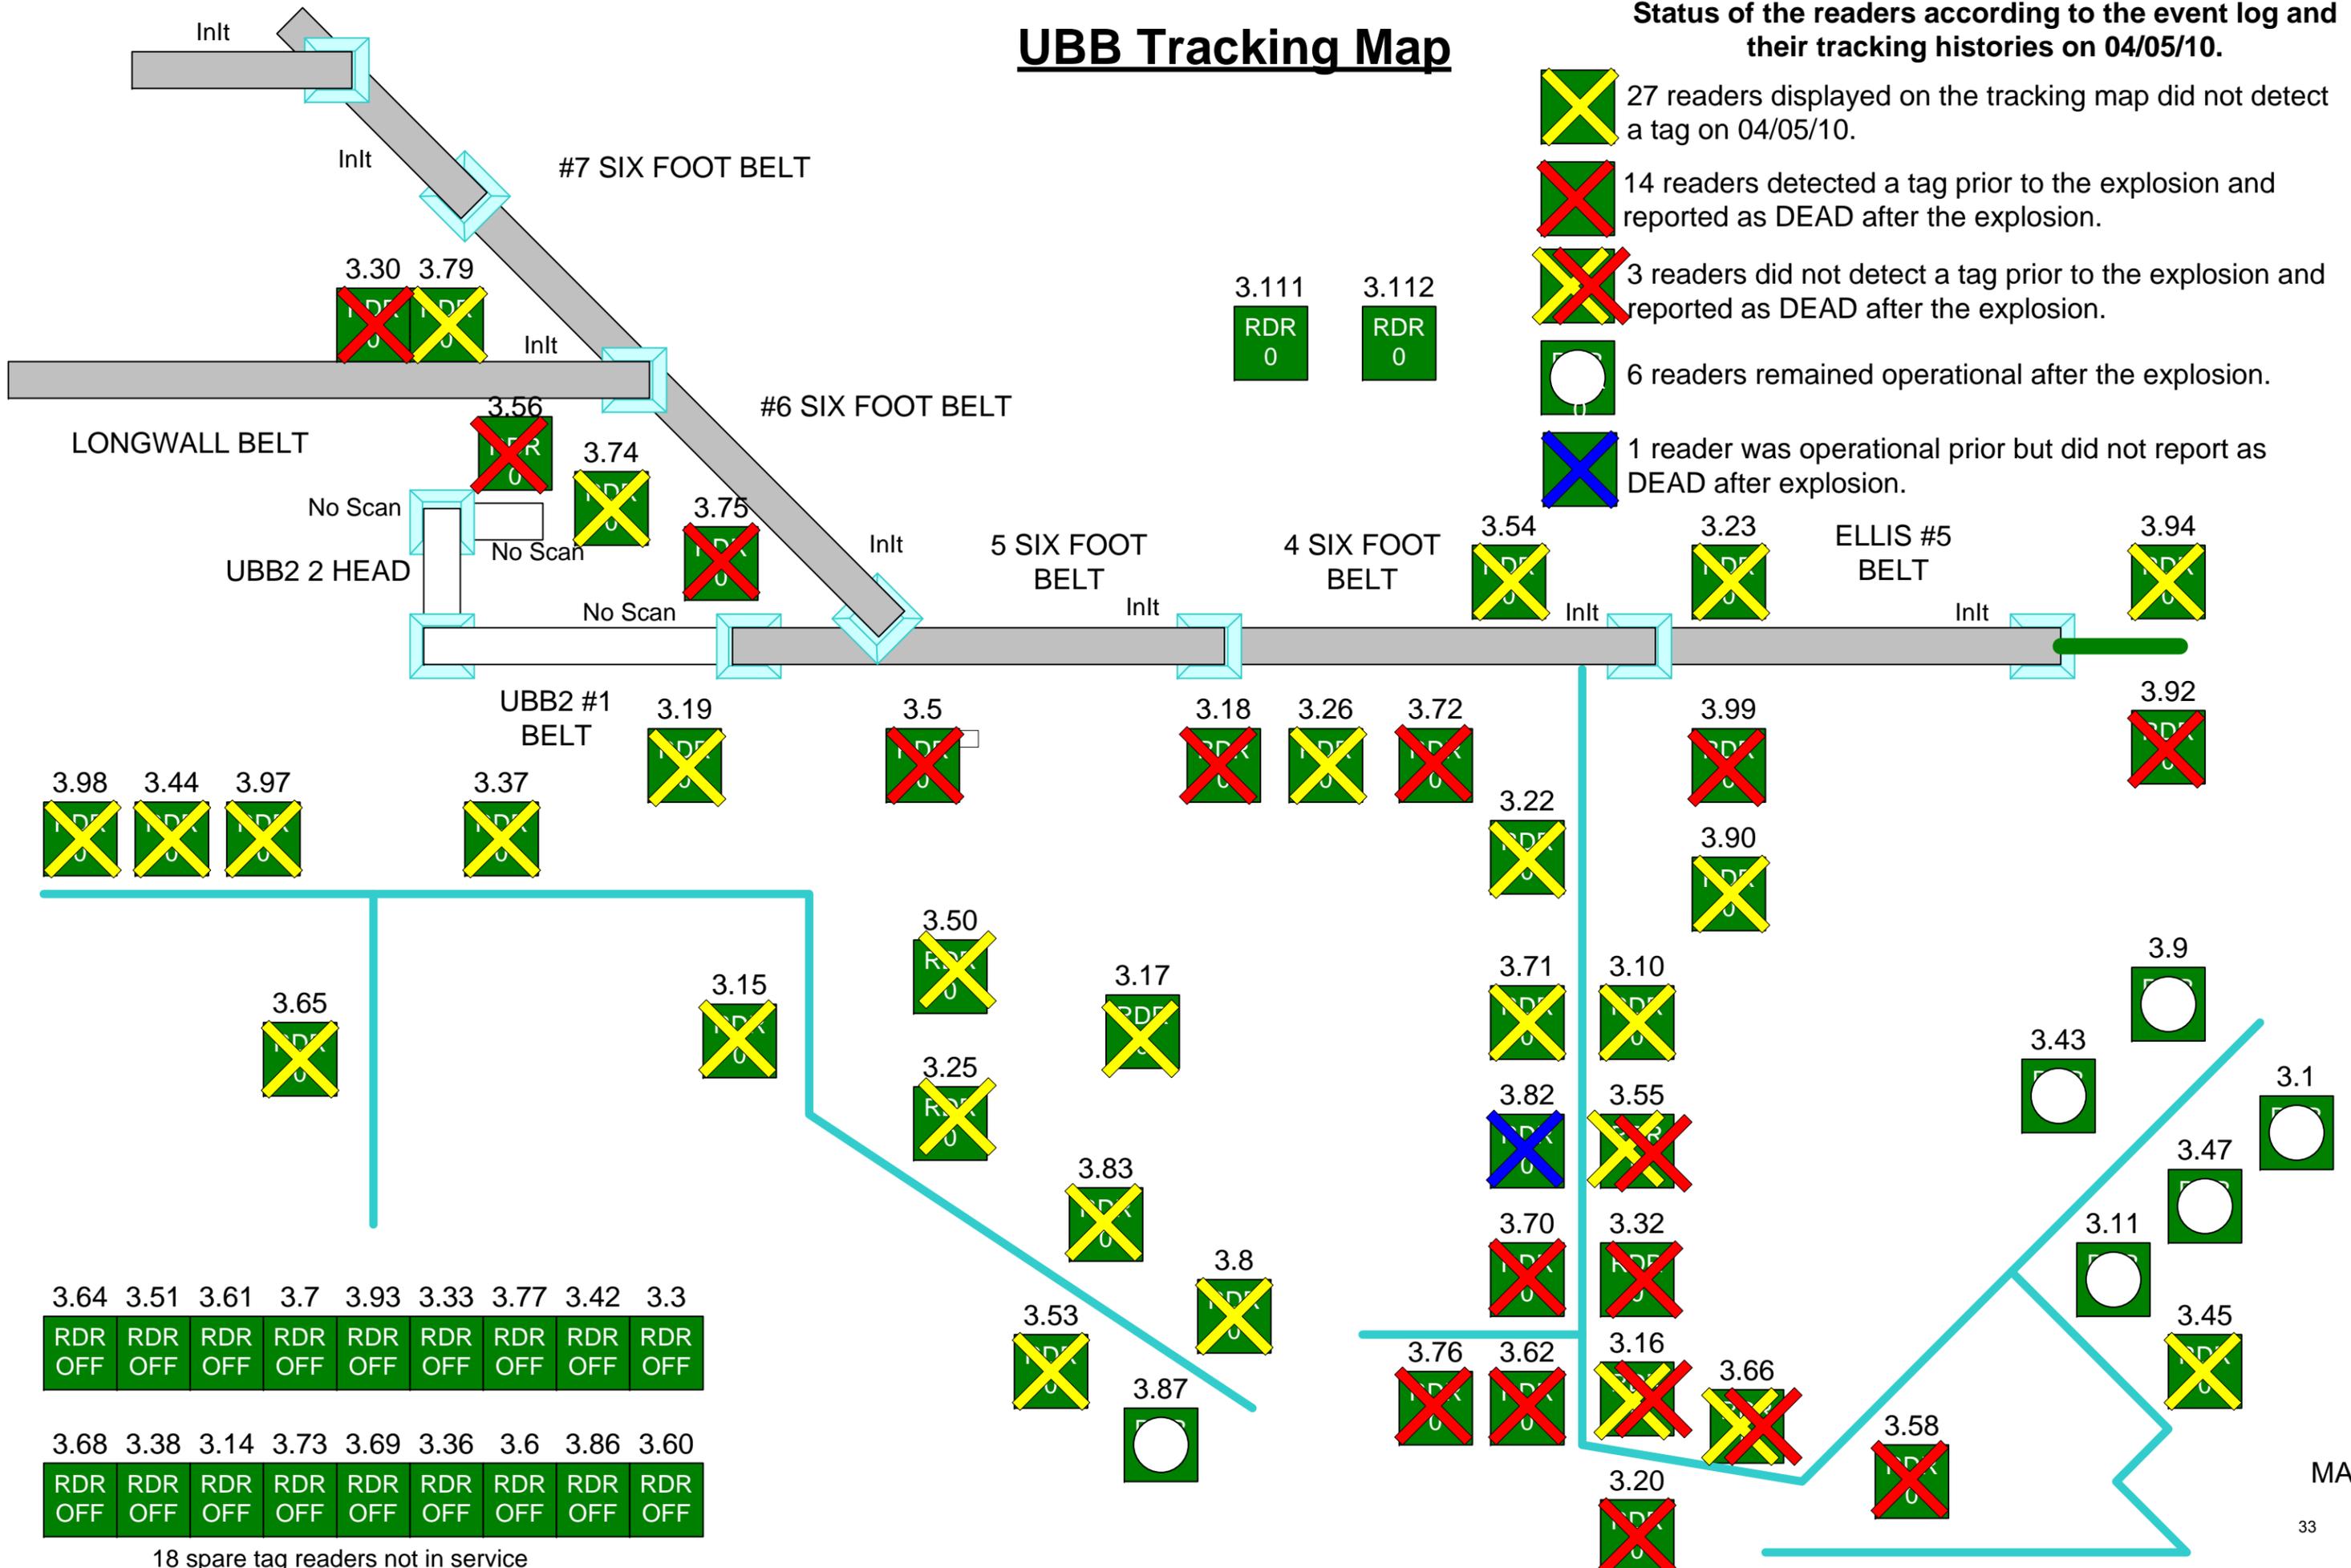
UBB Tracking Map

Status of the readers according to the event log and their tracking histories on 04/05/10.

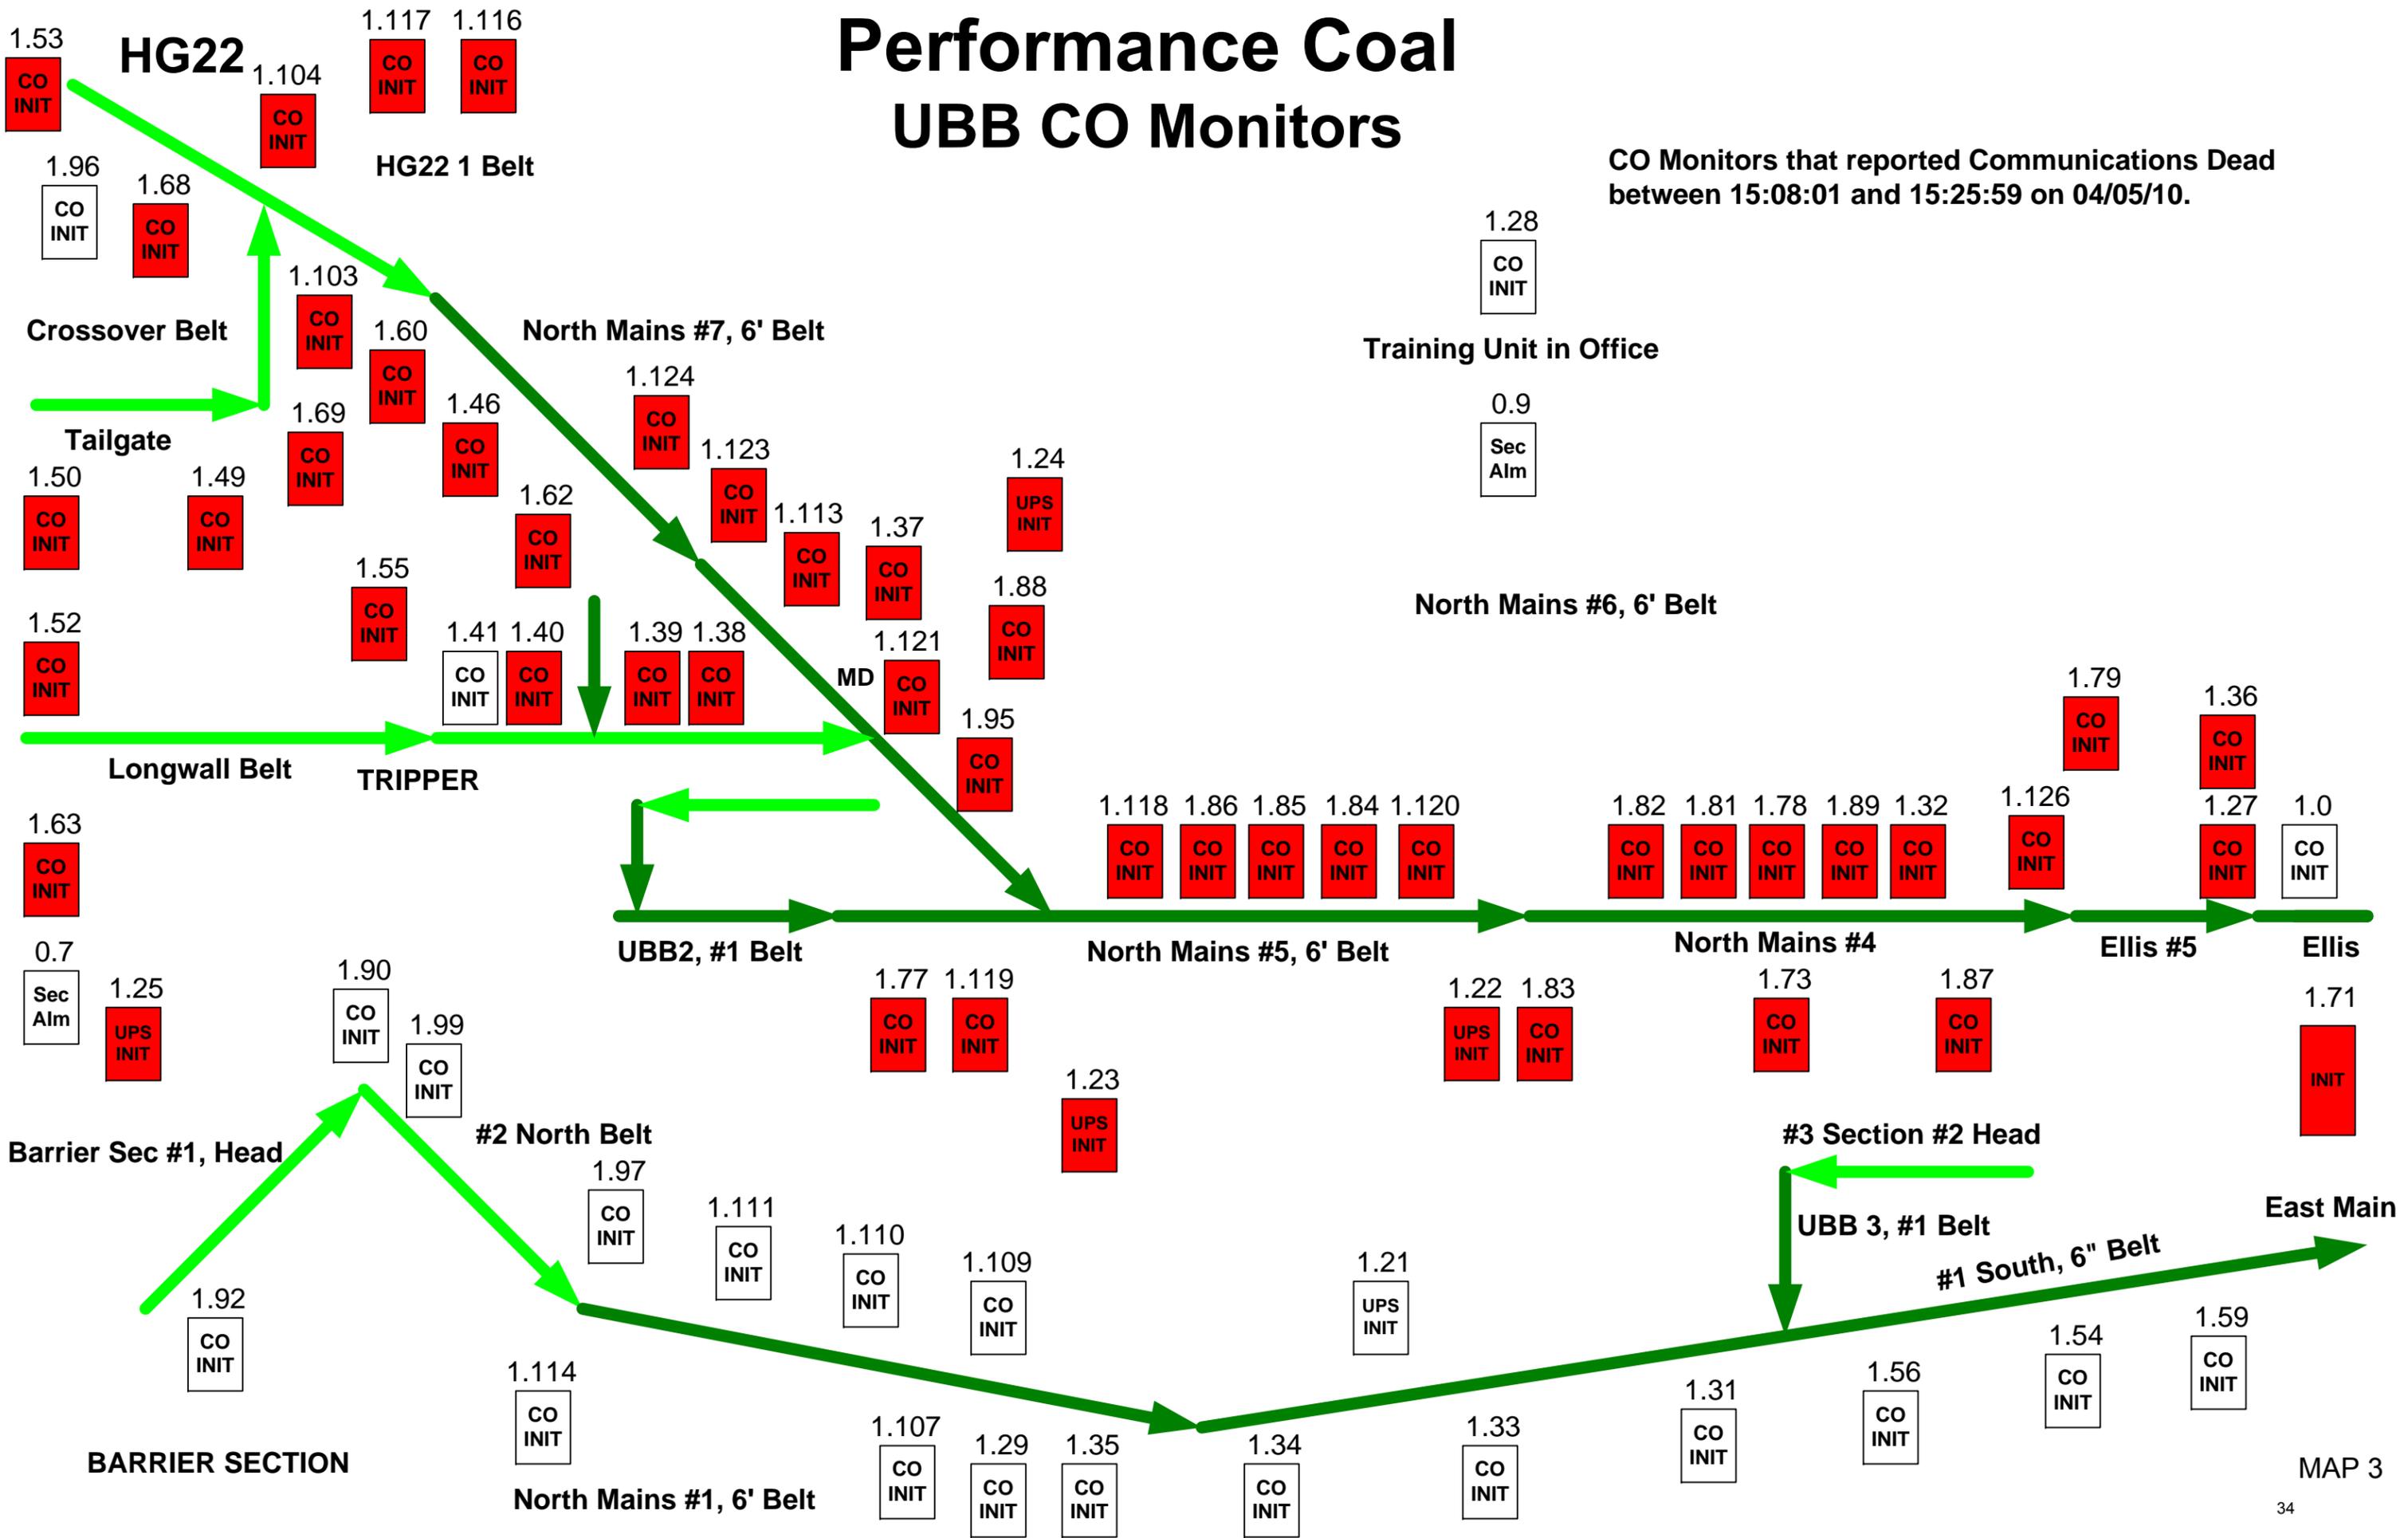
Performance Coal UBB CO Monitors

CO Monitors that reported Communications Dead between 15:08:01 and 15:25:59 on 04/05/10.

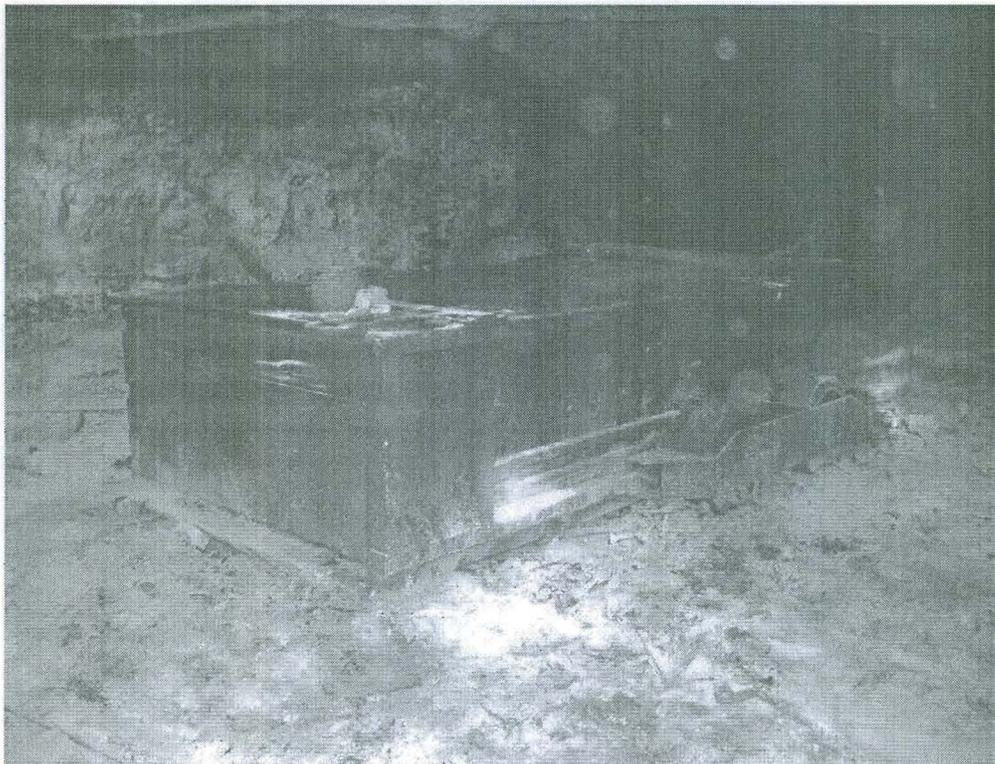
Location: **Headgate 21**
 Strata Fresh Air Bay Model M2624-3.5
 Serial Number 452043-02

- Side access door showed no visible damage.
- Solaris™ gas detector was located inside this side access door.
- Compressed gas cylinder pressures were within the manufacturer's specifications (4400-4600 psi).
- No corrosion or moisture in cylinder storage compartment.
- The tent inflated (approximately 4 minutes).
- Purge air system was functional.

- The CO2 scrubber fan motor started and ran. No scrubbing chemicals were used.
- The oxygen system functioned.
- The supplies were intact.

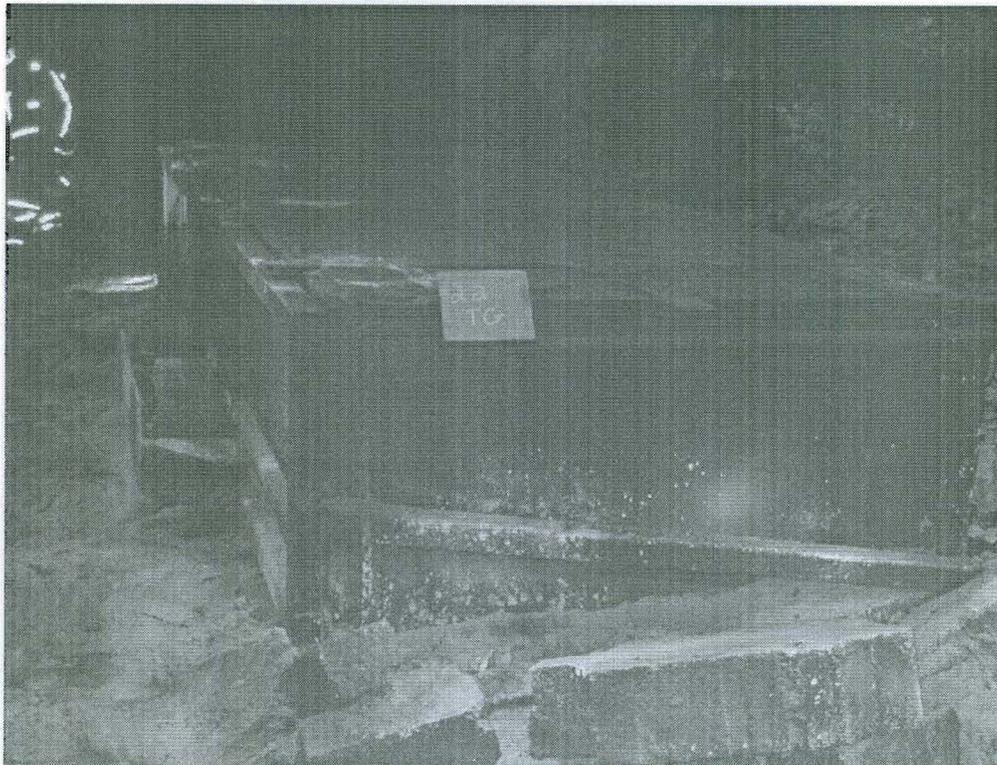
Location: Tailgate 22
 Strata Fresh Air Bay Model M2624-3.5
 Serial Number 452081-02

- Side access door showed no visible damage.

- No Solaris™ or other gas detector was located on this unit.
- Compressed gas cylinder pressures were within the manufacturer's specifications (4400-4600 psi).
- No corrosion or moisture was evident in cylinder storage location.
- The tent inflated. (approximately 4 minutes).
- Purge air system functioned.
- The CO2 scrubber fan motor started and ran..
- The oxygen system functioned.
- The supplies were intact.
- The tent deployment door would not open fully due to a rib roll. The tent was able to inflate and deploy around the door with no compromise.

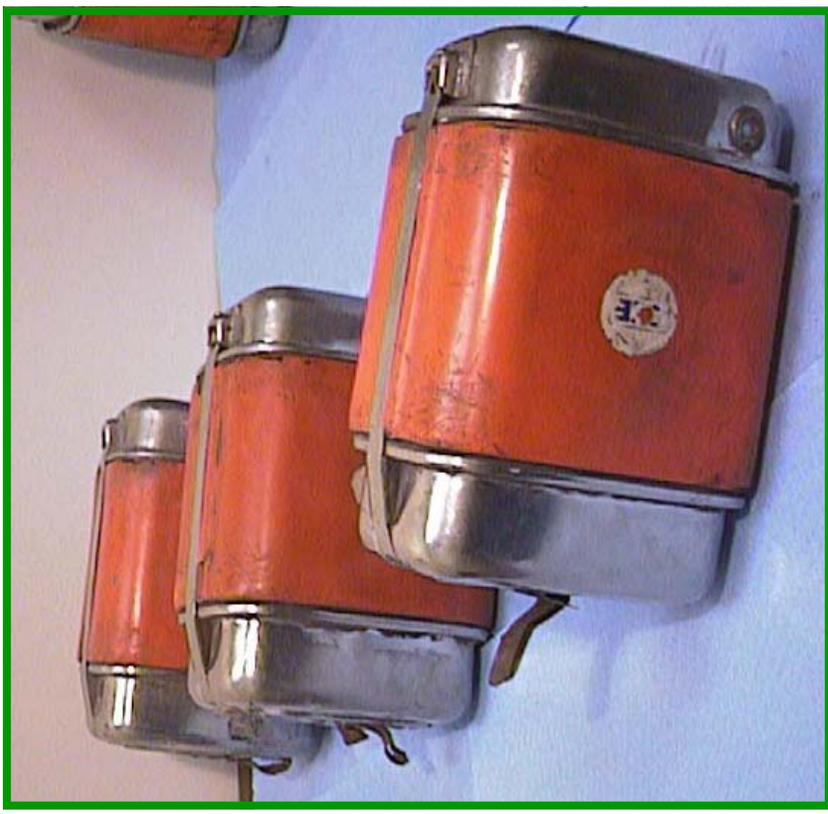
These three units have been in service for approximately six years and show the typical signs of normal wear and tear. The plastic dust covers are abraded on the corners and along the edges. There are also some dents in the top and bottom stainless steel covers.

However, the security bands are in place and the color indicators are blue, indicating no ingress of moisture. The two seals between the top and bottom covers and the chemical canister appear to be securely in place. These units pass the daily and 90-day visual inspection criteria.

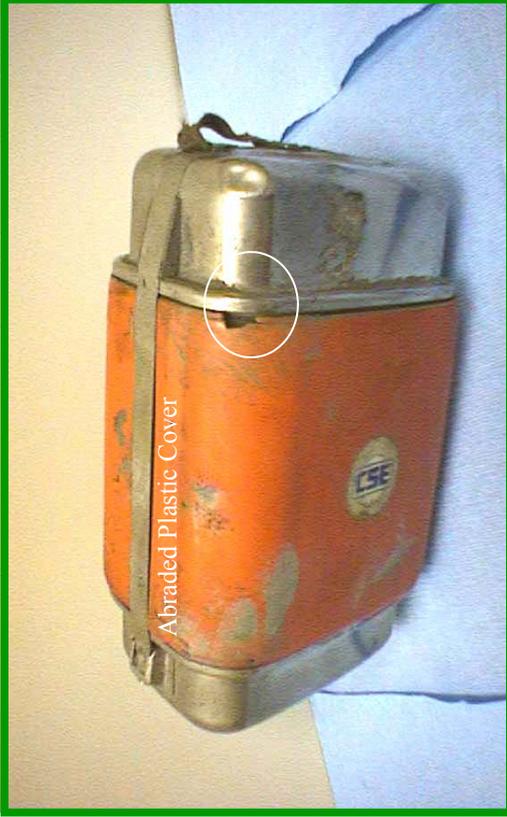
This unit's condition shows normal wear and tear. The abraded corner on the plastic cover and minor dent in the stainless steel top cover do not cause the unit to fail visual inspection. The unit may remain in service if it passes the remainder of the inspection.

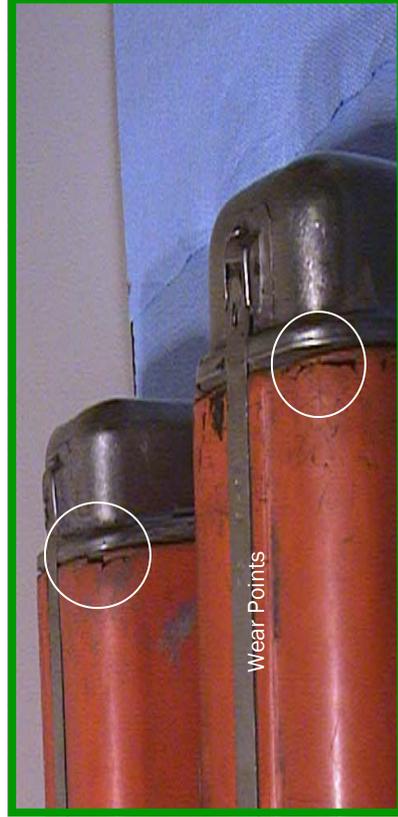
These wear points are the result of abrasion and minor impacts that do not adversely affect the SR-100 performance. These units may remain in service if they pass the remainder of inspection criteria.

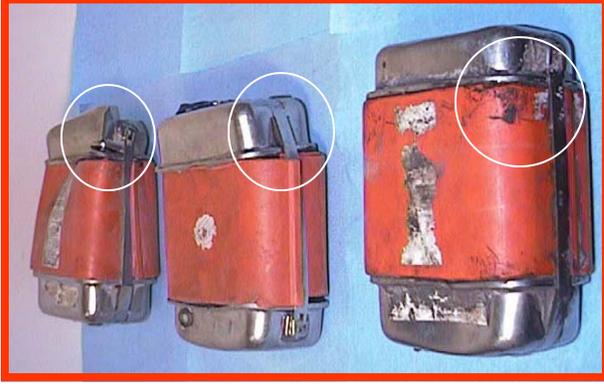
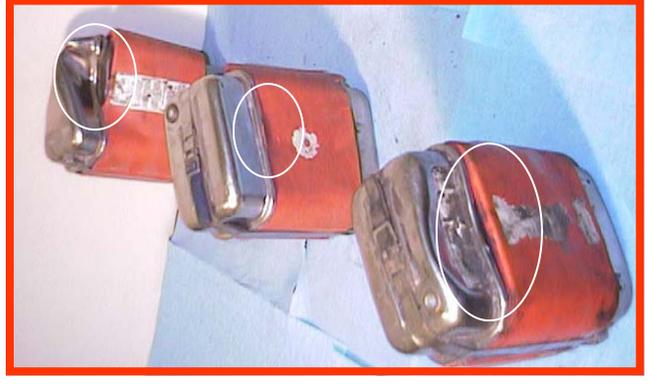
Examples of damaged units.

All units displayed must be removed from service

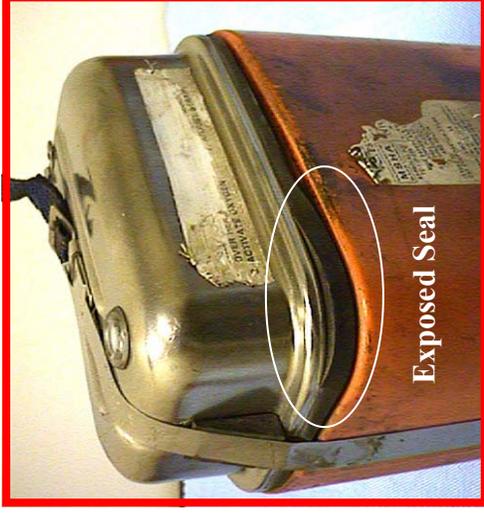
This unit fails the visual inspection because its seal has been displaced and is protruding from under the stainless steel cover.

This unit must be removed from service.

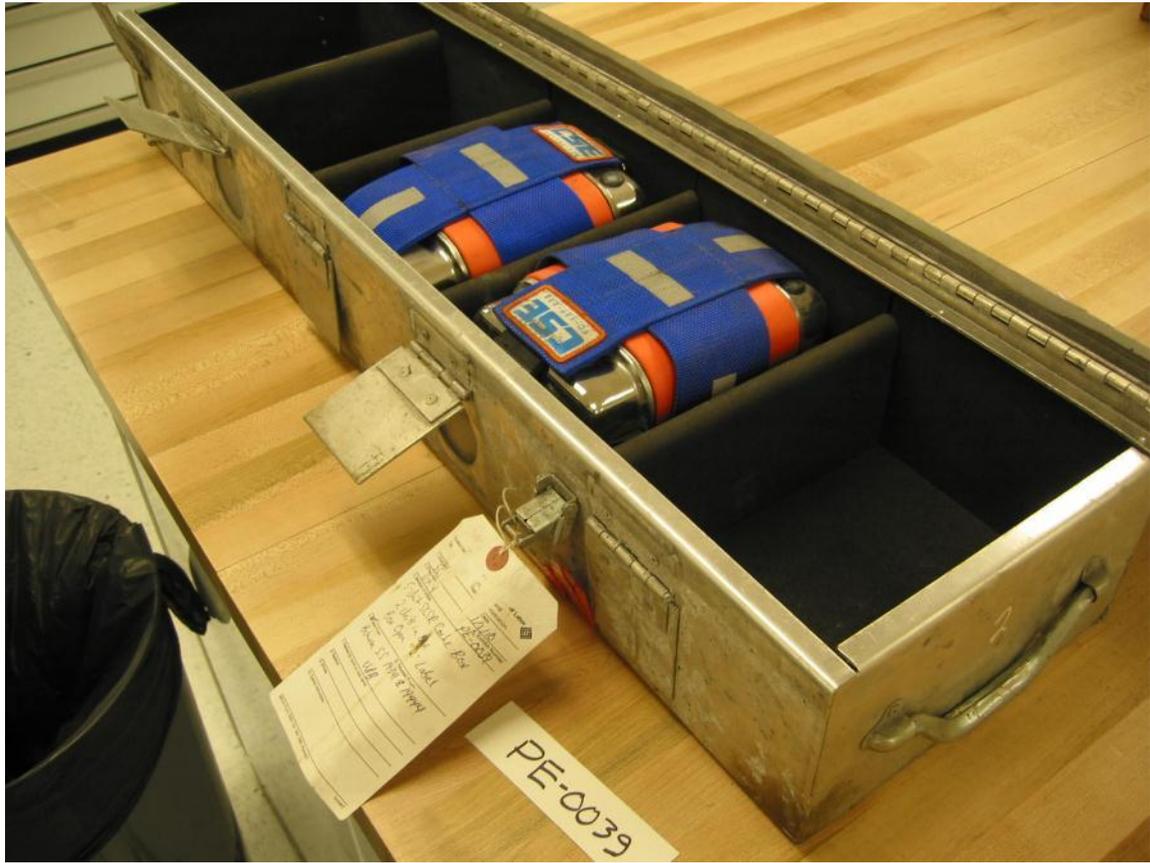
Figure 1 - PE-0039, Units -A and -B in Storage Box

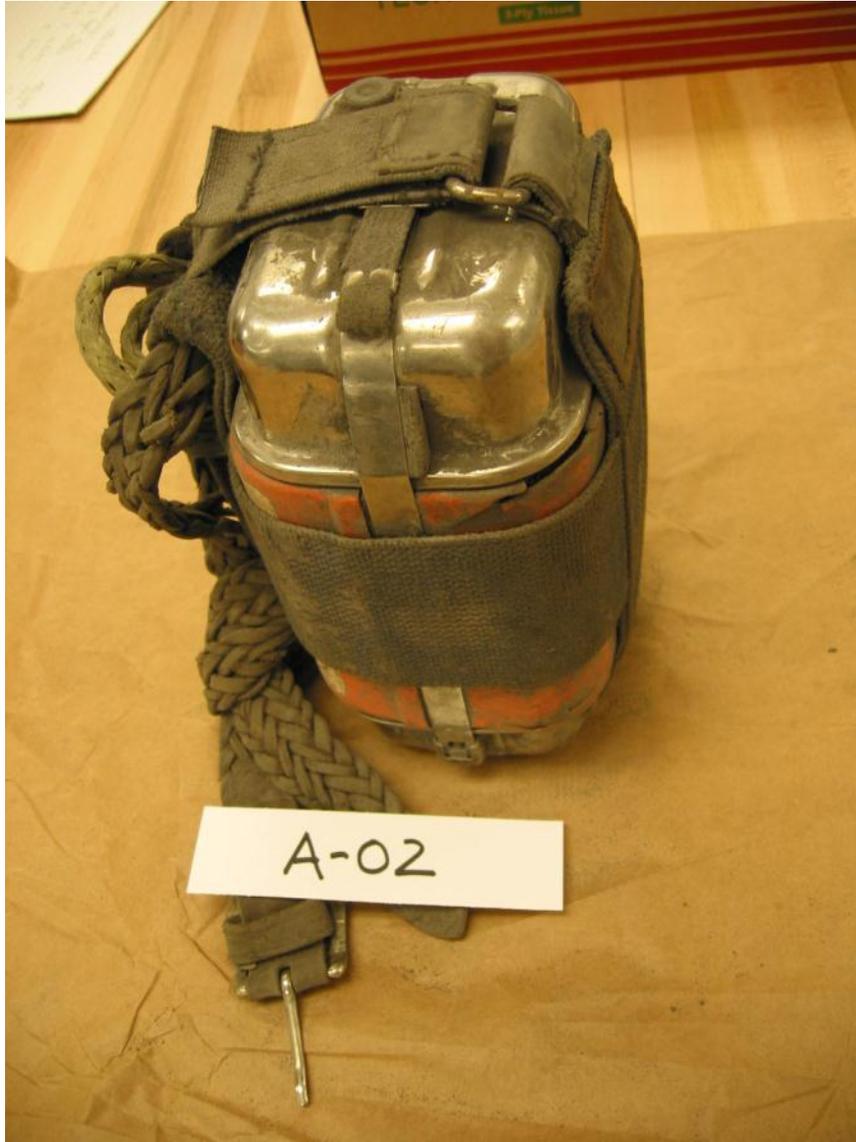
Figure 3 - Unit A-02-A, as Received

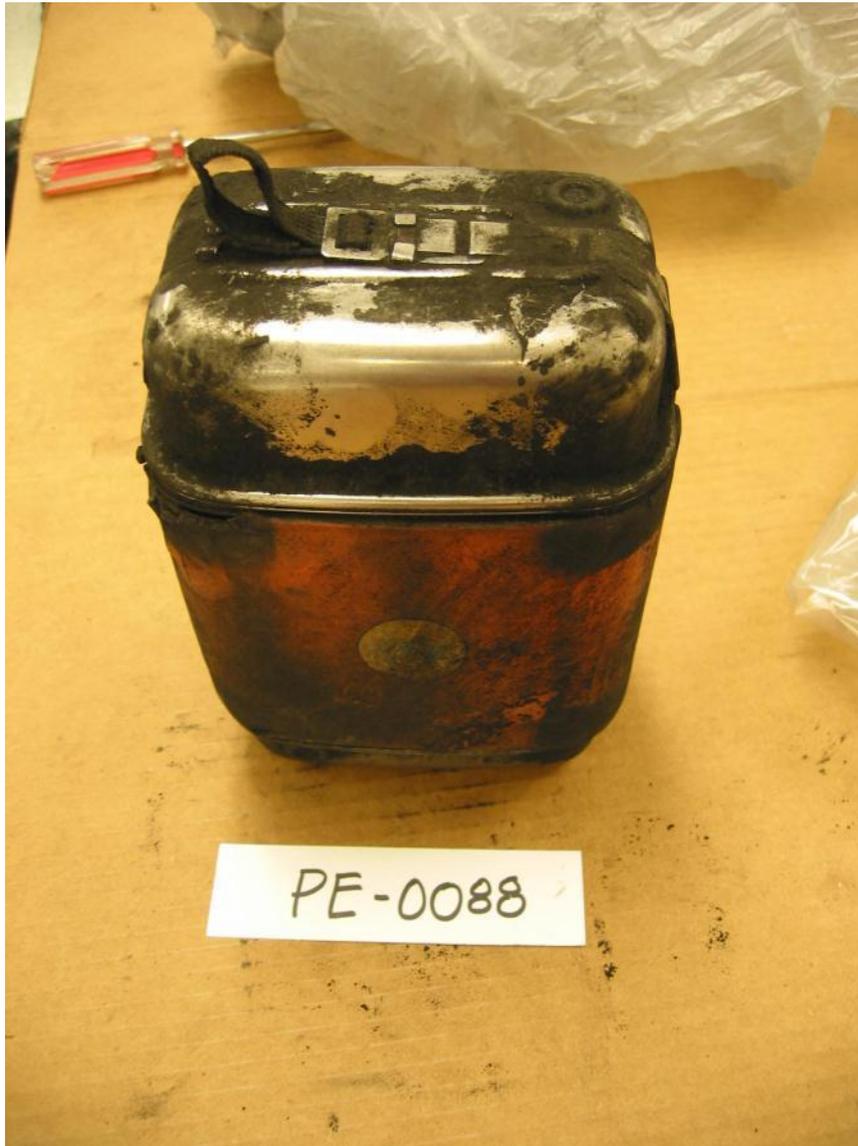
Figure 4 - Unit PE-0088, as Received

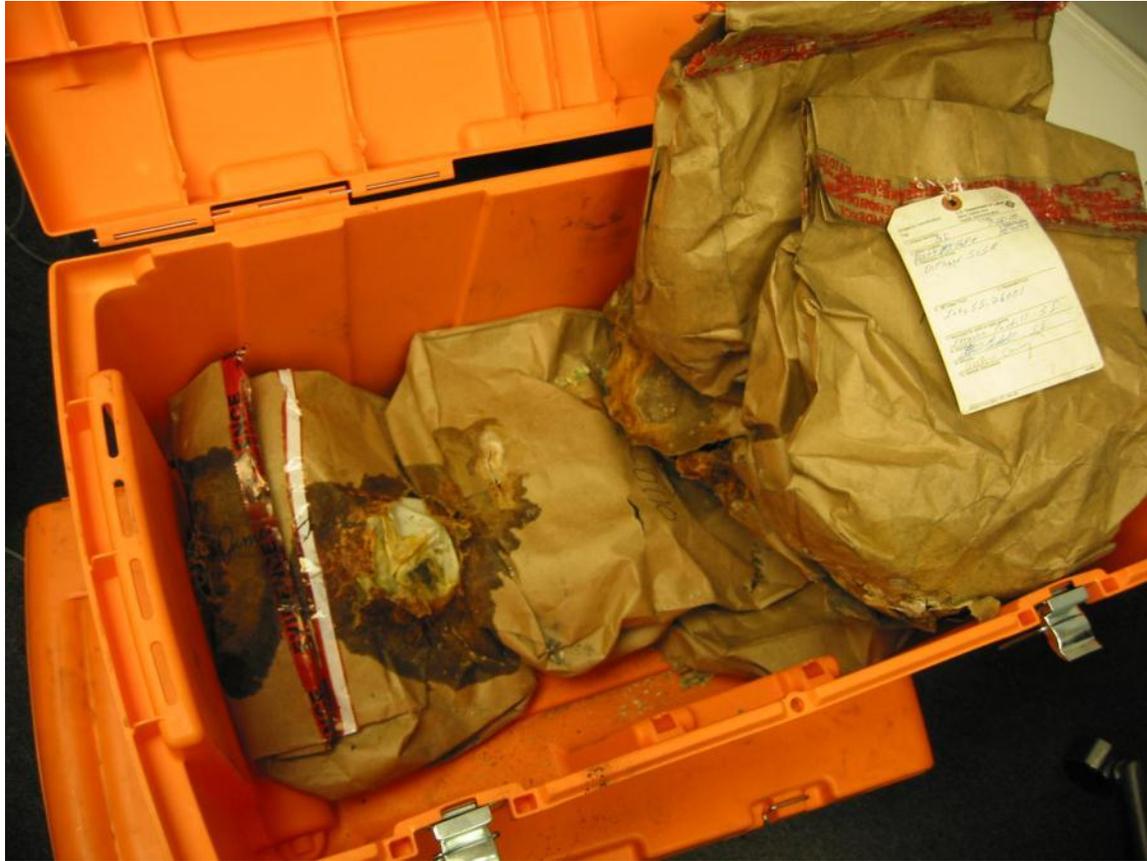
Figure 5 - Units PE-0101, PE-0108, PE-0110, PE-0111, PE-0197, and PE-0198, as Received

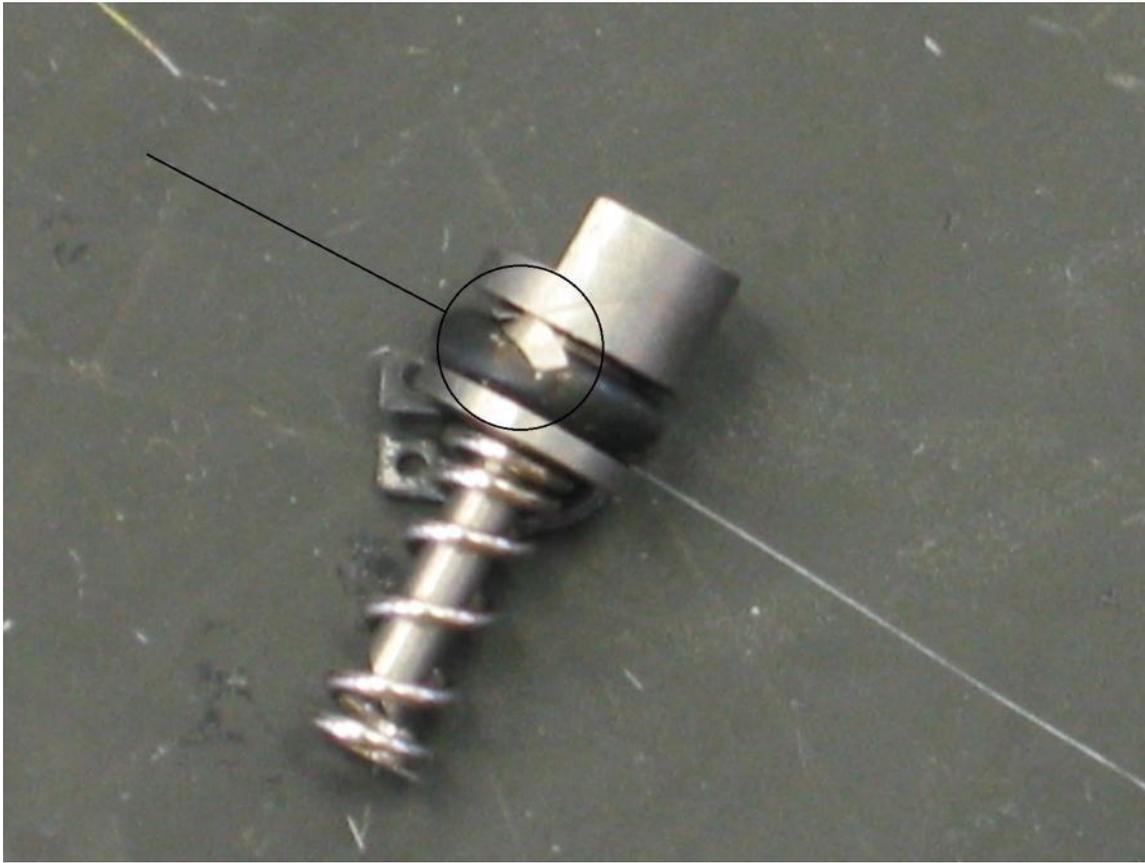
Figure 6 - Starter Plunger from Unit PE-0139-a , Showing Metal Shaving

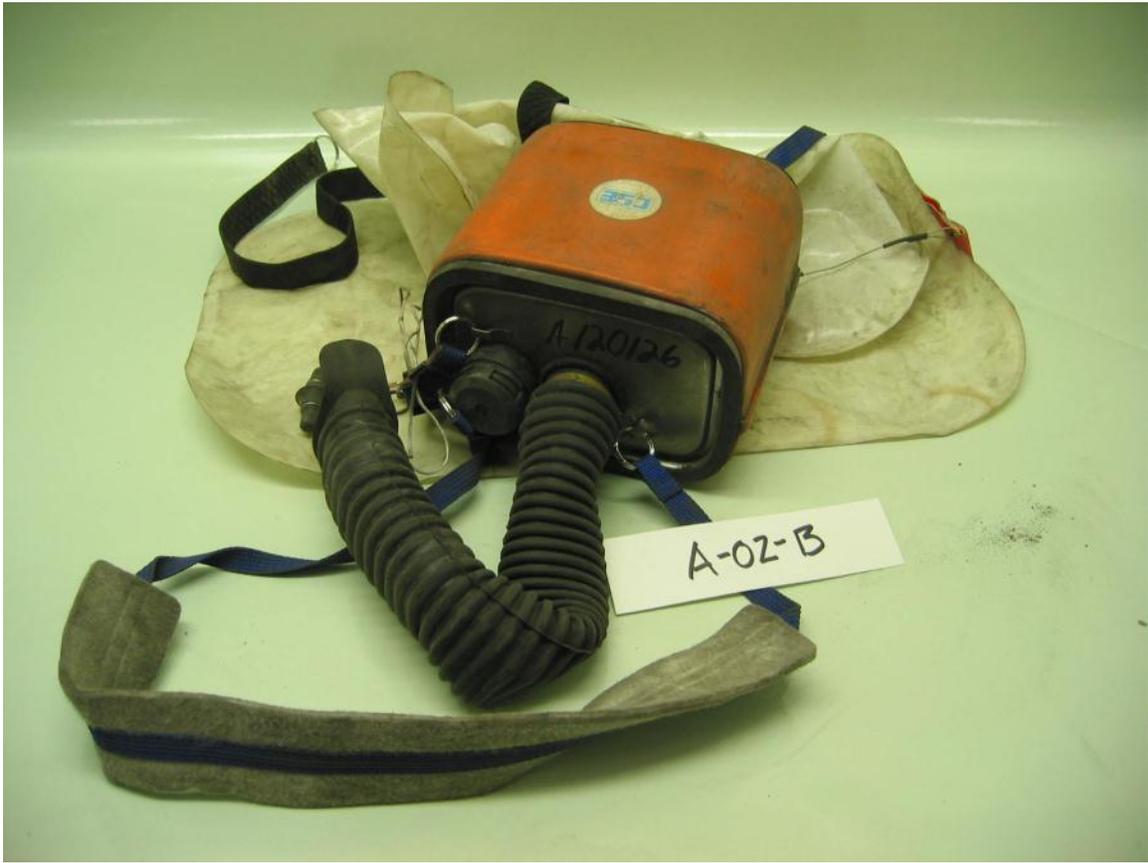
Figure 7 - Unit A-02-B, as Received (Unactivated)
