**UNITED STATES DEPARTMENT OF LABOR
MINE SAFETY AND HEALTH ADMINISTRATION
COAL MINE SAFETY AND HEALTH**

REPORT OF INVESTIGATION

**Fatal Underground Mine Explosion
April 5, 2010**

**Upper Big Branch Mine-South, Performance Coal Company
Montcoal, Raleigh County, West Virginia, ID No. 46-08436**

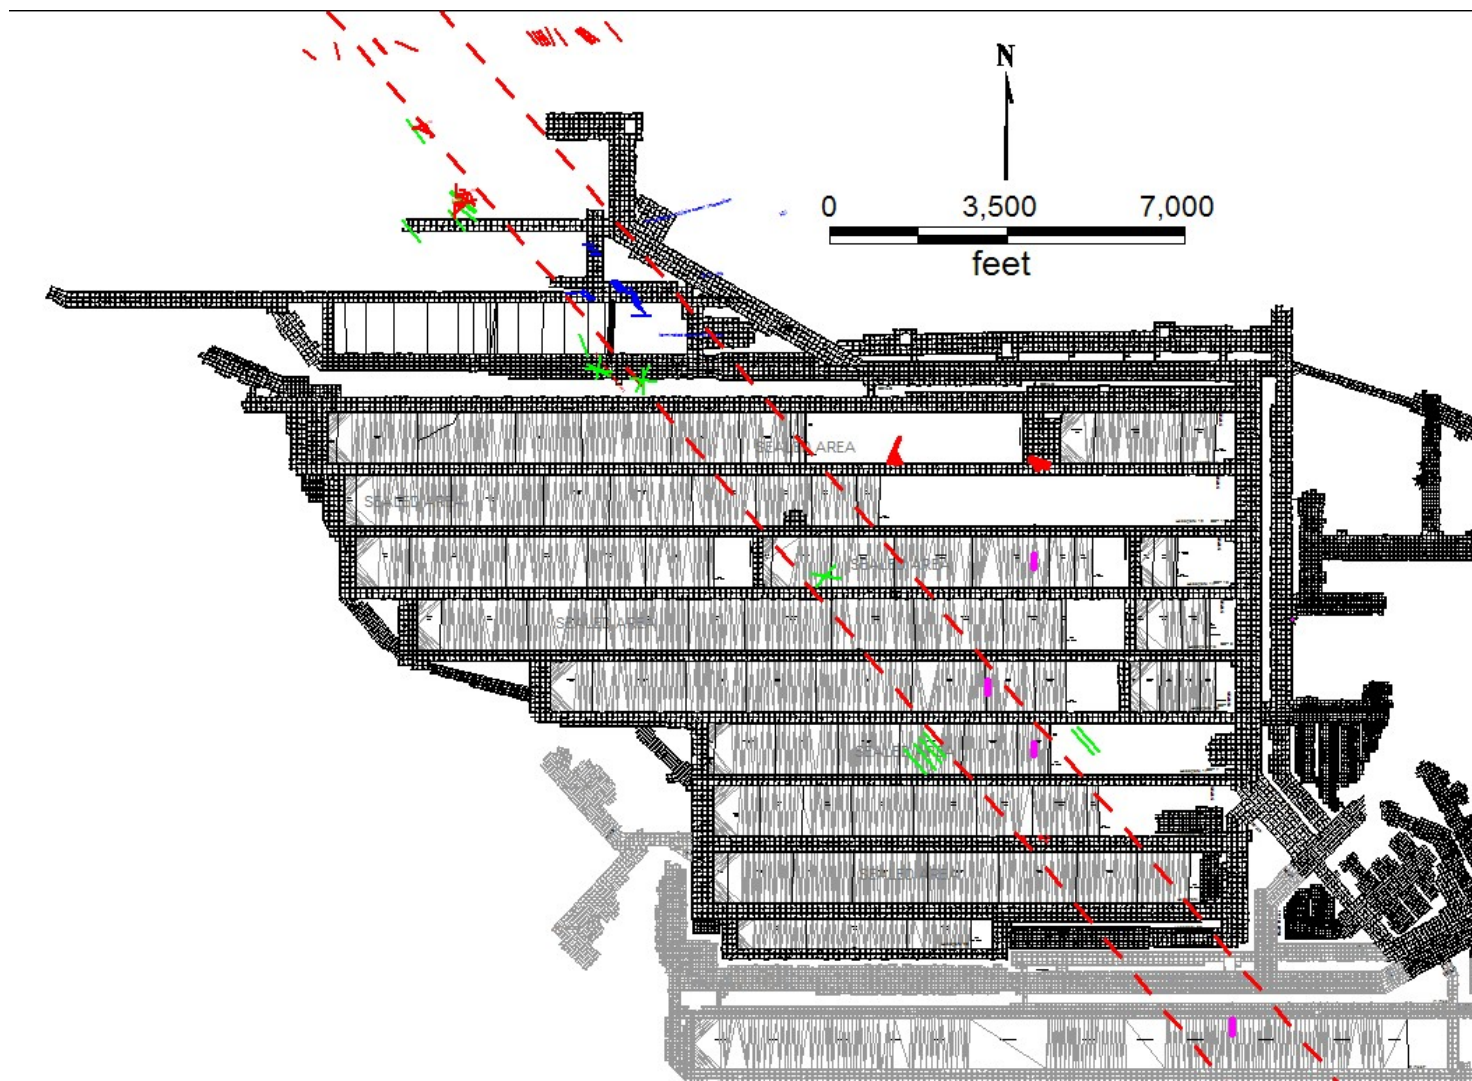
The investigation team concluded that a fault zone trends N 40° W across UBB, and dips 30° to the northeast (Figure 15). This is based on: 1) the locations of gas outbursts or explosions in 1997, 2003, and 2004, discussed above; 2) underground observations conducted at UBB in the 18 Headgate during the 2004 investigation; 3) extensive underground observations conducted between July 2010 and October 2010; 4) the face positions of Longwall Panels 11 and 12 when they were terminated; 5) observations of structural features in the overlying Powellton (Castle Mine) and Coalburg (Black Knight II Mine) seams; and 6) observations of structural features on the surface. To understand the conditions associated with the initial gas release, it is also critical to understand the interplay between the fault zone, the depth of overburden, and the redistribution of stress caused by longwall mining.

Figure 15. Upper Big Branch Mine with projected fault zone, and locations of joints (green, blue), slickensides (red), and floor burst locations (purple) used to constrain the location and trend of the fault zone.

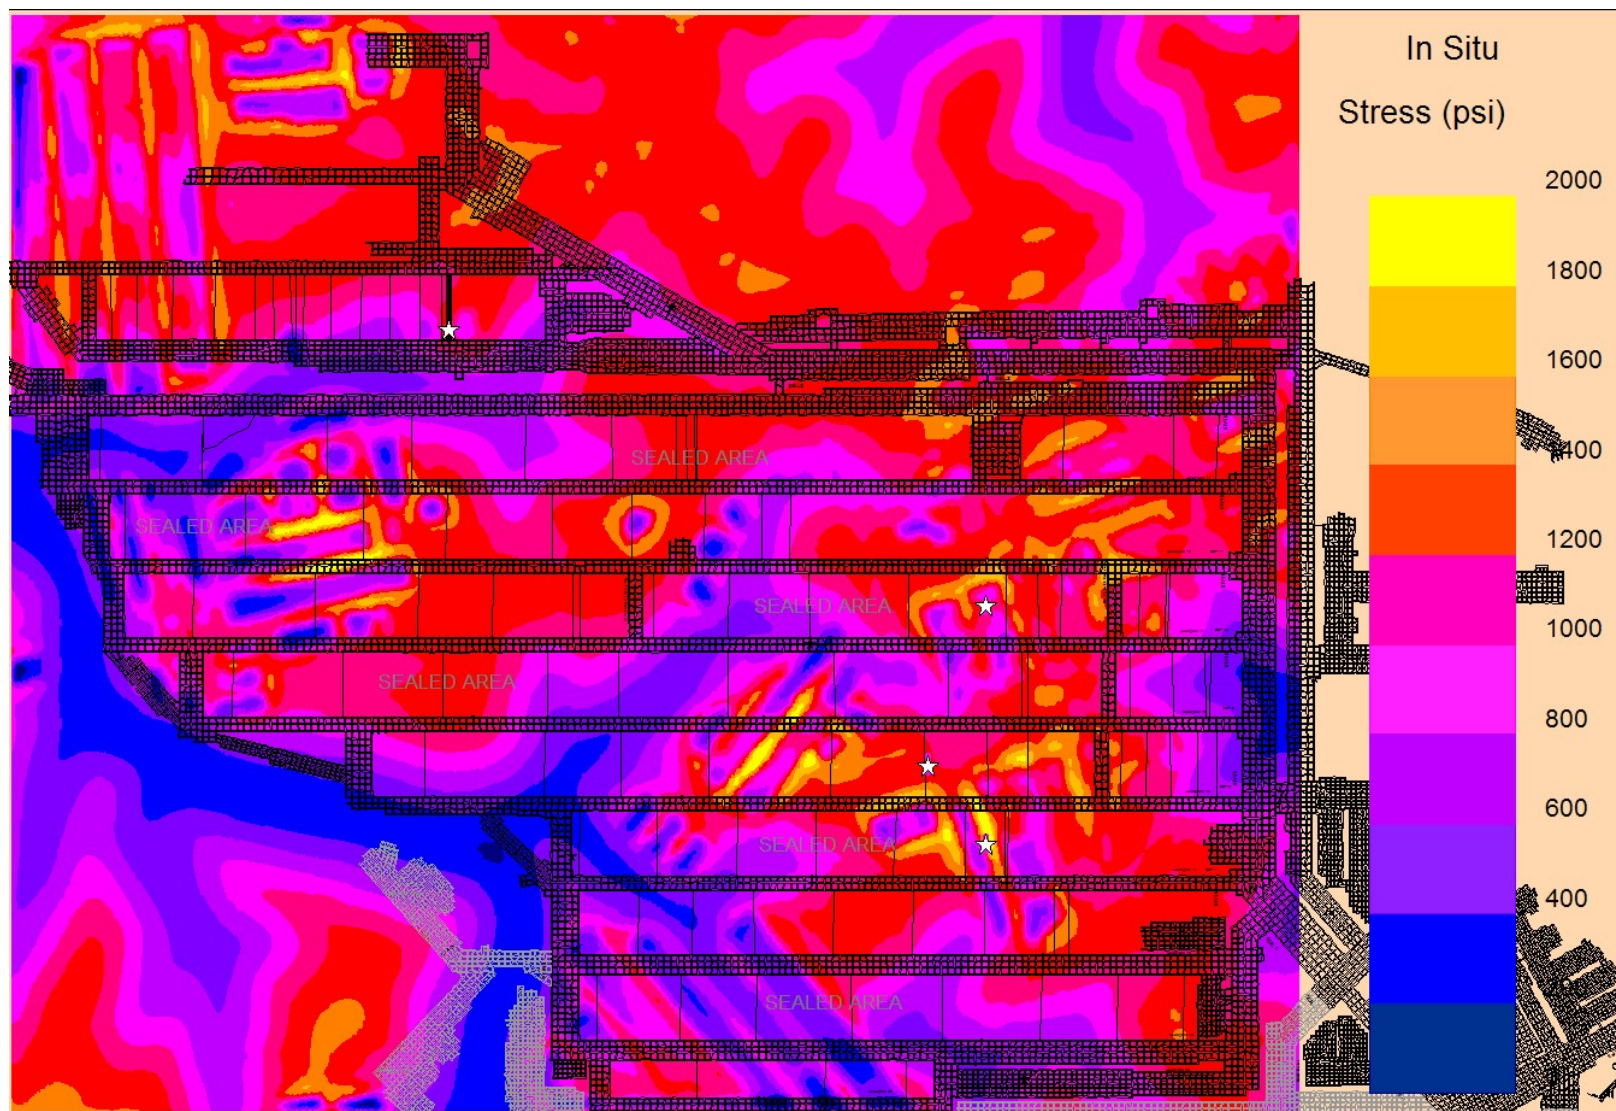
Dr. Heasley's model was used to assess the in-situ (in place) stress on the Eagle seam prior to mining to identify any high-stress areas and to assess any correlation between high stress areas and floor gas outbursts. Figure 18 represents a map of in-situ stress on the Eagle seam, including the vertical stress derived from the weight of overlying rock combined with stress associated with multiple seam interaction with the overlying Powellton seam mining. Although there appears to be a loose correlation between in-situ stress exceeding 1,200 pounds per square inch (psi) and the locations of the 2003 and 2004 gas feeder events, they are not associated with the highest stress values of 1,800 psi or greater.

At the time of the April 5 explosion, the longwall face was beneath a narrow swath of greater-than-1,200 psi stress associated with two rows of remnant pillars flanked by gob or thin, split pillars. Therefore, the documented outburst locations do not correspond to the highest stresses (>1,800 psi), and therefore, do not appear to be entirely stress-driven.

Figure 18. Map of in-situ stress on the Eagle seam, incorporating stress attributable to overburden and multiple seam interactions with the Powellton seam. White stars indicate locations of gas outbursts, with heavy black line on 1 North Panel (label), representing April 5, 2010 face position. Bright yellow patches represent >1,800 psi, with subsequent colors spaced at 200 psi intervals.

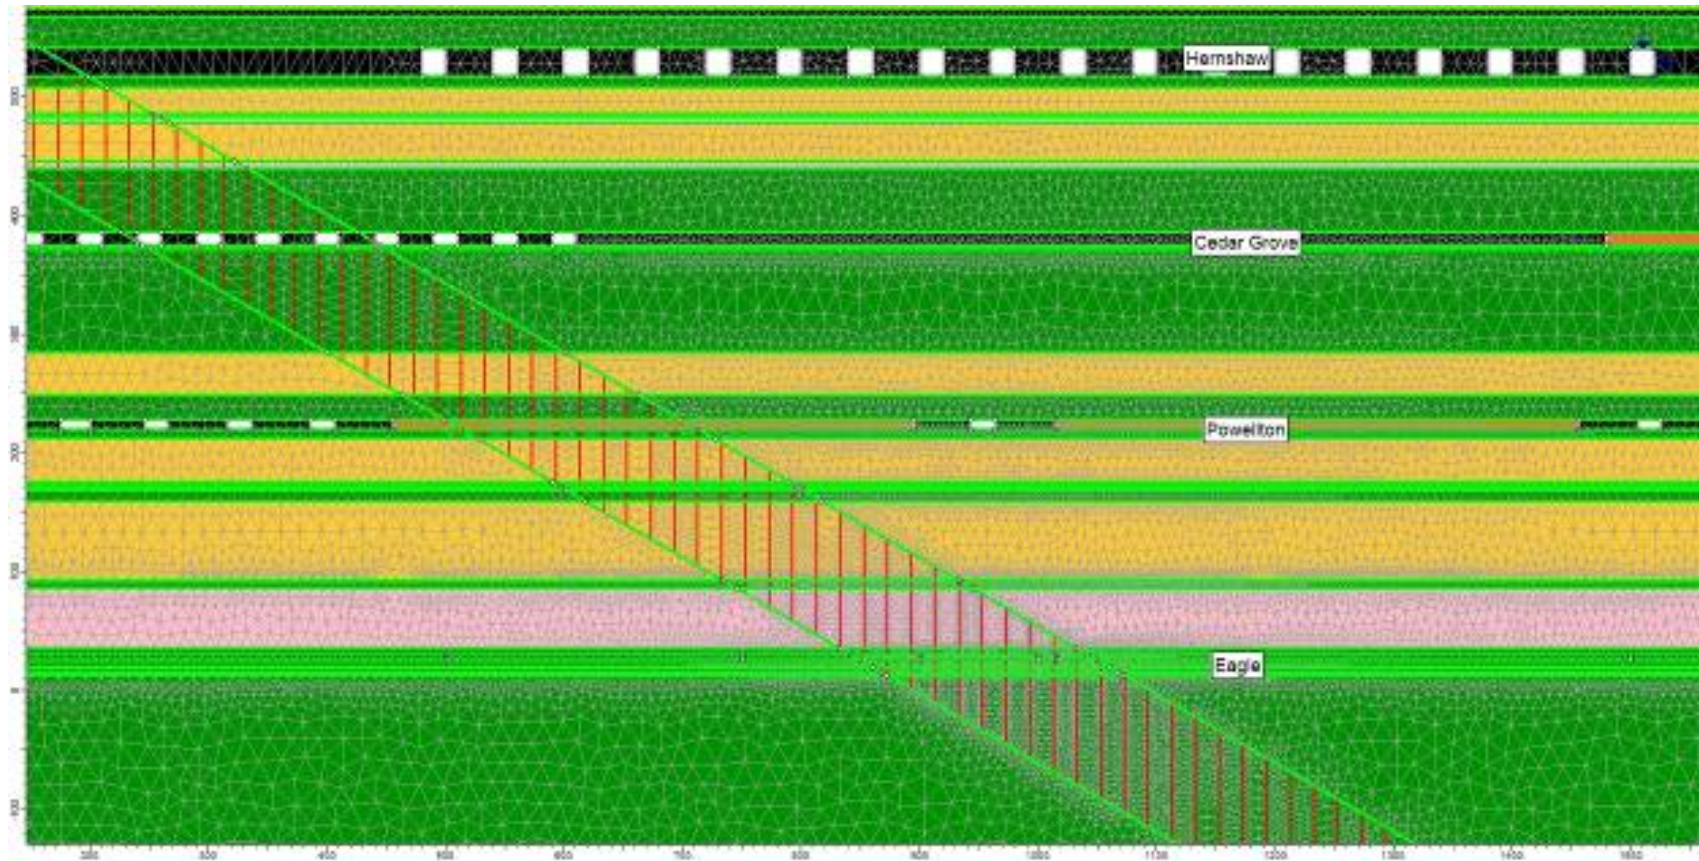
Investigators simulated the fault zone with a 100-foot thick zone, consisting of vertical joints, that dips 30° across the stratigraphic sequence (rock layers), resulting in an intercept width of 200 feet for each layer of strata (Figure 19). This configuration matches closely the geological observations, i.e. intact rock hosting widely spaced joints or other geological structures within the shallowly dipping fault zone. Simulated vertical joints were spaced 20 feet apart within the 30° dipping zone and given a friction angle of 28°, with no tensile strength or cohesion. Joint ends were specified as being open at excavation boundaries.

Figure 19. Stratigraphy in Rocscience showing incorporation of 30° dipping fault zone that is comprised of vertical joints spaced 20 feet apart for 1 North Panel cross section.

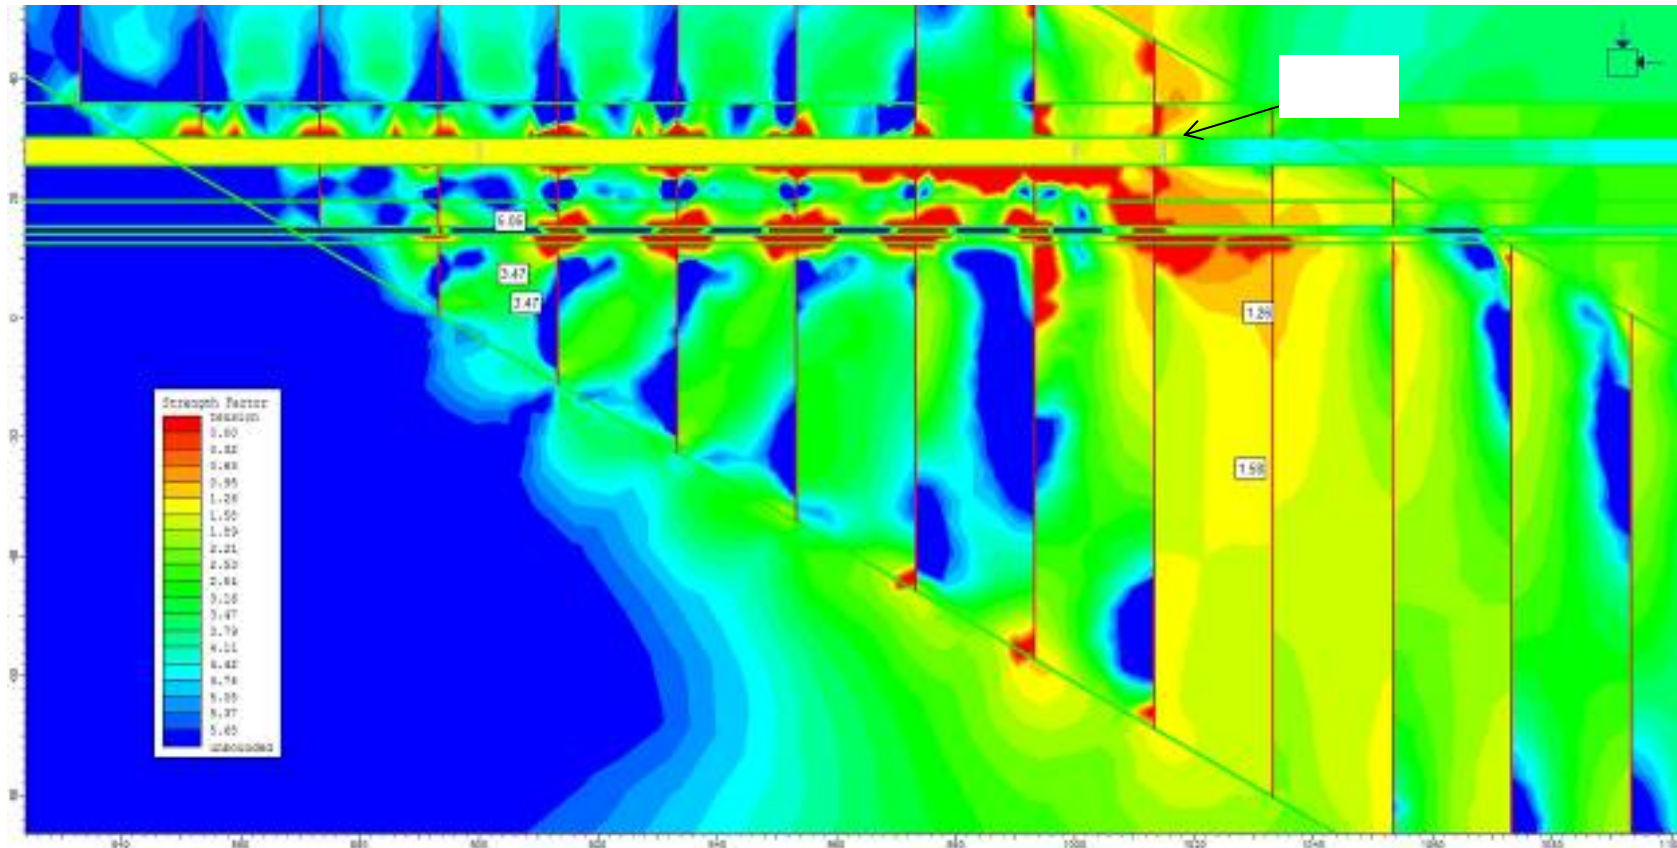
Thus, investigators concluded that the most likely explanation for the failure mechanism associated with the gas inflow at shields 160-171 is that mining into the fault zone beneath the two rows of remnant barriers at over 1,000 feet of depth resulted in a unique overlap of factors that caused the development of tension zones along pre-existing geologic structures for a calculated 25 feet into the floor.

Figure 21. Distribution of strength factors when the 1 North Panel longwall face is at its April 5, 2010 position. Zones of tension are developed along joints below the Little Eagle seam, with large swath of strength factors less than one extending 25 feet into the floor, which encompasses the Little Eagle seam and underlying strata.

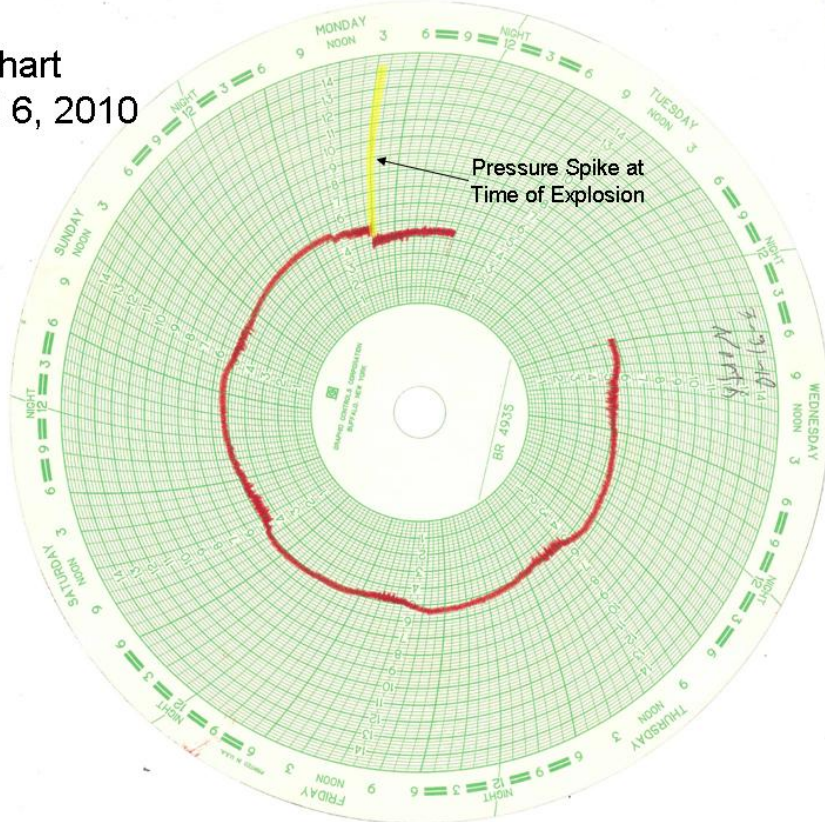
North Fan Chart
March 31 – April 6, 2010

UBB was ventilated with two blowing fans and one exhausting main mine fan. The North Portal blowing fan was a Joy, Model Number 12065D, Serial No. MF4110, ten-foot axial vane fan. The fan was operated with a 1,000-horsepower, 4160 volt, 900 revolutions per minute (rpm) motor. Figure 24 is a copy of the North fan chart which was on the fan pressure recorder when the explosion occurred and shows the fan was operating at about 4.8 inches of water gauge (in. w.g.).

Figure 24. Chart for North Fan, showing pressure spike at time of explosion.

Although the fan charts shown in Figures 24 to 26 were not aligned correctly on the pressure recorder to correspond with actual time, each fan chart shows the pressure spike from the explosion. The North fan recorded a spike of over 9 in. w.g. over its normal pressure of 4.8 in. w.g. The South fan recorded a spike of 2 in. w.g. over its normal pressure of 1.4 in. w.g. The Bandytown fan spike went downward off the chart because this fan was exhausting and the pressure spike was positive. The magnitude of the spike cannot be determined but it was greater than the fan operating pressure. Several small variations in fan pressure were noted on the Bandytown fan chart following the explosion, although persons who were underground during that time reported no additional explosions.

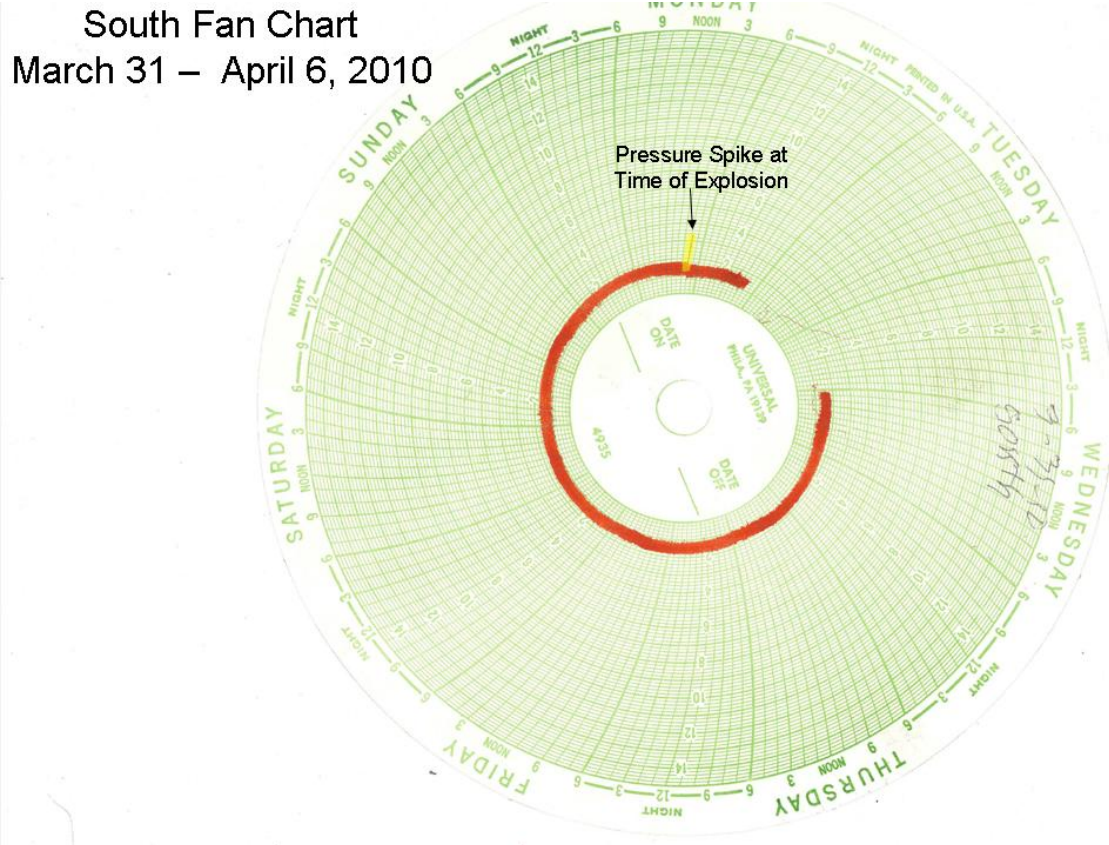
The South Portal blowing fan was an Industrial Welding Buffalo, six-foot diameter axial vane fan. The fan was operated with a 200 horsepower, 480 volt, 1,200 rpm motor. Figure 25 is a copy of the South fan chart which was on the fan pressure recorder when the explosion occurred and shows the fan was operating at about 1.4 in. w.g.

Figure 25. Chart for South Fan, showing pressure spike at time of explosion.

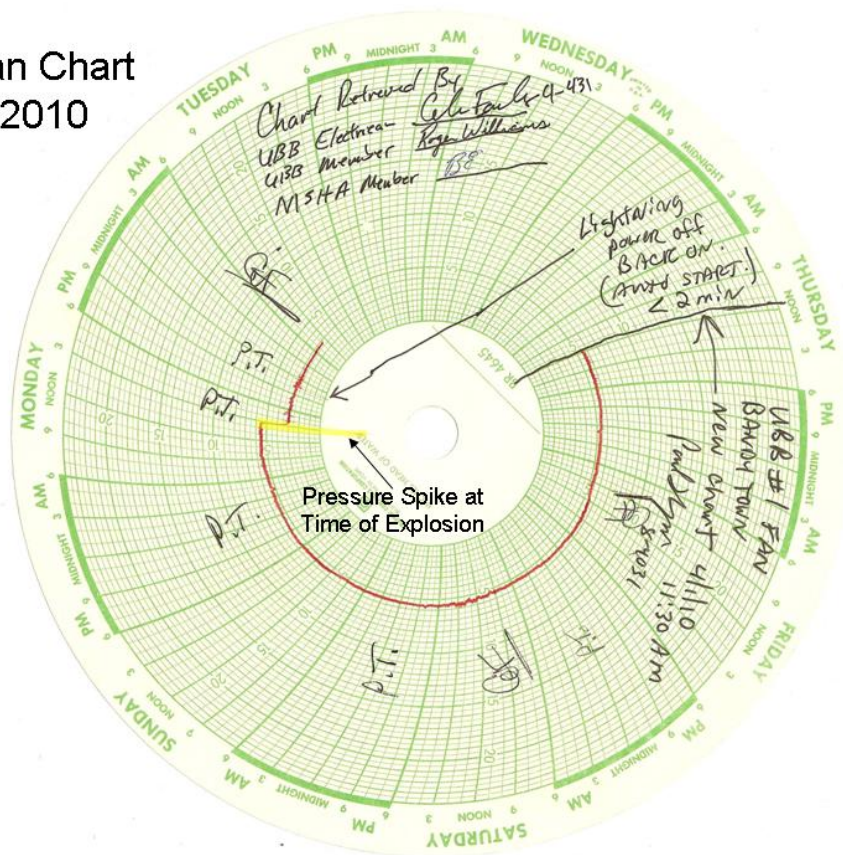
Bandytown Fan Chart April 1 – 6, 2010

The Bandytown exhausting fan was a Robinson, Model Number DA-97AF1029-116, Serial No. 208-167, eight-foot centrifugal fan. The fan was operated with a 2,000 horsepower, 4160 volt, 890 rpm motor. Figure 26 is a copy of the Bandytown fan chart, which was on the fan pressure recorder when the explosion occurred and shows the fan was operating at about 5.5 in. w.g.

Figure 26. Chart for Bandytown fan showing pressure spike at the time of the explosion.

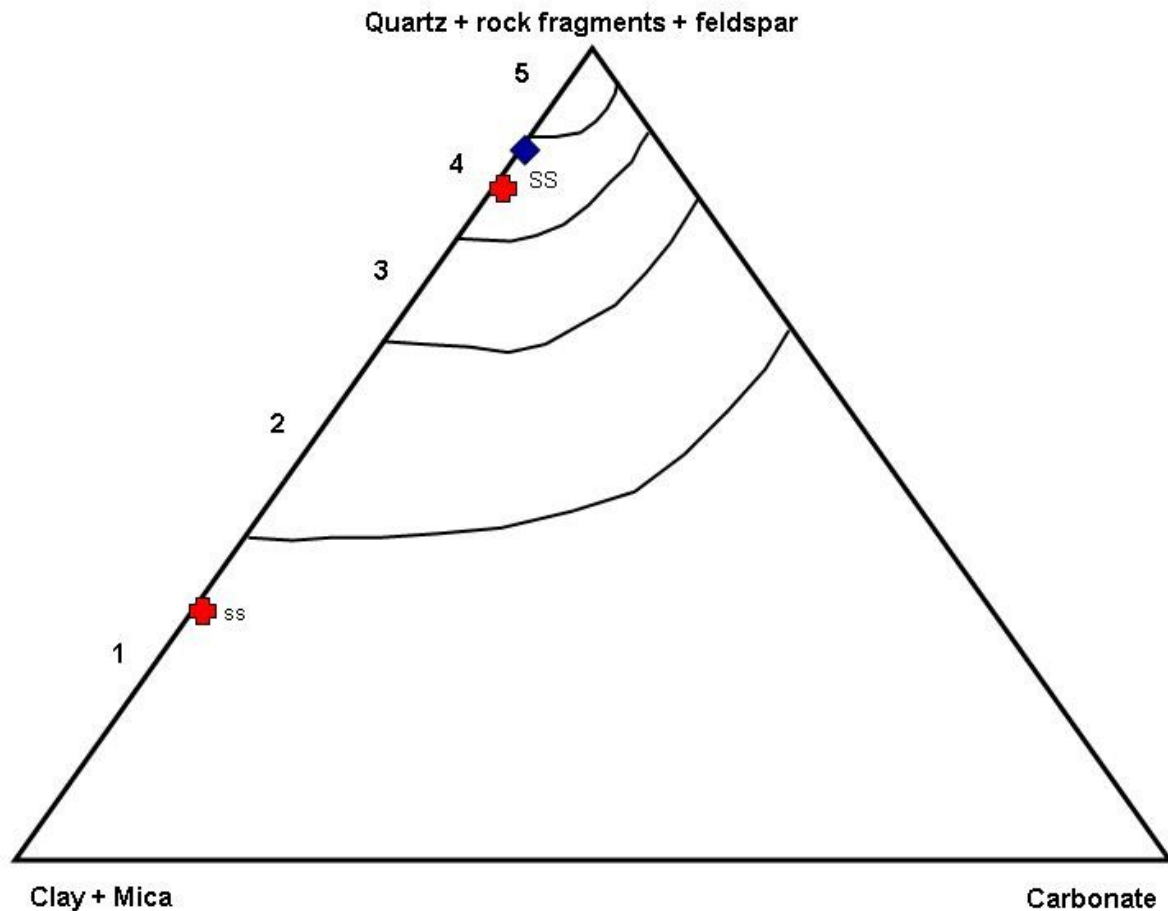
Underground observations indicated that the tail drum was cutting sandstone in the roof and floor, while the head drum was cutting sandstone in the floor. Accordingly, MSHA collected samples of the roof and floor from the tailgate side of the 1 North Panel face for petrographic analyses (Appendix Q). Based on the mineral contents determined by thin section petrography, the samples were plotted on the diagram below for comparison with the incendivity index developed for rocks in Australian coal mines (Figure 28).

The sandstone that the longwall shearer was cutting into on April 5 had a high potential for frictional ignition. The layers of coarse siltstone, which contain high mica content, plot in Category 1, indicating a low potential for frictional ignition. In contrast, the sandstone plots in Category 4 indicating a high potential for frictional ignition. The floor sandstone very nearly plots in the Category 5 zone, because of its high quartz content. Compared to the sample collected from the roof, the floor sample contains much greater quartz, and is characterized by a much greater degree of grain interlocking. Rocks with an incendivity index of 4-5 were shown in tests to have a high potential for frictional ignition, for rock-on-rock and metal-on-rock ignitions.

Figure 28. Diagram showing relation of UBB roof (red crosses) and floor (blue diamond) sandstone (SS) and siltstone (ss) to contour lines of incendiarity index.

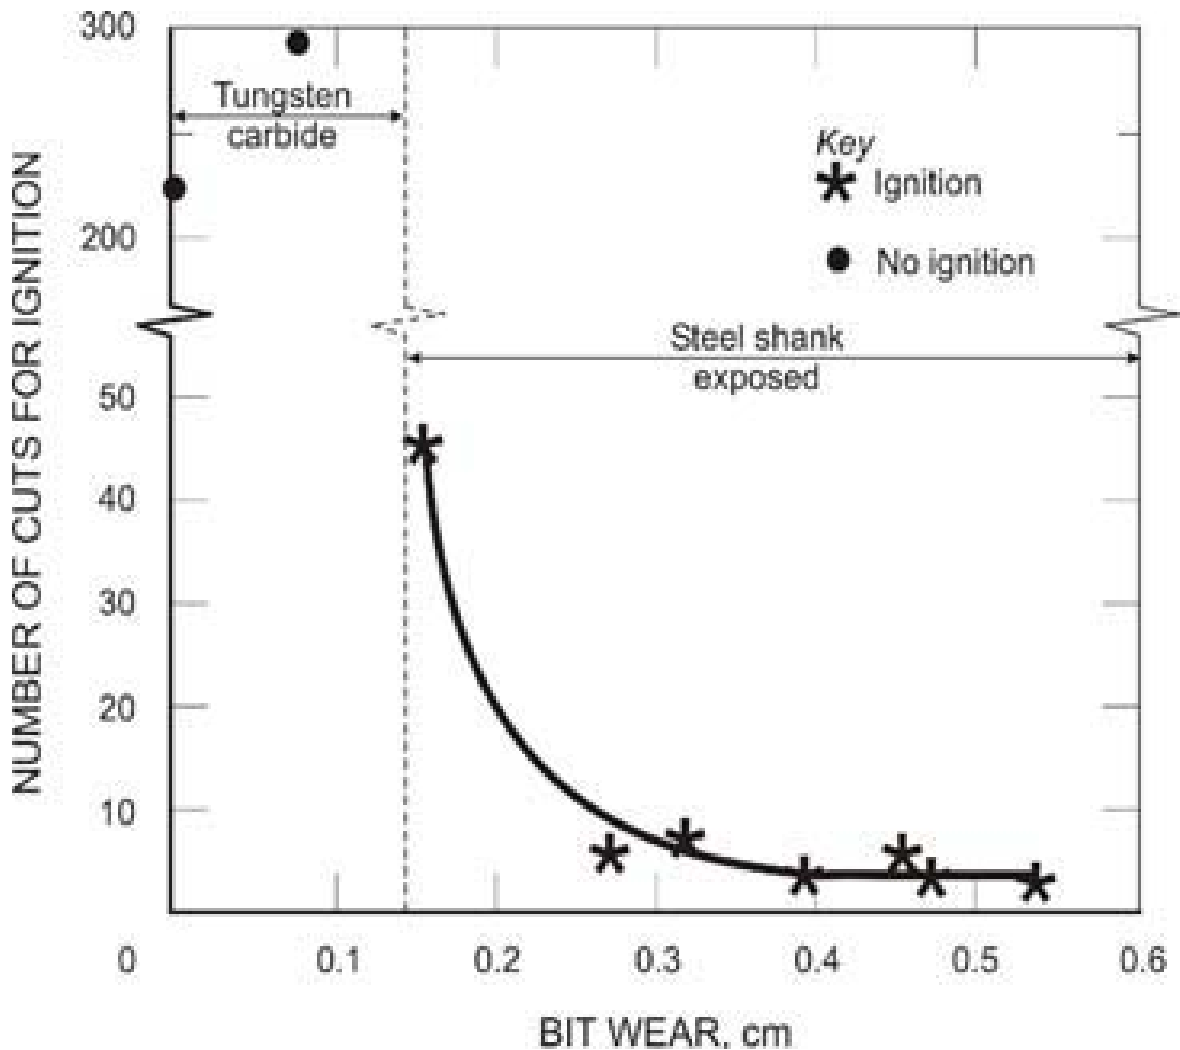
In addition, experiments have revealed that bit surface area is significantly related to the incendiary potential of a hot streak. Large wear flats on the cutting bits are more likely to cause an ignition, especially when the carbide tip has worn off and as little as 3 mm of the steel shank has been abraded away (Figure 29).

Figure 29. Relation between bit wear, in centimeters, and the number of cuts required to induce a frictional ignition, from Kissell et al. (2007).
