REPORT OF INVESTIGATION

Fatal Powered Haulage Accident  
August 11, 2021

HWM Truck Lines, Inc. (E467)  
Summersville, West Virginia

Star Bridge Preparation Plant-Rail Load  
Carter Roag Coal Company  
Mill Creek, Randolph County, West Virginia  
ID No. 46-06736

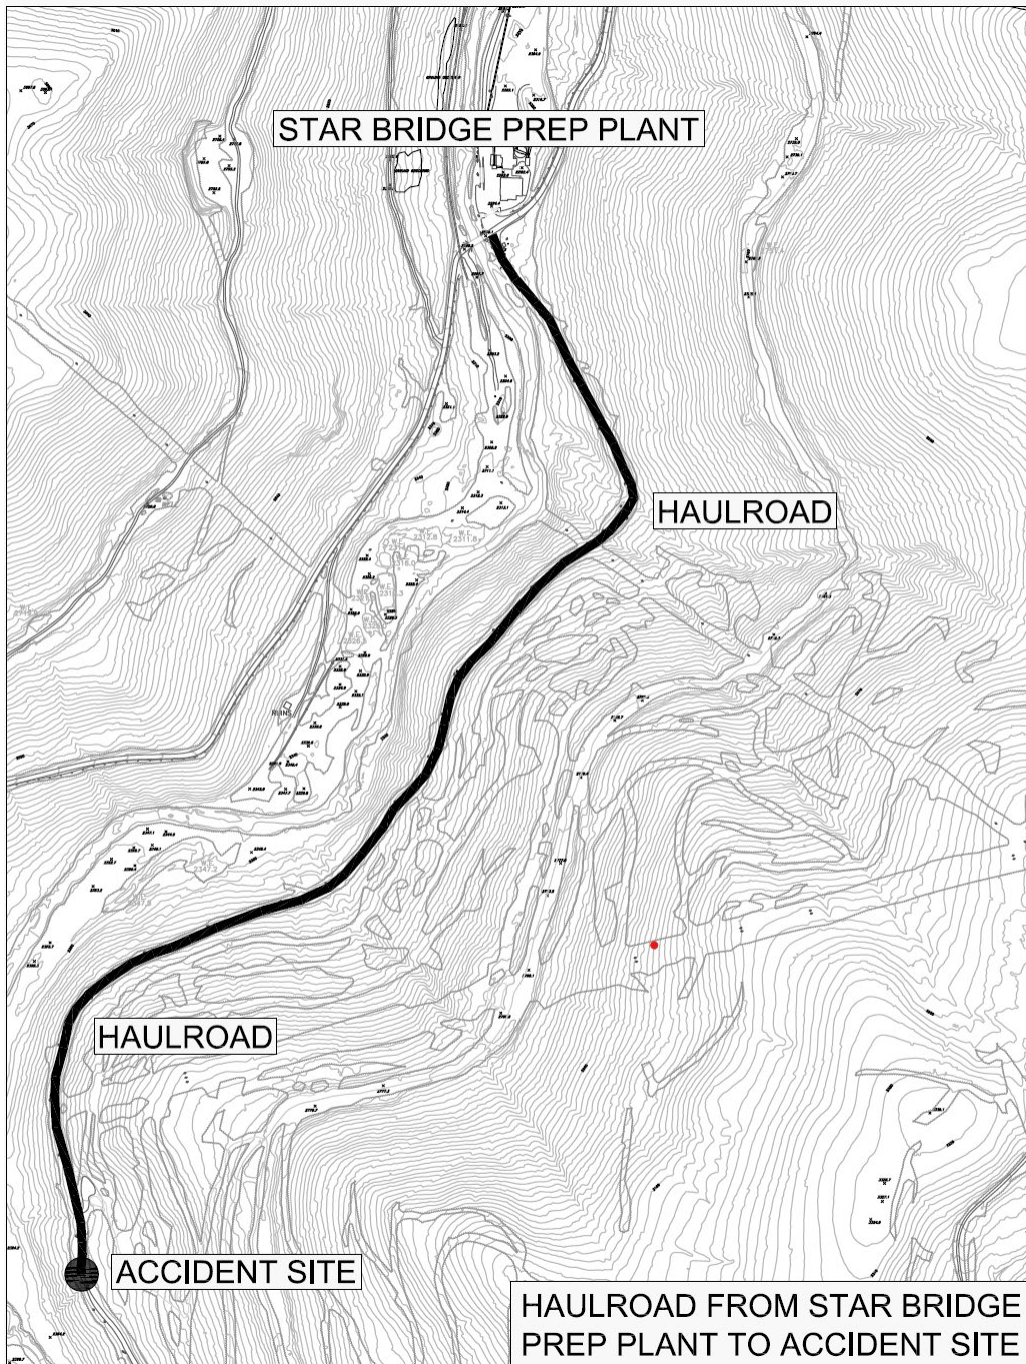
APPENDIX A – Map of Haul Road

Investigators found Collins' truck rolled over a rock berm with the front tires in the ditch. The grade along the truck's path of travel increased in steepness as the truck moved away from its parked position. The grade ranged from approximately 4.5 to 19 percent. The defined tire tracks left in the mud indicated the tires on the truck were rolling, not sliding, demonstrating the parking brakes did not stop the truck.
