REPORT OF INVESTIGATION

Fatal Handling Material Accident
June 7, 2021

Plant #10
R.E. Janes Gravel Company
Slaton, Crosby County, Texas
ID No. 41-01111

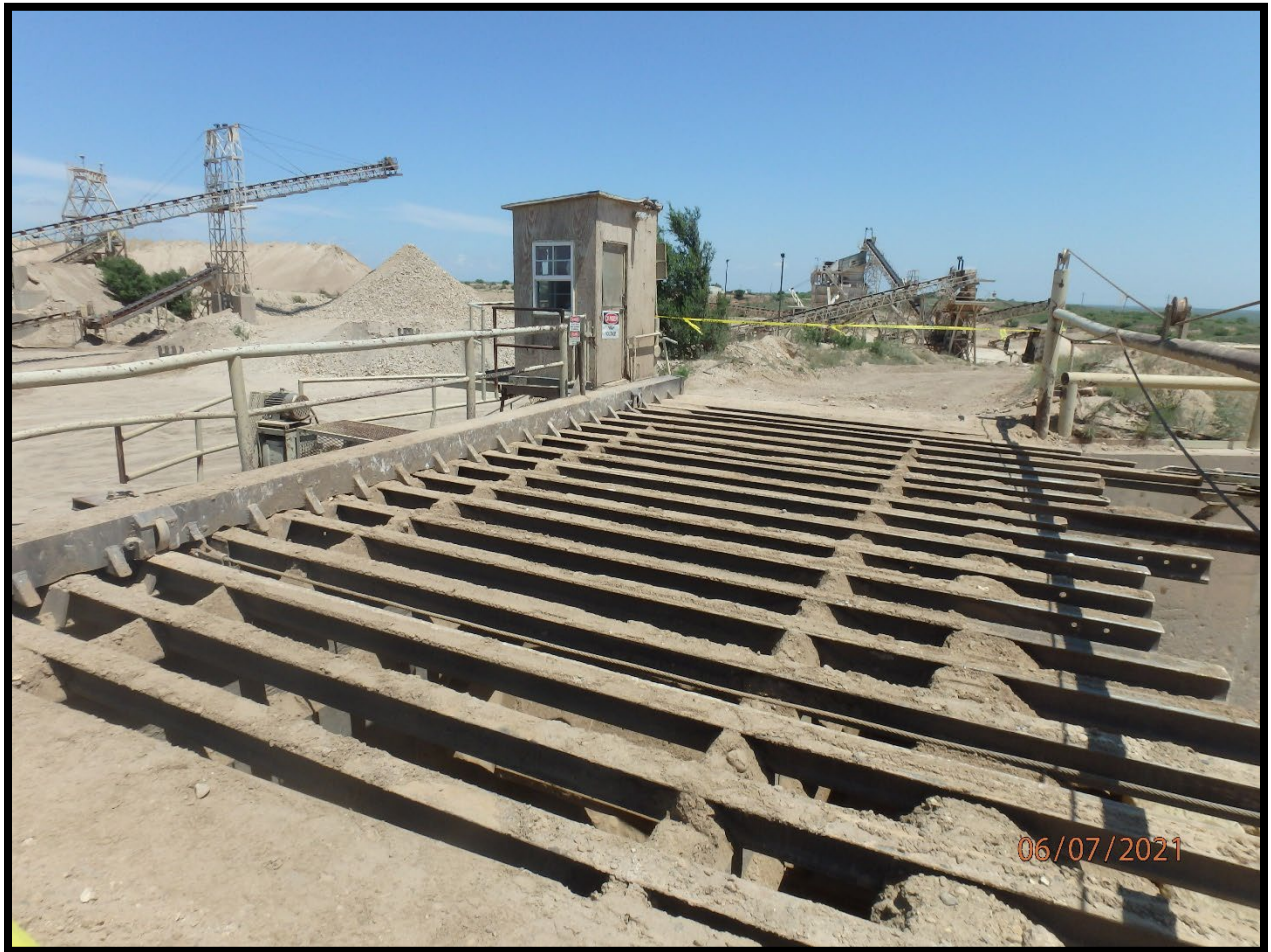
On June 7, 2021, at approximately 8:00 a.m., Rogelio Garcia-Rivera, a 55 year-old hopper operator with over six years of mining experience, was fatally injured when he was engulfed by materials inside the grizzly feed hopper. Garcia-Rivera entered the grizzly feed hopper to clear a blockage at the bottom of the grizzly feed hopper. Garcia-Rivera was attempting to clear the blockage when a large amount of material dislodged and engulfed him.
