REPORT OF INVESTIGATION

Underground  
(Coal)

Fatal Powered Haulage Accident  
November 23, 2020

American Eagle Mine  
Panther Creek Mining, LLC  
Cabin Creek, Kanawha County, West Virginia  
ID No. 46-05437

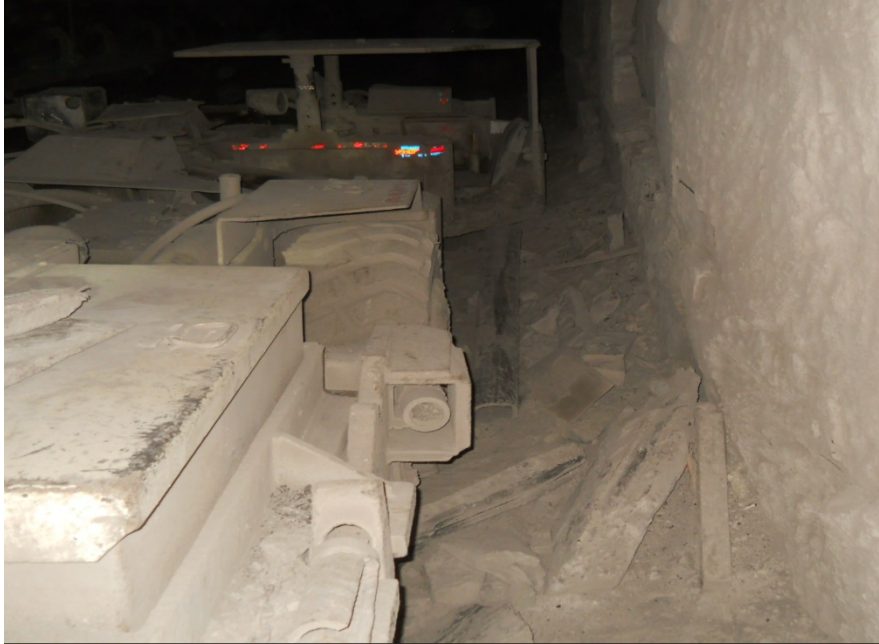
On November 23, 2020, at approximately 11:15 a.m., Taylor Halstead, a 20-year-old miner with approximately 14 months of mining experience, died when the scoop he was operating ran over a four-inch diameter, seventeen-foot long polymer pipe laying in the roadway. When the scoop tire ran over the polymer pipe, the end of the pipe entered the operator's compartment and struck the victim.

On November 23, 2020, Halstead started his shift at 7:00 a.m. He traveled from the Coal Fork Portal to the Dawes slope where he assisted several miners in removing accumulations and spillage on the Dawes slope. At approximately 11:00 a.m., Jeffery Edwards, Foreman, directed Halstead and Casey Burkhamer, Laborer, to retrieve belt conveyor structure located at the end of the Dawes slope track. They needed the structure to make repairs on the slope belt conveyor. Halstead, Edwards and Burkhamer traveled to the No. 537 battery scoop charging area to get a scoop to assist with moving the structure. Edwards directed Halstead to operate the scoop. Edwards and Burkhamer traveled to the end of the track where the belt conveyor structure was loaded on rail cars. They waited at the end of the track approximately 10 minutes for Halstead to arrive with the scoop before becoming concerned, at which point they went looking for him. Edwards and Burkhamer found Halstead approximately one crosscut away, pinned in the scoop by a piece of polymer pipe. The polymer pipe had been laying in the track entry roadway. Halstead was traveling towards the rail cars with the battery end of the scoop leading. As the scoop traveled over the polymer pipe, the weight of the scoop raised it, and it entered the operator's compartment and struck Halstead (see Appendix A).
