REPORT OF INVESTIGATION

Surface
(Sand and Gravel)

Fatal Handling Material Accident
October 1, 2021

Ovyn #1 Pit
Dennis Ovyn Trucking Inc
Withee, Taylor County, Wisconsin
ID No. 47-03016

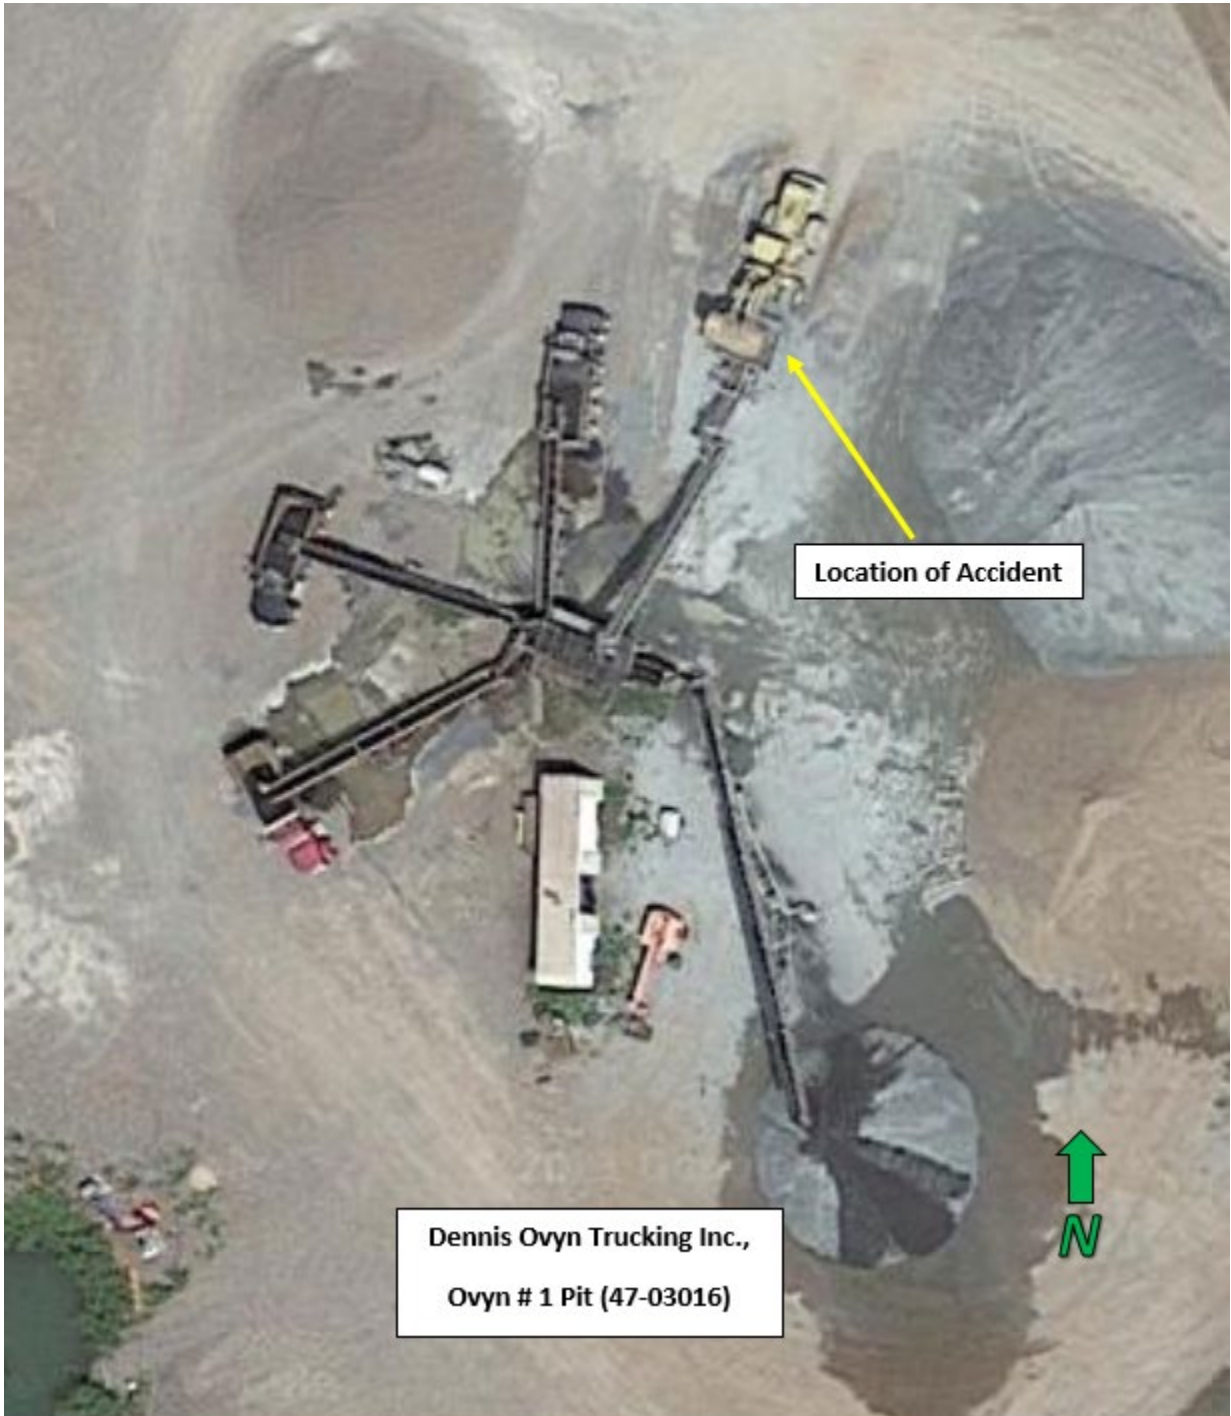
APPENDIX B – Aerial View of the Wash Plant Where the Accident Occurred

The accident occurred at the wash plant, located on the south side of the mine (see Appendix B).
