REPORT OF INVESTIGATION

Surface Mine
(Crushed and Broken Sandstone)

Fatal Machinery Accident
October 19, 2020

Mobile
Rubble Inc.
Lyons, Larimer County, Colorado
ID 05-04470

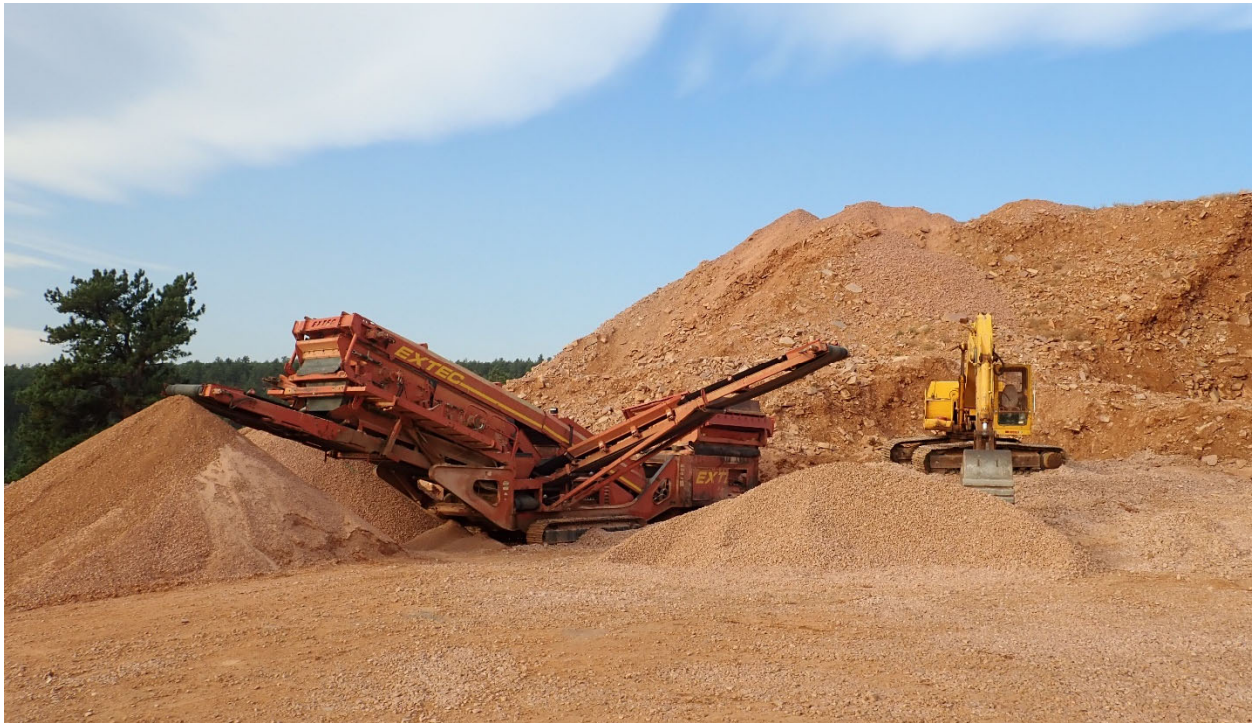
On October 19, 2020, at approximately 11:30 a.m., John C. Castle, a 58-year-old Plant Operator with eight weeks of mining experience and who had not received new miner training, died when an excavator bucket struck him. Castle was working on a screen plant when the excavator operator swung the excavator bucket and pinned him against the screen plant's feed hopper.
