REPORT OF INVESTIGATION

Fatal Falling, Sliding, or Rolling Rock or Material of Any Kind Accident
September 14, 2021

Butte Gulch
Higher Ground Resources
Murray, Shoshone County, Idaho
ID No. 10-02336

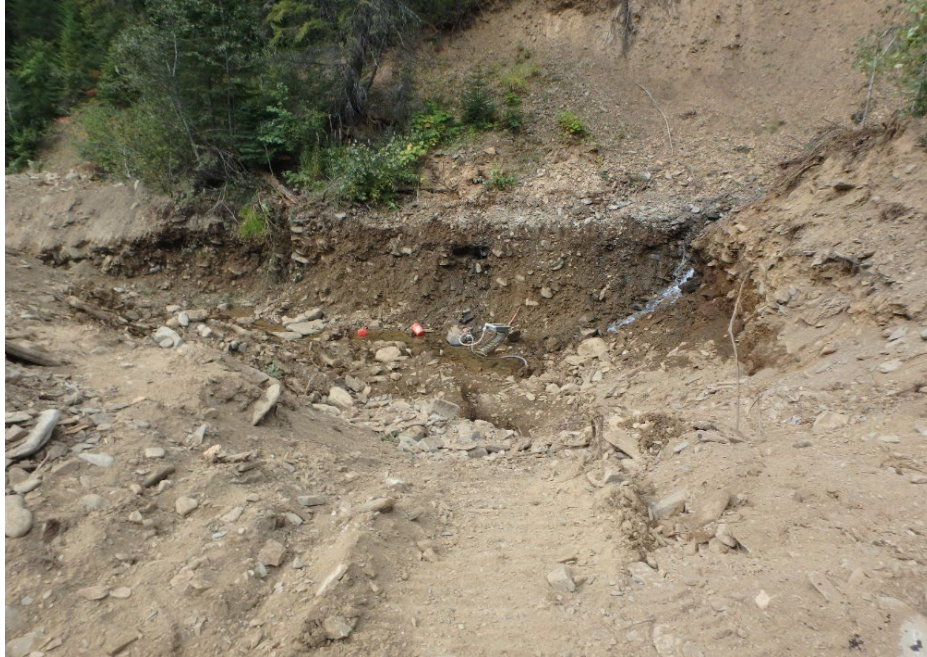
On September 14, 2021, at approximately 1:00 p.m., Richard Schwentner, a 70 year-old guest at the mine, died when a 20-foot highwall collapsed and engulfed him.

At the time of the accident, the north bank of the pit contained a trench approximately four to five feet wide, 50 feet long, with walls 20 feet high. Ground conditions in the trench were hazardous because the walls of the trench consisted of unconsolidated material, were angled too steeply for stability, and were not supported. When the excavator operator left the area, there were no warnings, signs, or barricades installed at the entrance point to the trench to impede unauthorized entry. The mine operator did not have policies or procedures in place for taking down, sloping, supporting, or otherwise stabilizing bank edges.

Corrective Action: The mine operator developed a new written procedure for restricting access or providing safe access to hazardous areas of the mine. The mine operator trained all miners in this new written procedure.
