REPORT OF INVESTIGATION

Fatal Drowning Accident
March 22, 2022

AMI Silica LLC
AMI Silica LLC
Hixton, Jackson County, Wisconsin
ID No. 47-03742

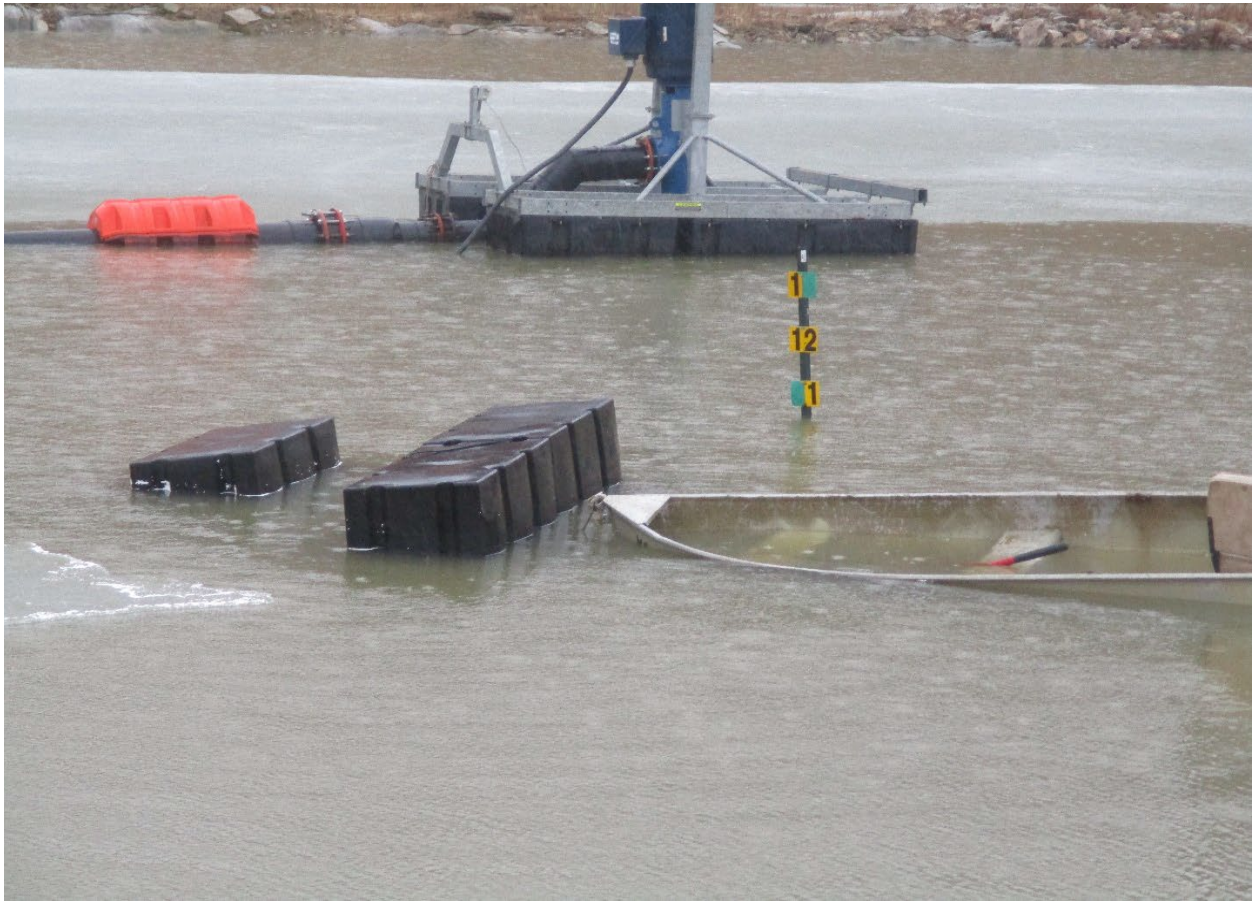
On March 22, 2022, at approximately 9:30 a.m., Tony Killian, a 44 year-old heavy equipment operator, with over six years of mining experience, died when a pump raft he was working on capsized, causing him and another miner to fall into a stormwater retention pond. Killian became entangled with the pump raft, causing him to drown.
