REPORT OF INVESTIGATION

Fatal Slip or Fall of Person Accident
August 4, 2021

Marfork Coal Company - Marfork Environmental (S463)
Whitesville, West Virginia

Marfork Processing
Marfork Coal Company, LLC
Whitesville, Raleigh County, West Virginia
ID No. 46-08374

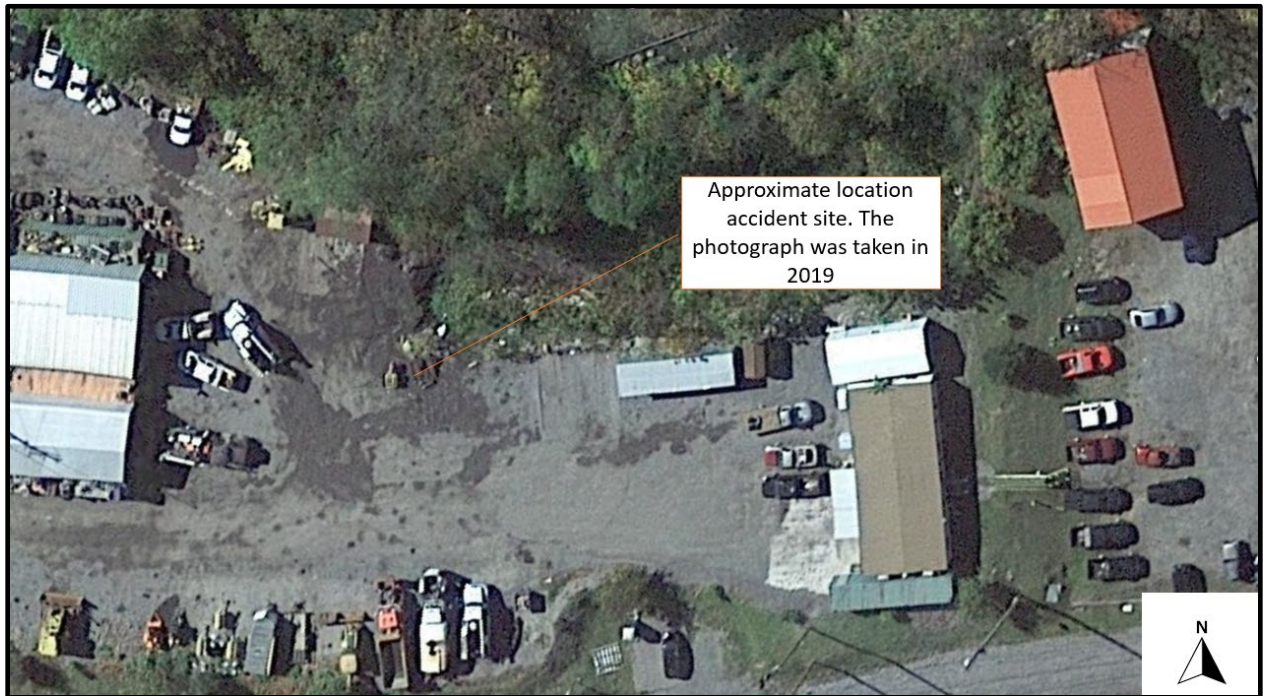
APPENDIX B – Aerial View of Accident Scene

The accident occurred at the Marfork Environmental maintenance yard steam pad (see Appendices B and C).
