UNITED STATES  
DEPARTMENT OF LABOR  
MINE SAFETY AND HEALTH ADMINISTRATION

REPORT OF INVESTIGATION

Fatal Powered Haulage Accident  
March 22, 2023

Longview Mine  
Century Mining LLC  
Volga, Barbour County, West Virginia  
ID No. 46-09447

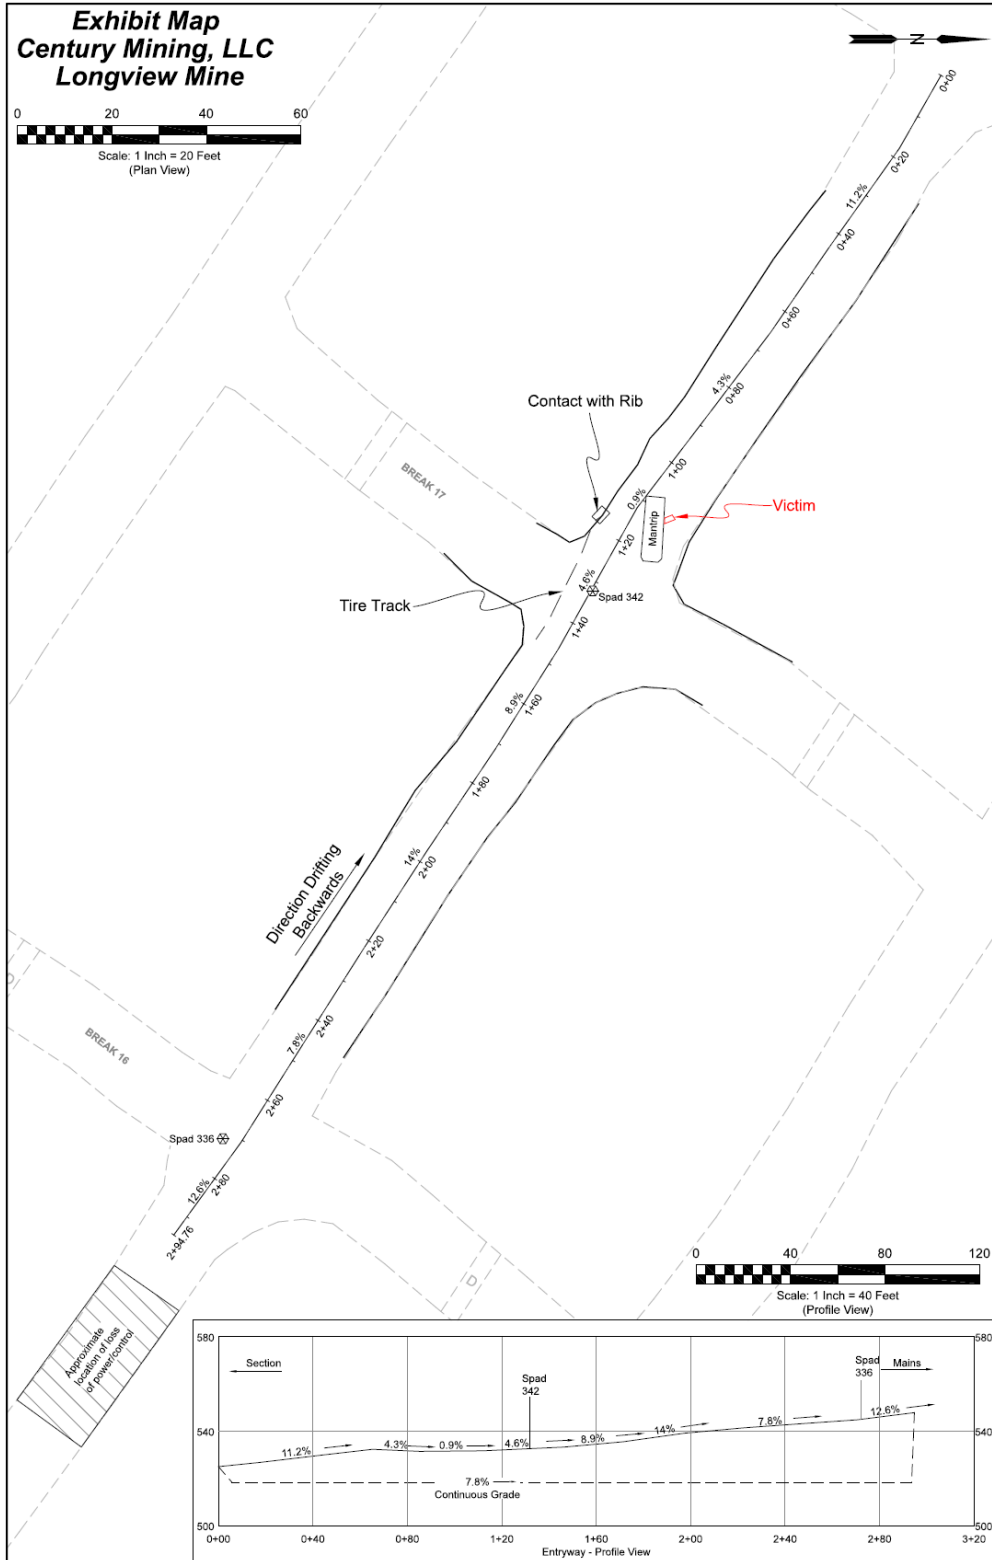
# APPENDIX A – Map of the Accident Scene

At approximately 8:50 a.m., the rear passenger side of the Stryker impacted the rib inby the 17-block intersection. The passenger side rear tire travelled up the rib, causing the Stryker to overturn. Barker and Allen ended up underneath the Stryker and Elkins was thrown clear. Allen crawled out from under the Stryker and yelled for Barker and Elkins but only got a response from Elkins. Allen ran around the Stryker and found Barker pinned under the passenger side.
