REPORT OF INVESTIGATION

Fatal Powered Haulage Accident
May 9, 2024

Streetman Plant
Arcosa LWS, LLC
Streetman, Navarro County, Texas
ID No. 41-01628

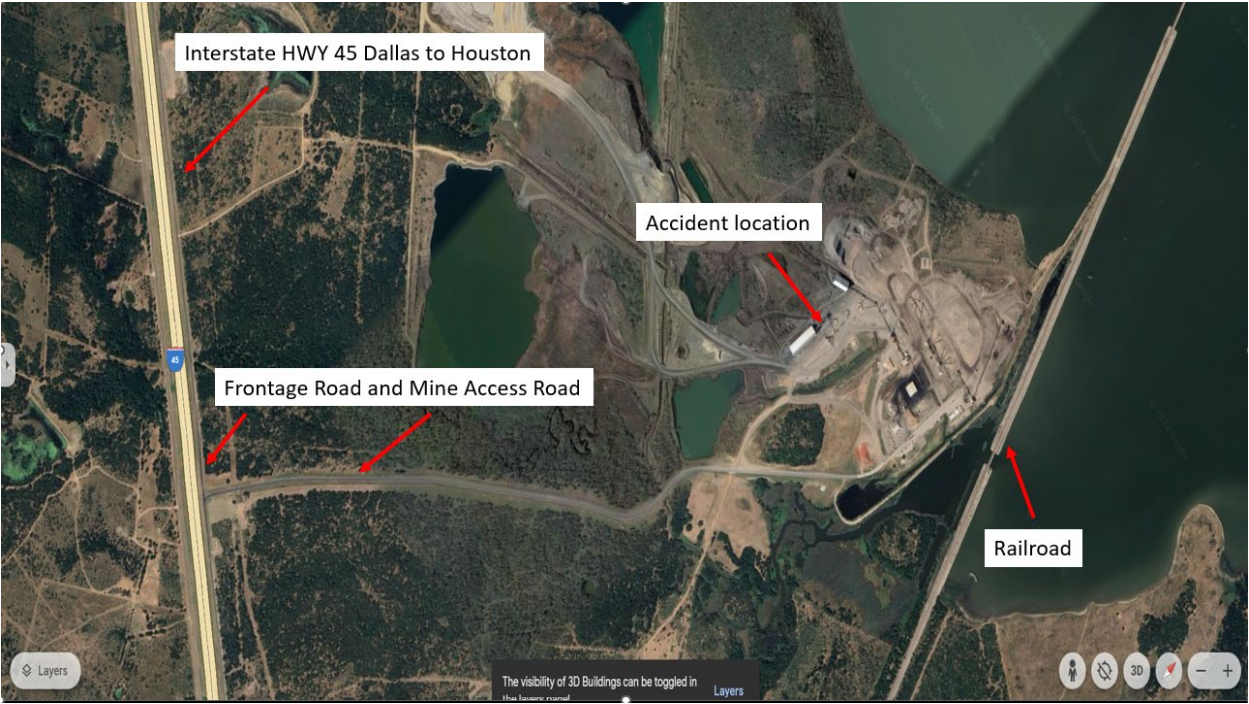
APPENDIX C – Aerial View of the Mine

The accident occurred at the Raw Shale Storage area at the C-35 belt conveyor tunnel and the C-34 elevated belt conveyor (see Appendices C and D). The area was dry with no visible dust. Ground conditions were smooth and lightly compacted with an approximate two to three percent grade.
