REPORT OF INVESTIGATION

Fatal Hoisting Accident  
August 26, 2025

Marfork Processing  
Marfork Coal Company, LLC  
Whitesville, Raleigh County, West Virginia  
ID No. 46-08374

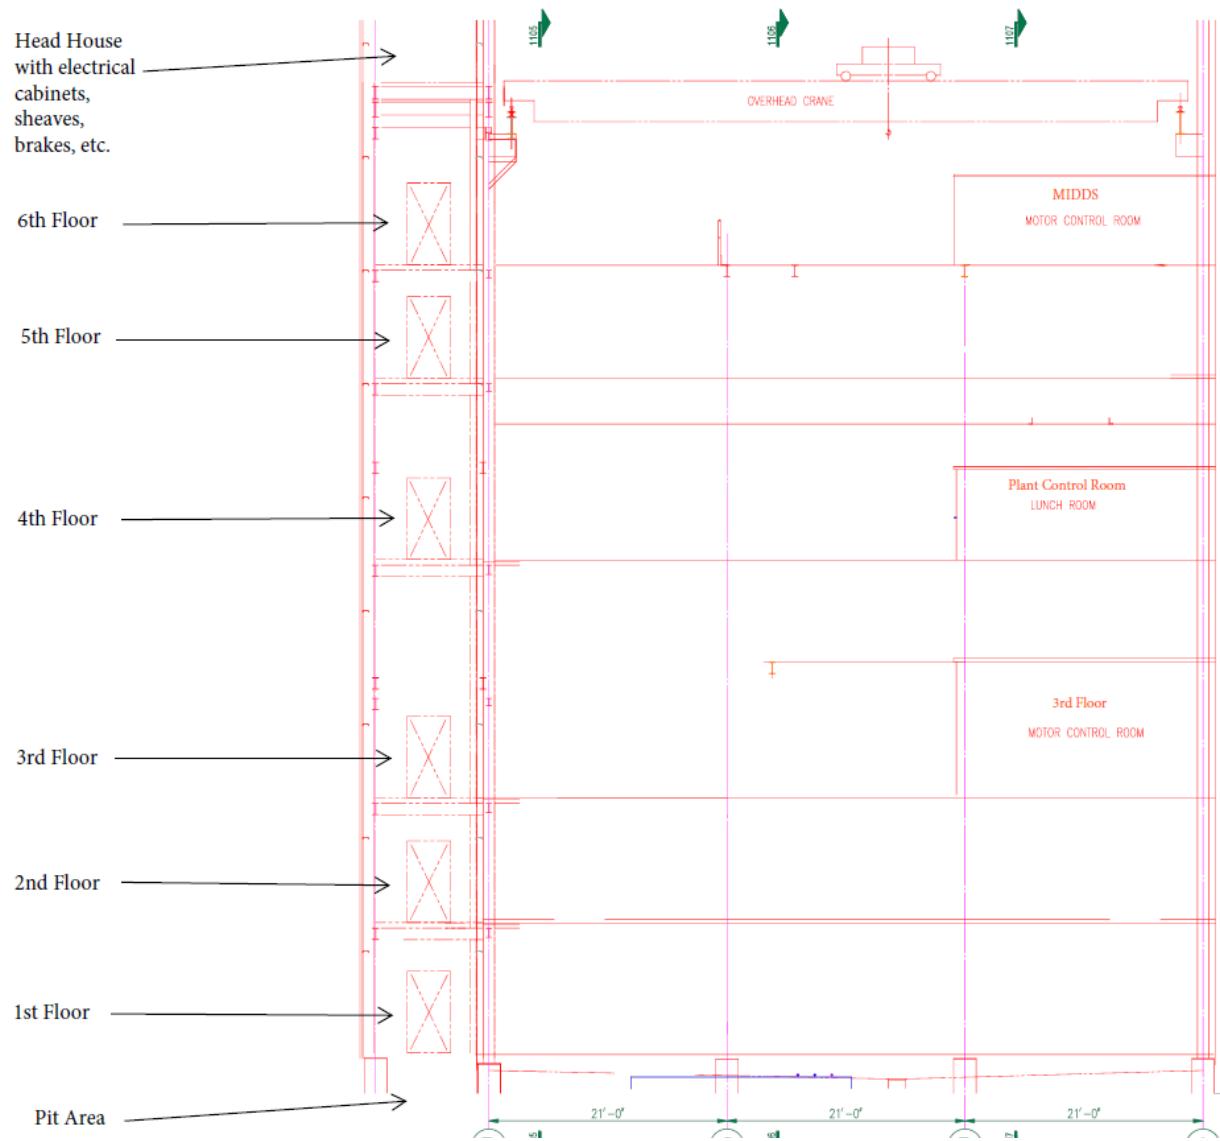
## APPENDIX A – Profile of Plant

The accident occurred inside the preparation plant at the first-floor elevator landing.

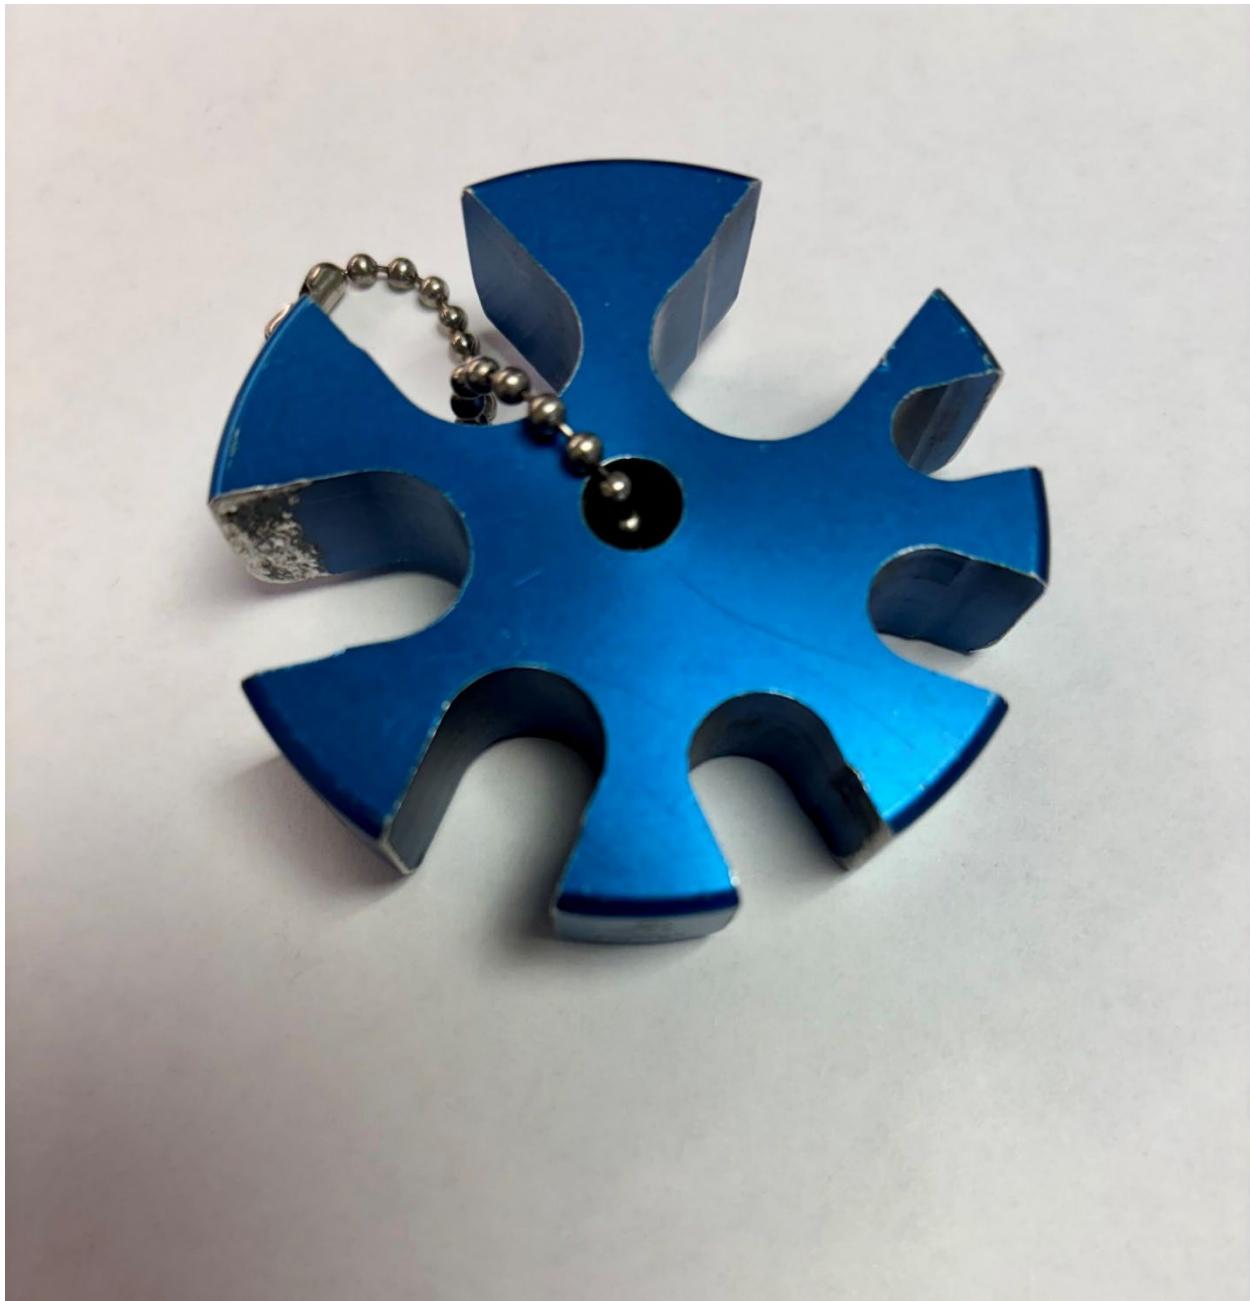
## APPENDIX C – Go/No-Go Gauge

Bartram opened the exterior elevator doors on the first floor. McNeely observed the counterweight at the pit. This indicated the elevator was on the sixth floor. Bartram and McNeely began looking for the Go/No-Go gauge in the pit from the first-floor landing but did not see it. Bartram then leaned or kneeled on the first-floor landing to reach the emergency stop button (e-stop) located in the pit area. McNeely asked if the e-stop felt like it was depressed, which should prevent the elevator from moving, and Bartram replied, “Yes.” McNeely then left the plant to get his Go/No-Go gauge from his vehicle, which was a three- to five-minute walk from the elevator.
