**REPORT OF INVESTIGATION**

**Fatal Fall of Ground Accident  
January 25, 2007**

**J. S. Redpath Corp..  
Contractor I.D. No. R83  
at  
Teck Cominco American Inc  
Pend Oreille Mine  
Metaline Falls, Pend Oreille County, Washington  
Mine I.D. No. 45-00366**

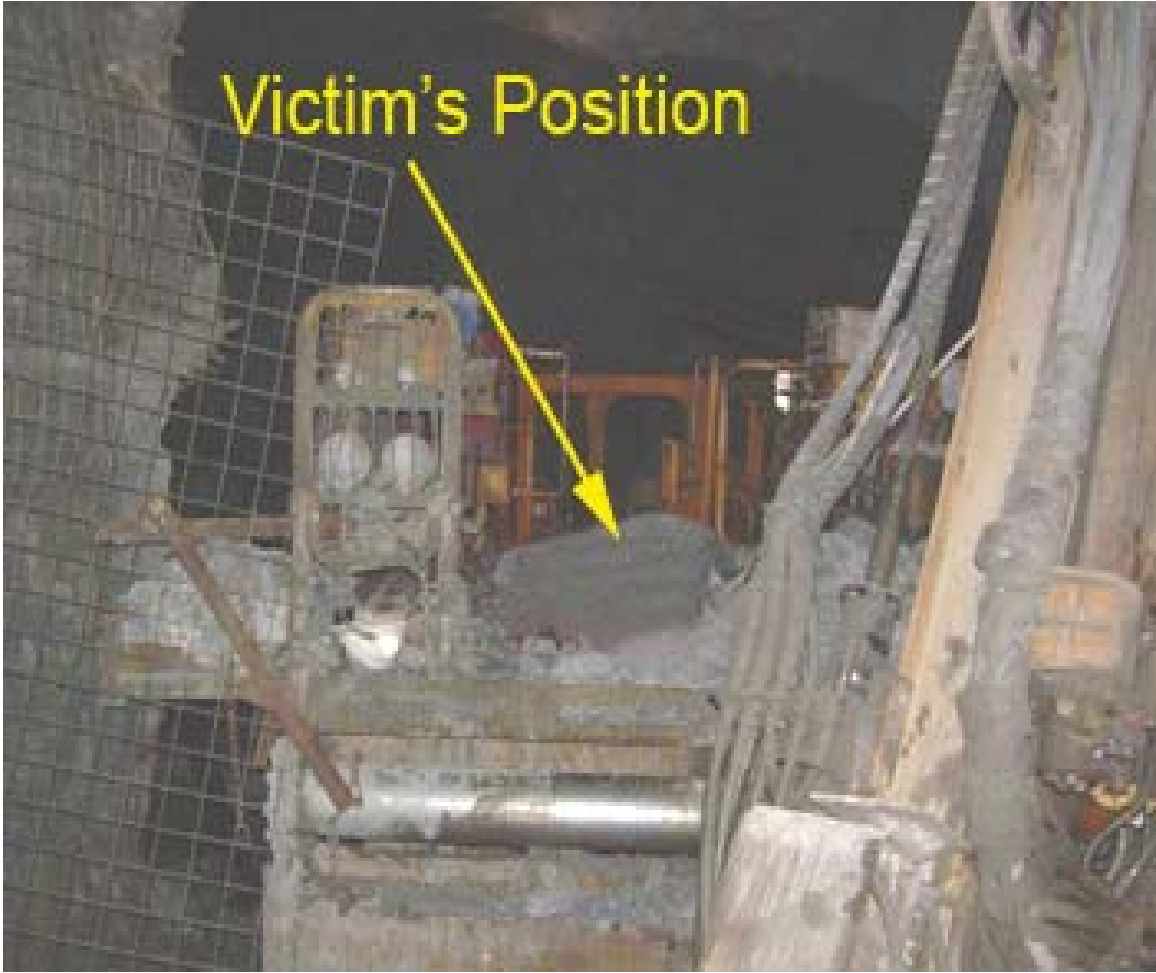
Phillip O. Markhart, underground miner, age 43, was fatally injured on January 25, 2007, while operating a roof bolter. Markhart was installing wire mesh when a large rock fell and struck him.

The accident occurred because management failed to design and maintain a ground support system in a manner that would control the ground where the bolter operators were performing their assigned tasks. A bolt sequence to ensure the safe handling and installation of the welded wire ground support panels was not in place at the time of the accident.
