REPORT OF INVESTIGATION

Surface Nonmetal Mine  
(Hydraulic Cement)

Fatal Falling Material Accident  
August 17, 2012

Tarmac America, LLC  
PENNSUCO Cement Plant  
Medley, Miami-Dade County, Florida  
Mine ID No. 08-00051

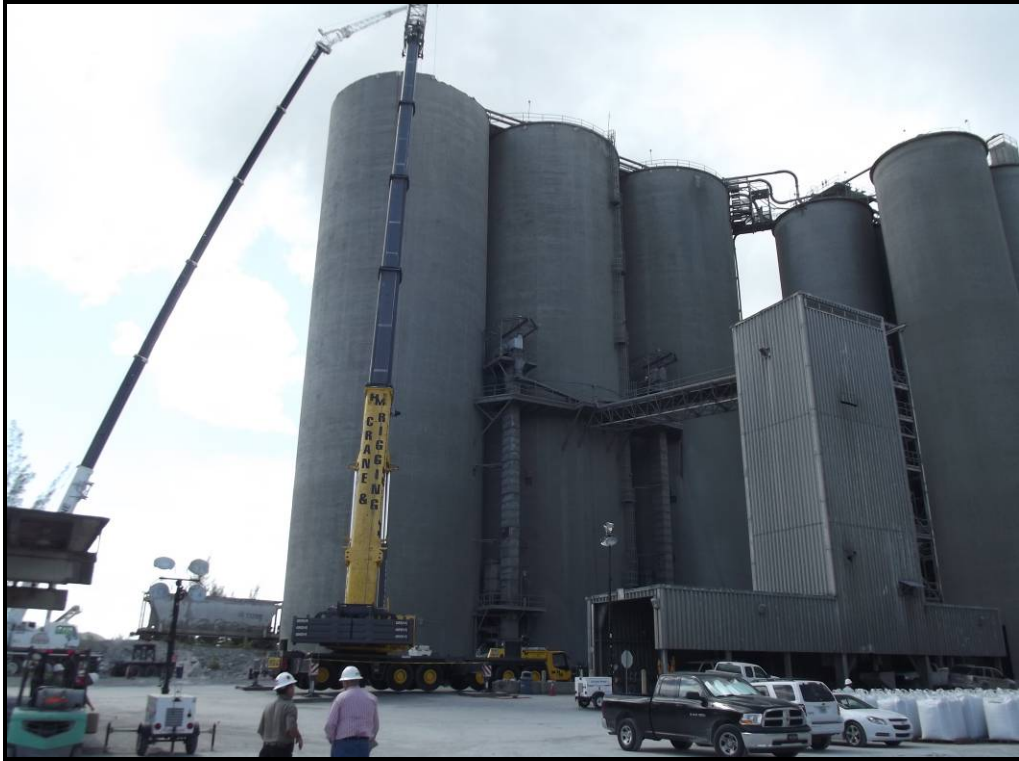
Photo 1 – Overview of Silo 12 (left), 11 and 10. Silo cluster 1-9 is on right side of picture.

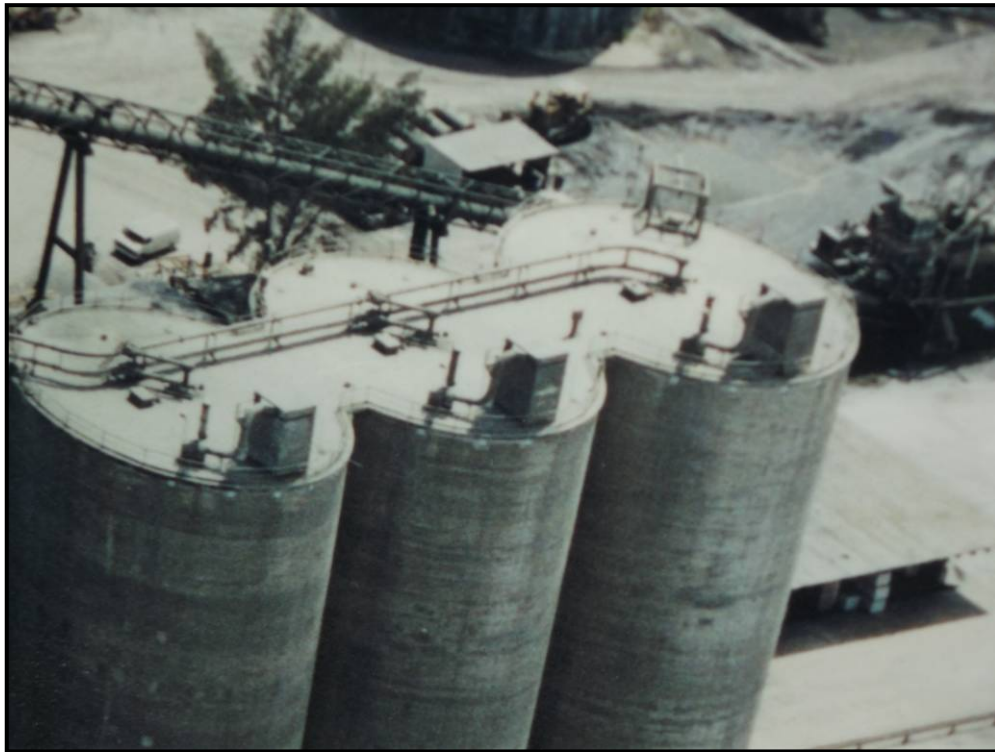
The silo roof was a reinforced concrete slab with a varying thickness (photo 2). The slab was designed to be 4½ inches thick at the edge and 11½ inches at the center to create a slope for drainage. These thicknesses included the 1½ inches of depth of the corrugated metal floor decking (specified as 16/16 GA) that supported the wet concrete while it hardened during initial construction. The gauge ratio referred to the thickness of the top hat plate and the thickness of the flat bottom sheet of the embossed cellular decking, which were both 16 gauge (equal to 0.06 inches). The center to center spacing of the corrugations in the roof decking was 6 inches. The top hat geometry was B-LOK. The decking sheets were as much as approximately 31 feet long and spanned north to south over multiple roof beams. The roof slab was reinforced by four layers of reinforcing steel, with two of the layers being oriented north to south and the other two layers east to west. The bars were specified as No. 4 bars on 18 inch centers. The concrete compressive strength was specified at 3,500 psi and the reinforcing steel at 60,000 psi yield strength. The roof slab was designed for its self-weight plus 50 psf<sup>3</sup> live loading. The slab was tied to the silo walls via continuity of the vertical reinforcing steel bars. Specifically, the two layers of vertical bars in silo walls were extended three feet above the top elevation of the wall. These extensions were then bent over into the roof slab to become part of the slab pour. Aside from this continuity of the wall reinforcing into the roof slab and the bearing around the perimeter, the primary means of support for the slab came from the six underlying steel roof beams.

Photo 2 – Silo 10 (left), 11, and 12 (circa 1996). This was prior to the MCC and F6 mill piping being added.

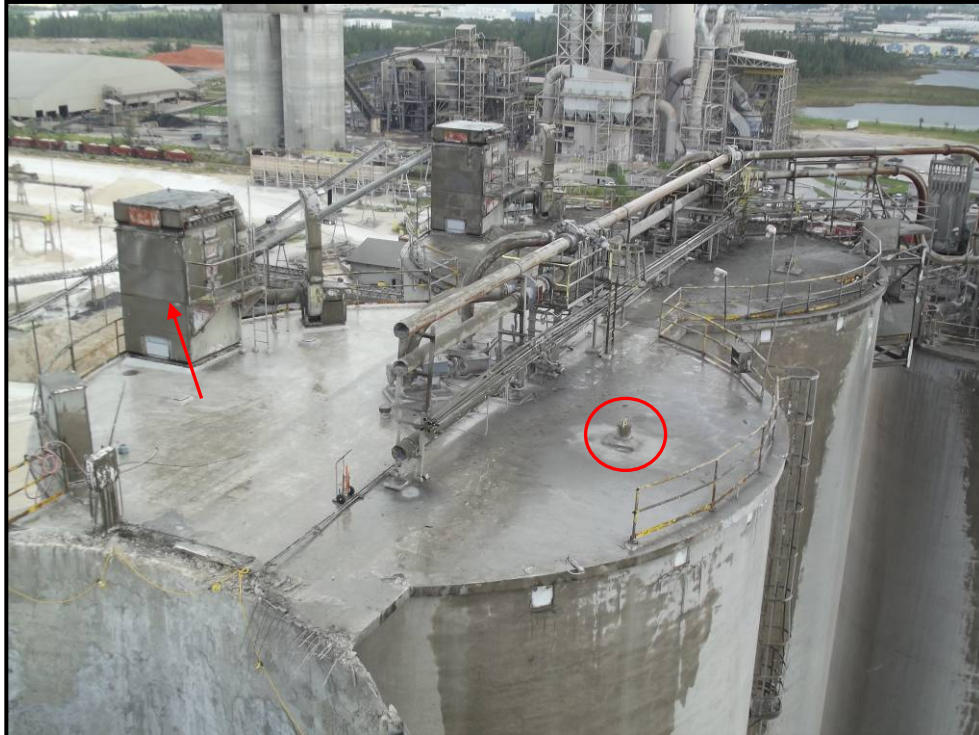
F3, F4, and F6 mills feed Silos 10, 11, and 12. Each mill had its own 12-inch diameter piping system to feed whichever silo was desired (photo 3). Typically, only one mill would feed a silo at a time, although it was possible to feed a silo with more than one pipe. If more than one pipe was used at a time, it was possible to overpressure a silo, as the dust collection system would likely not be able to vent the excess pressures fast enough as the silo filled. One such overpressure event occurred within Silo 11 in 2011, that caused the roof to bulge up, the reinforced concrete to significantly crack, and the bent over reinforcing bars at the perimeter of the slab to pop out (photo 4). Persons interviewed stated, that after that event the fill height on Silo 11 was restricted to no closer than 40 feet, as dust was coming out of the roof if the level got too close to the roof. In addition, when the silos fill, the internal pressure could cause a net positive pressure on the roof when the silo was getting full even with the dust collector operating and only one mill feeding.

Photo 3 – Roof of Silo 11 showing dust collector position (arrow) and fan on the west side (left) and the feed pipe rack with F6 piping being the uppermost. The measuring port (right) is circled. Note all piping leading to Silo 12 (lower left) was removed during the recovery.

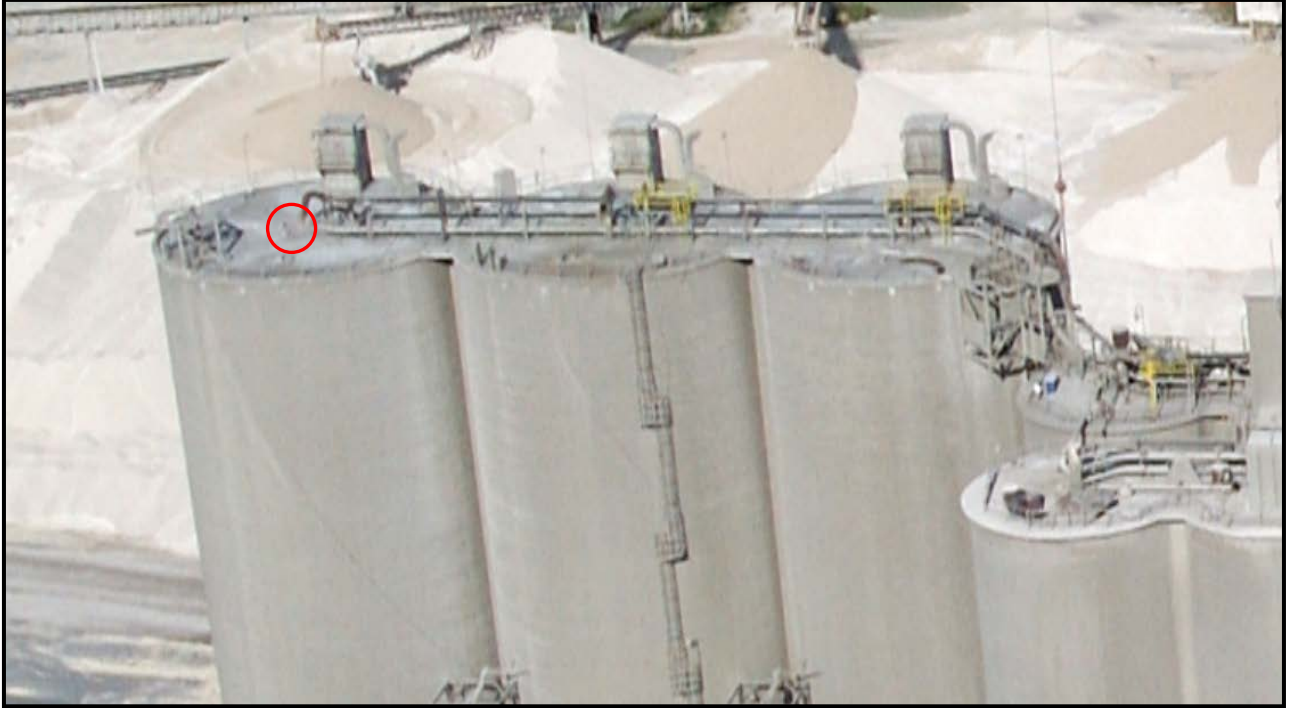
Photo 15 – Overview taken in 2004 looking at the east side of Silo 12 (left), 11, and 10 roofs. Circled area shows two ports on Silo 12. The upper left port was an observation port as per the original drawings and the lower right port was for a radio transmitter level indicator added (circa 2004). Note this photo was taken prior to the addition of F6 mill piping.

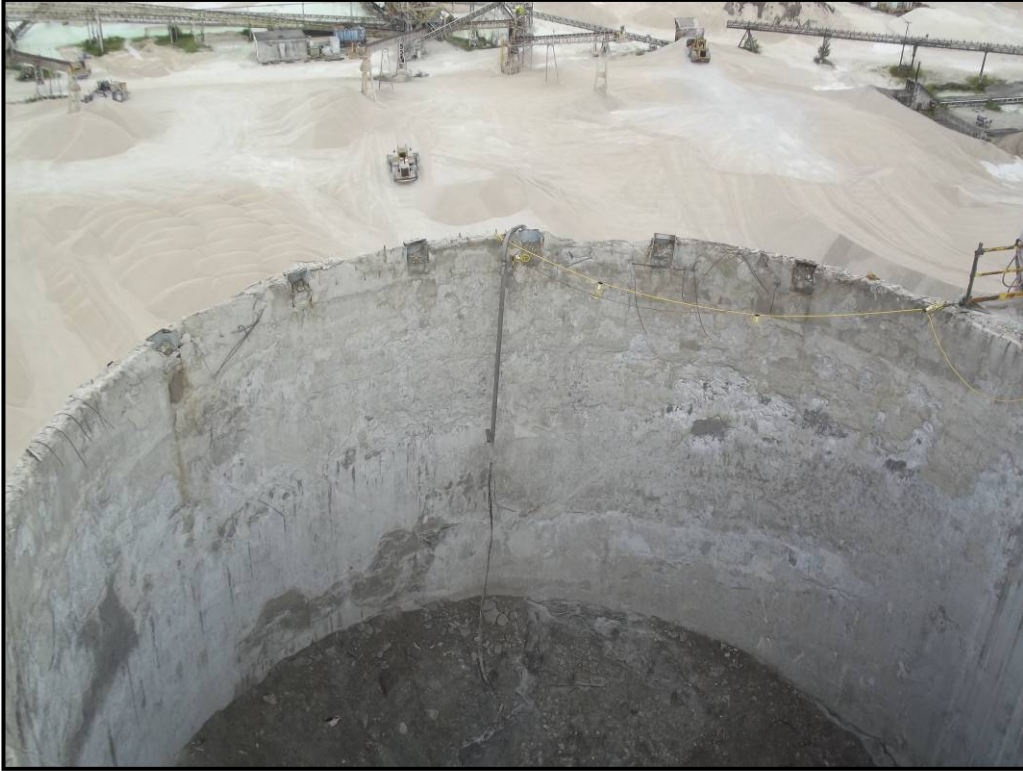
Photo 17 – Overview of the six west side beam pockets on Silo 12. Pocket W1 is on the left of the photo and Pocket W6 is on the right.

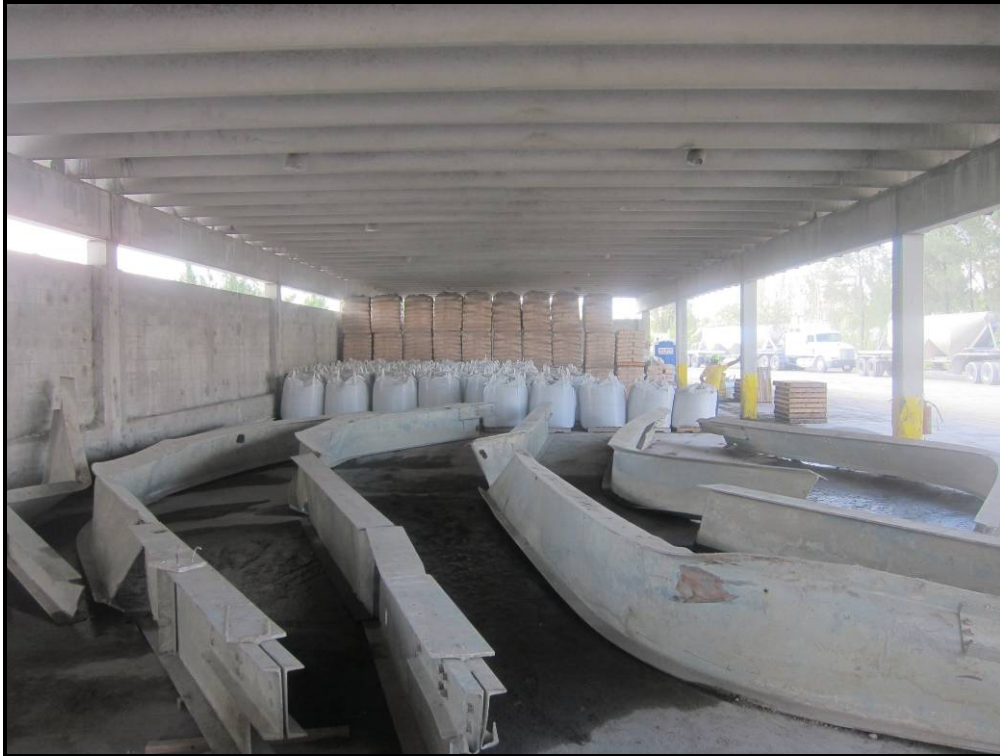
Based on the unique features of the beams, the investigation team was able to identify which beams would have been considered Beams 1 through 6. Beams 3 and 4 were mirror images of each other and were laid out backwards in the evidence lay down area. By comparing the fillet weld remnants that attached the dust collector to the top flange of the beams, it was possible to later determine the correct orientation of the two middle beams. Beam 3 had been damaged by a torch cutting the top flange. Specifically, nearly one half of the flange had been burned through when an opening was added to the roof of the silo (photo 28). This was likely for the installation of the radio transmitter level indicator. Apparently, when the roof slab and decking were cut open, the hole aligned with the location of the roof beam, so the installer cut part of the roof beam. When the flange was cut to the intersection with the web the individual appeared to have moved the port a few inches over and then re-cut the flange. The radius of the arc cut the second time did not interfere with the web of the beam. This second cut was a 9 inch wide by 3.5 inch deep arc in the flange. Cutting significantly weakened the stability of the top flange of the beam; therefore, the overall carrying capacity of the beam was diminished.

Photo 29 – Layout of Silo 12 roof beams. Beam 1 (only partly visible) is against left wall. Left to right is Beam 2 (2 sections), 4 (3 sections), 3 (2 sections), 5 (2 sections), and 6 (intact).

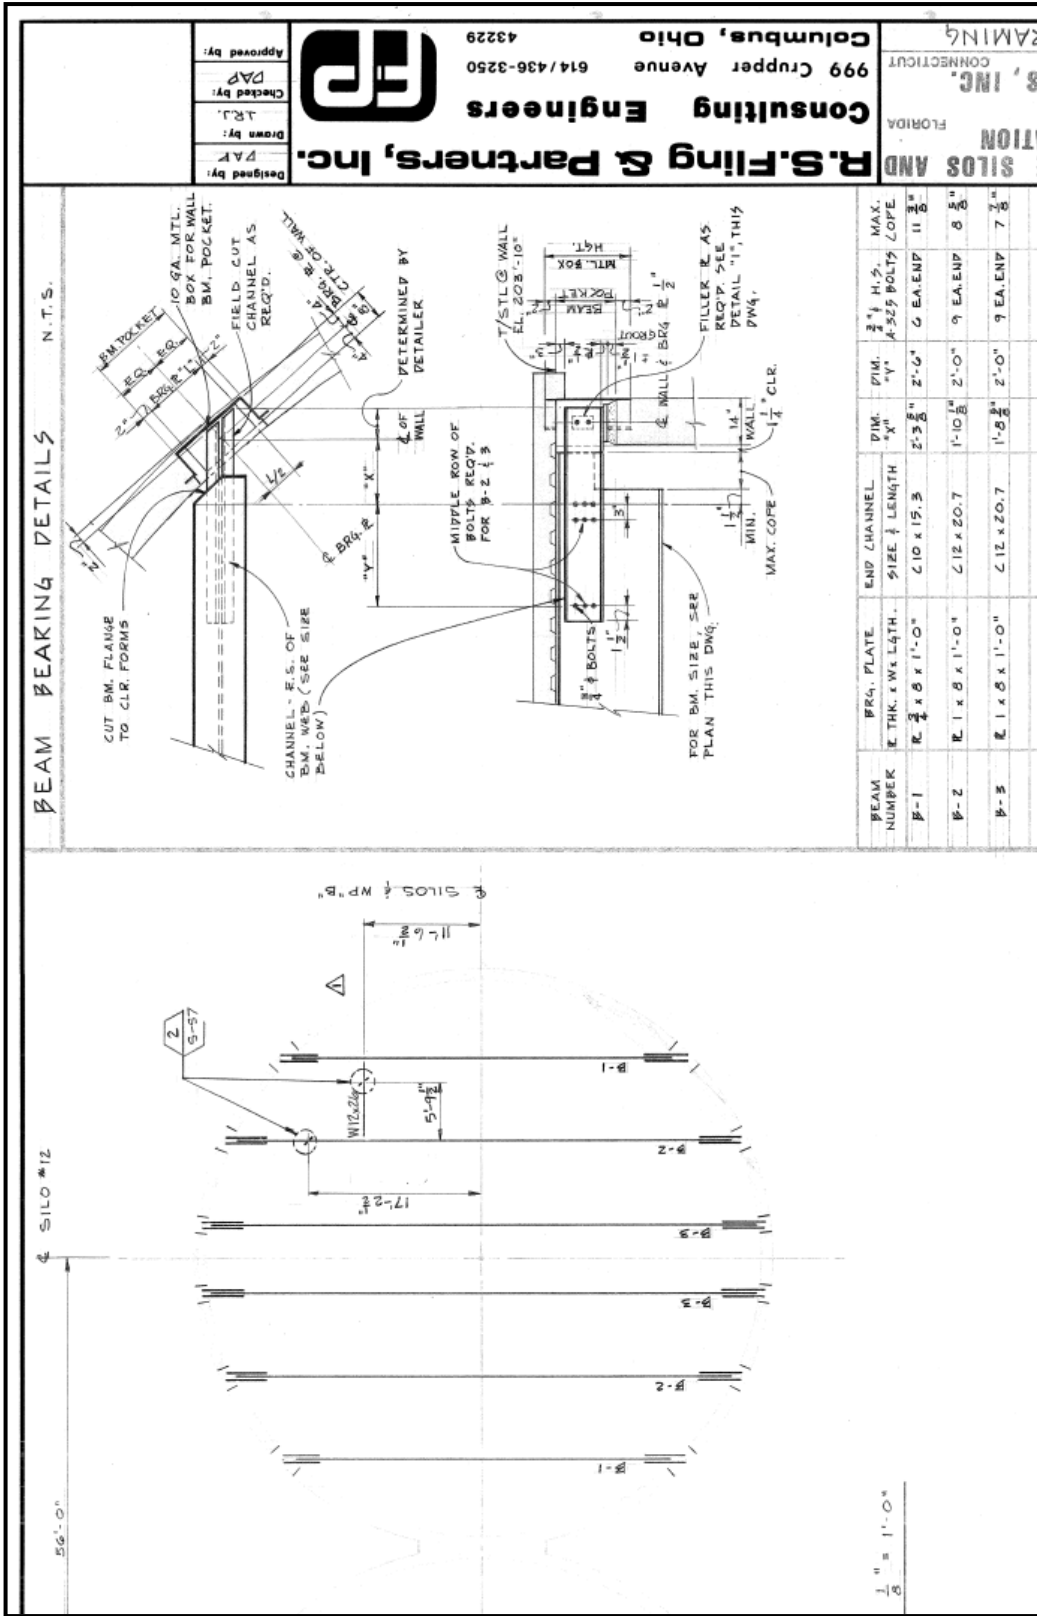
The silo roof beams spanned east/west and rested in wall pockets left open at the top of the wall (figure 1). Within the pocket, a bearing plate was installed. The

The channel extensions that were bolted to the ends of each of the roof beams rested on bearing plates that were cast into the silo wall within the confines of a metal beam pocket box (figure 1). As per the design drawings, the channels were not welded to the bearing plates so that lateral movement of the beams would be permitted. The sheet metal boxes were 8 inches deep, 16 inches wide and 23 inches high. There was no plate on the bottom side of the box. Within the box, there was a bearing plate that was dimensioned 8 inches wide by 12 inches long. The bearing plates for Beams 1 and 6 were  $\frac{3}{4}$  inches thick and the plates for Beams 2-5 were 1 inch thick. Four bent studs were welded to the underside of each plate. These studs were L-shaped and had a  $\frac{3}{8}$  inch diameter and were 5 inches long. Specifically, the stud was straight down for a distance of  $3\frac{1}{2}$  inches and to the right for a distance of  $1\frac{1}{2}$  inches.

Figure 1 – Original engineering drawing by R.S. Fling showing the roof beam layout and beam pocket details.

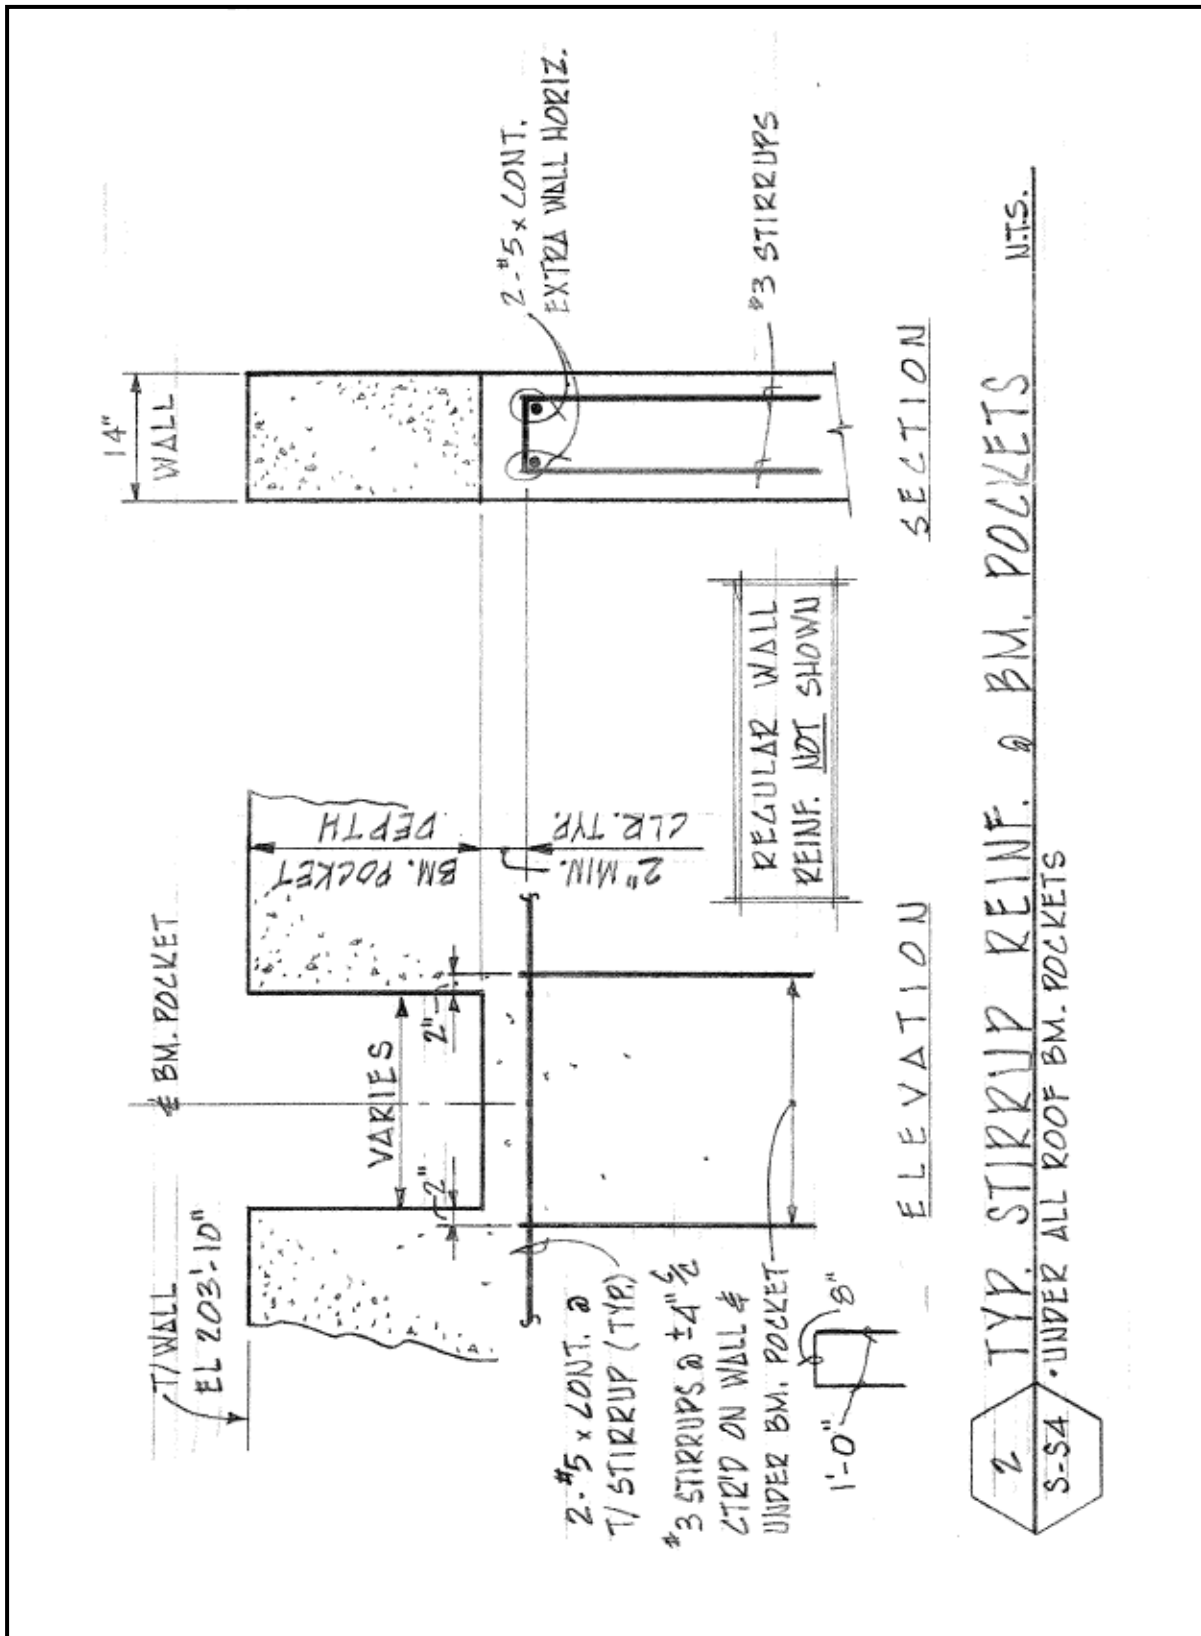
At a distance of two inches below each of the beam pockets, the designer specified that size No. 3 shear stirrups should be installed on 4-inch centers (figure 2). The stirrups were to be Grade 40 steel. Typically five stirrups would be placed below a pocket.

Figure 2 – Original engineering drawing by R.S. Fling showing beam pocket shear reinforcing.

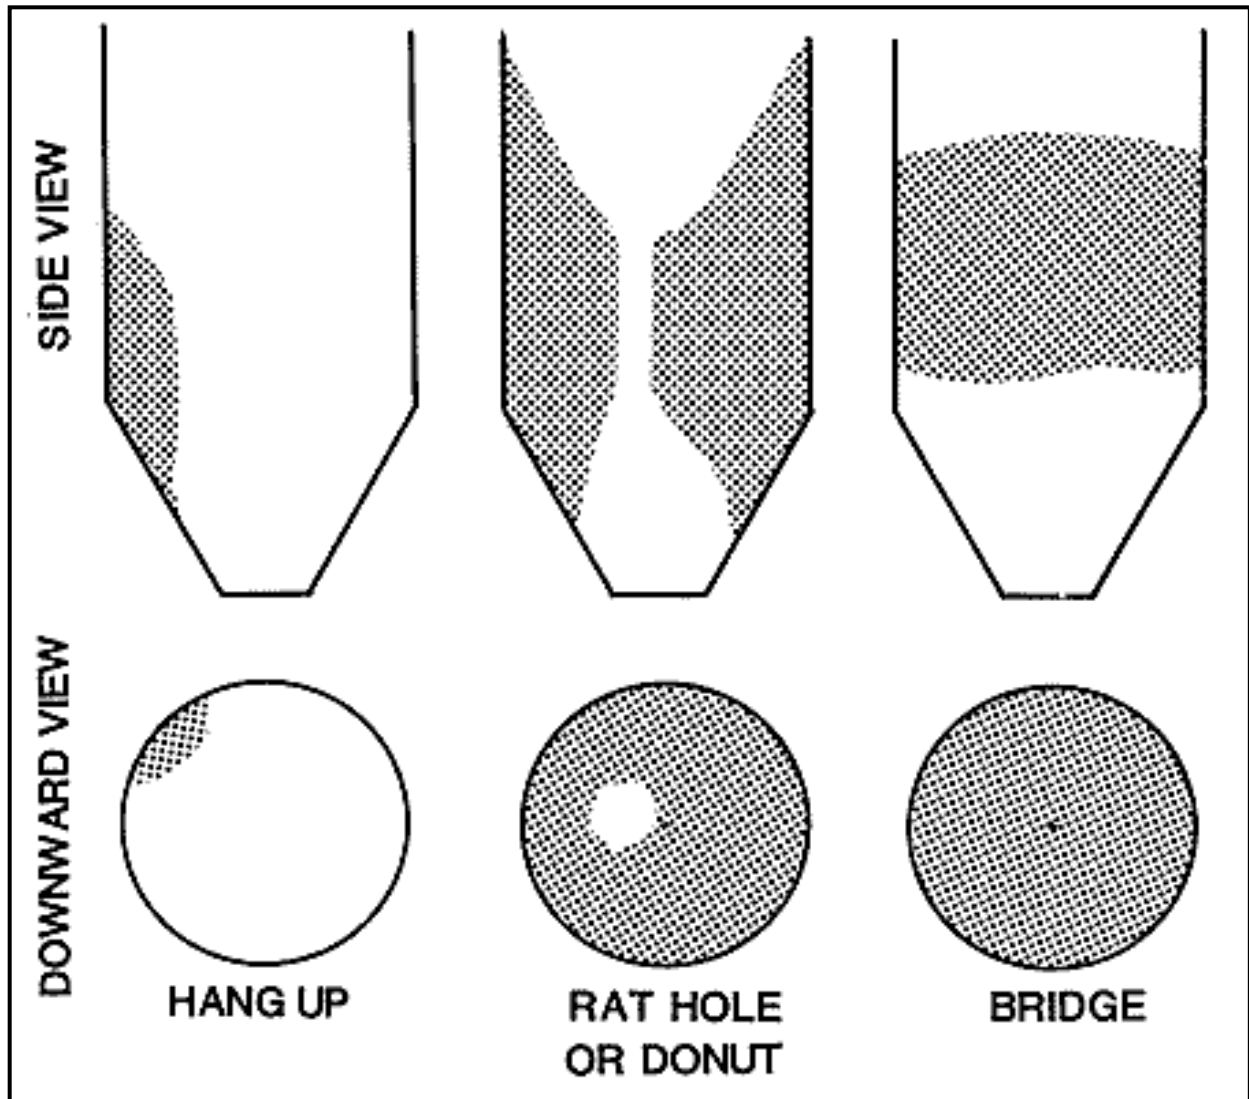
The silo was designed with a funnel flow hopper. However, over time, cement powder built up inside and formed a rathole or donut, which decreased the live storage capacity of the silo (figure 4, photos 12-13). When stored cement powder bridges over a rathole or donut and then suddenly collapses into the flow channel, it can cause large suction loads on the silo roof, depending on the amount of collapsing stored material above the flow restriction. Collapsing material caused a piston effect where high overpressures could occur in the lower part of the silo and suction could occur in the upper part. Flow-induced silo vibrations could cause significant dynamic loads. Several workers reported feeling vibrations on the roof of Silo 12.

Figure 4 - Illustration of types of material flow irregularities.  
Source: Canadian Grain Commission Website.
