REPORT OF INVESTIGATION

Underground Metal Mine
(Silver Ore)

Fatal Explosives and Blasting Agents Accident
November 17, 2013

Star Mine Operations LLC
Revenue Mine
Ouray, Ouray County, Colorado
Mine ID No. 05-03528

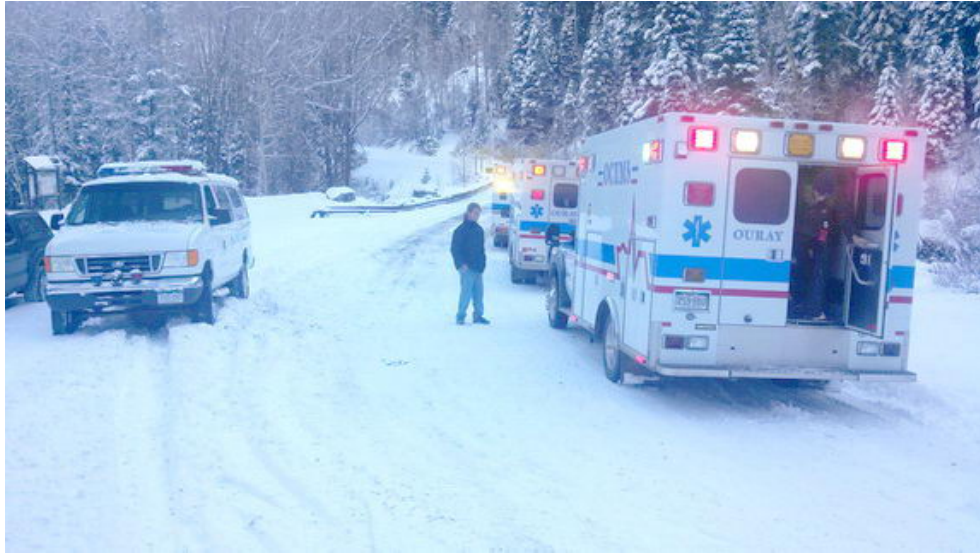
On the day of the accident, the weather at the mine was snowing and the average temperature was 34° Fahrenheit. The road to the mine was snow covered and initially did not allow ambulance access to the mine (see Figure 2). A county plow truck operator saw emergency crews traveling toward the mine, came to their aid, and plowed the road to the mine. Weather was not considered to be a contributing factor to the accident.

Figure 2 - Ambulance Staging Area at Angel Creek on November 17, 2013

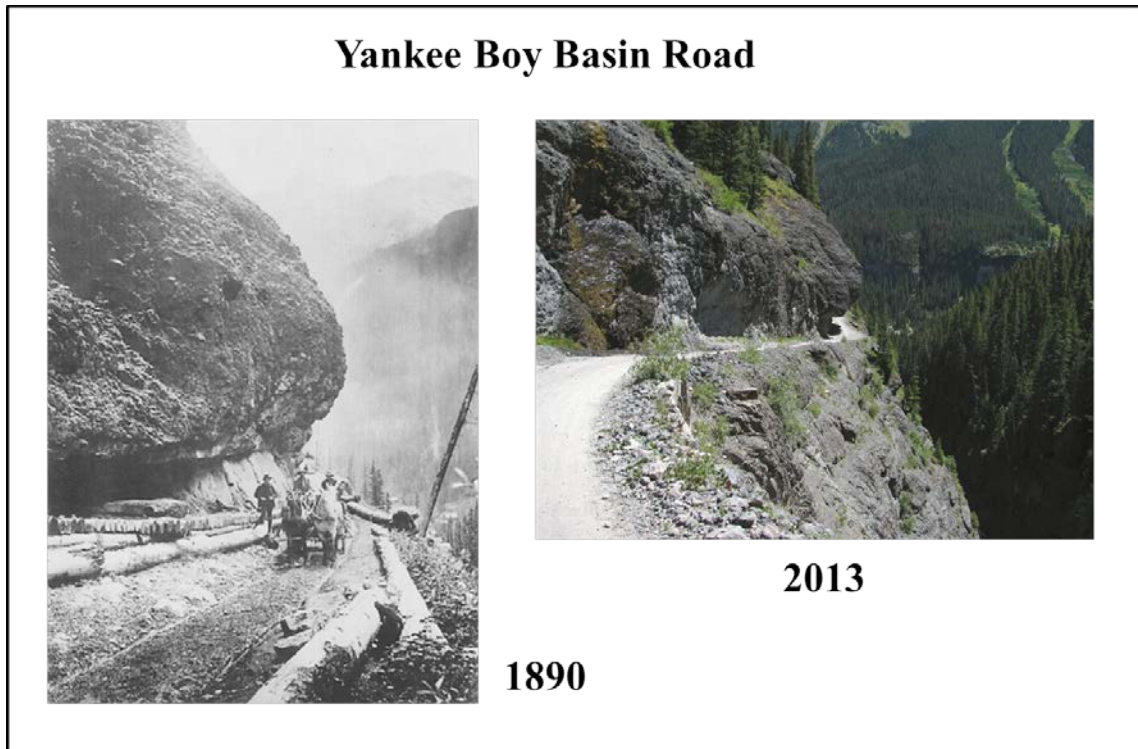
Previous roads to the mine were replaced by the current road which was completed in 1890 (see Figure 3). The completion of the road reduced the steepest grade on the road to 15 percent, at the sharp turns or “switchbacks.” The road climbs from 7,900 feet in Ouray to 11,000 feet at the mine portal. The U.S. Forest Service closes the road to the public during the winter months at a location just before the switchbacks.

Figure 3 – The Road to the Mine, Past and Present

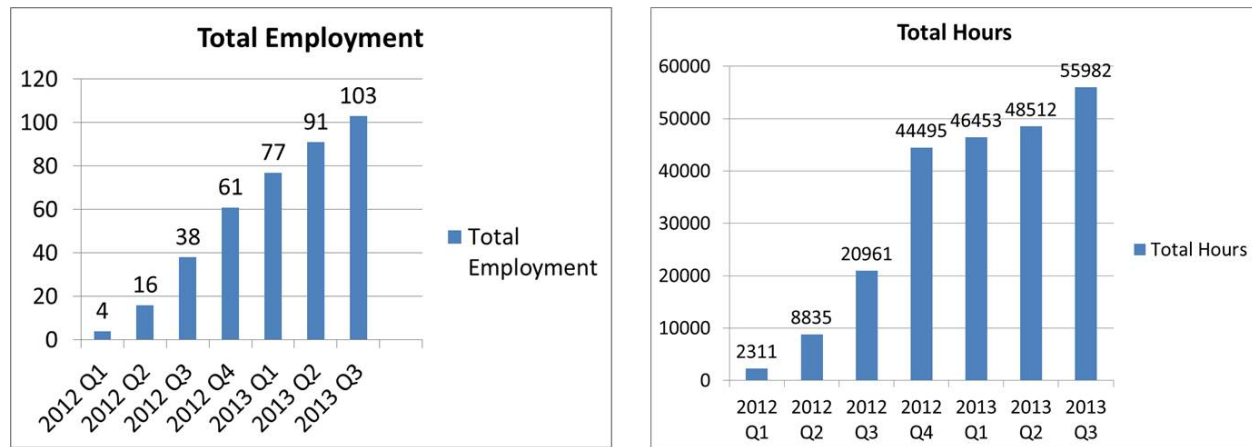
In the fourth Quarter of 2011, the mine operator reported that two surface miners were employed at the mine. In the first Quarter of 2012, the mine operator reported it employed four surface miners. After that, employment rose as the mine was rehabilitated and mining began. Figure 15 shows the dramatic growth of employment and the hours worked over a 1.75 year period. At the

Figure 15 –Total Employment and Hours Worked at the Revenue Mine
