MAI-2015-13

REPORT OF INVESTIGATION

Fatal Falling Material Accident
August 3, 2015

Pinky's Aggregates Inc.
Pinky's Aggregates Inc.
New Town, Rolette County, North Dakota
Mine ID No. 32-00909

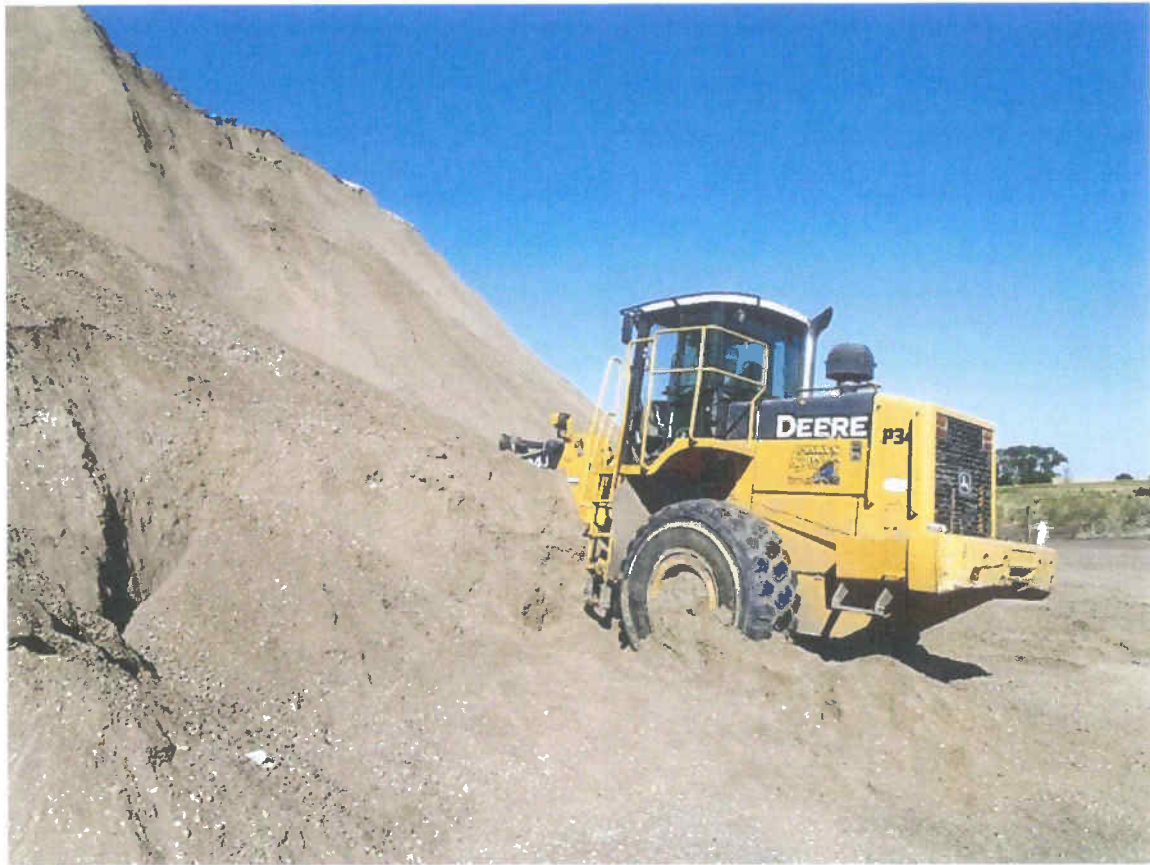
Large cracks on the surface of the stockpile, areas of material separation and previous sloughing of material were evident on all sides of the stockpile.

The accident occurred on the south face of the stockpile which was measured to be 39 feet high. The slope failure extended the full height of the pile and was 90 feet wide at the bottom, displacing an estimated 400 cubic yards of material. The slope failure occurred directly adjacent to the loader, and the fallen material partially covered the front and left side of the loader resulting in six feet of material at the front of the loader and four feet at the side of the loader where the victim was located. An estimated 15 cubic yards of fallen material adjacent to the victim had been removed during the rescue efforts.
