REPORT OF INVESTIGATION

**Underground Metal Mine
(Lead-Zinc Ore)**

**Fatal Exploding Vessels under Pressure Accident
October 2, 2018**

**Empire State Mines
Empire State Mines LLC
Gouverneur, St. Lawrence County, New York
Mine ID No. 30-01185**

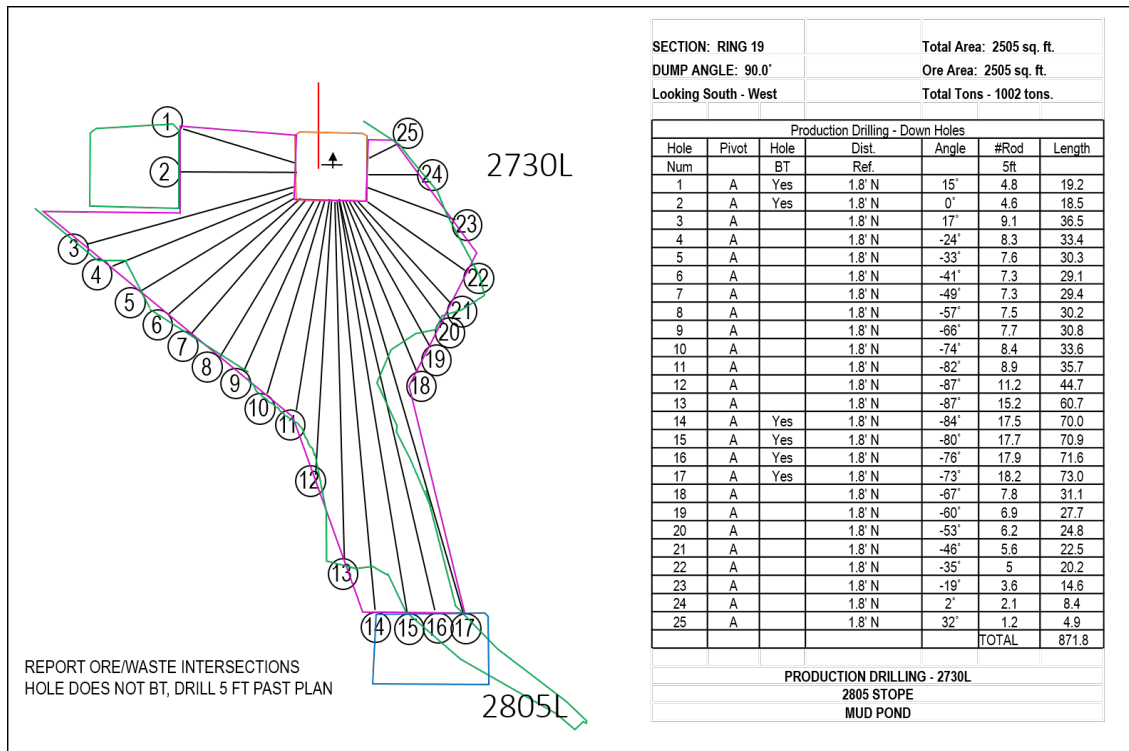
Figure 2 - Production Drilling - M2730 Level - 2805 Stope - Ring 19

A borescope was used to obtain video footage of the interior of the 3-inch diameter, No. 11 vertical drill hole to evaluate conditions within the hole. The evaluation of the borehole along its entire length found no evidence of residual explosive material left in the hole. The drill hole was clear of obstruction for the first 31.5 feet in a hole that was drilled 34.25 feet below the collar. This indicates at least 2.75 feet of roof and bottom of the borehole fell into the muck in the preceding several days. The borescope showed no large cracks, voids or intersections with another borehole.

Interviews indicated one 50-pound bag of sand was used as stemming in each borehole, which Major Drilling Underground claimed would fill about 10 feet of a drilled hole. The No. 11 drill hole was a wet borehole and would have caused the sand to bond together, making it harder to clean out the hole. After reportedly blowing out approximately 3 feet of material, the contractor encountered a blockage. As the grout hose was pushed through the blockage, a pressure void was filled with the compressed air until it could no longer be contained (see Figure 6). When the air released, a column of stemming was thrust to the surface of the borehole. This evacuation of air and stemming material struck the contractor foreman, who was in close proximity to the borehole opening, causing fatal injuries. No evidence of residual explosive material was found in the hole.
