REPORT OF INVESTIGATION

Underground Metal Mine
(Gold)

Fatal Fall of Back Accident
October 25, 2018

Lee Smith Mine
Small Mine Development LLC
Elko, Elko County, Nevada
Mine ID No. 26-02397

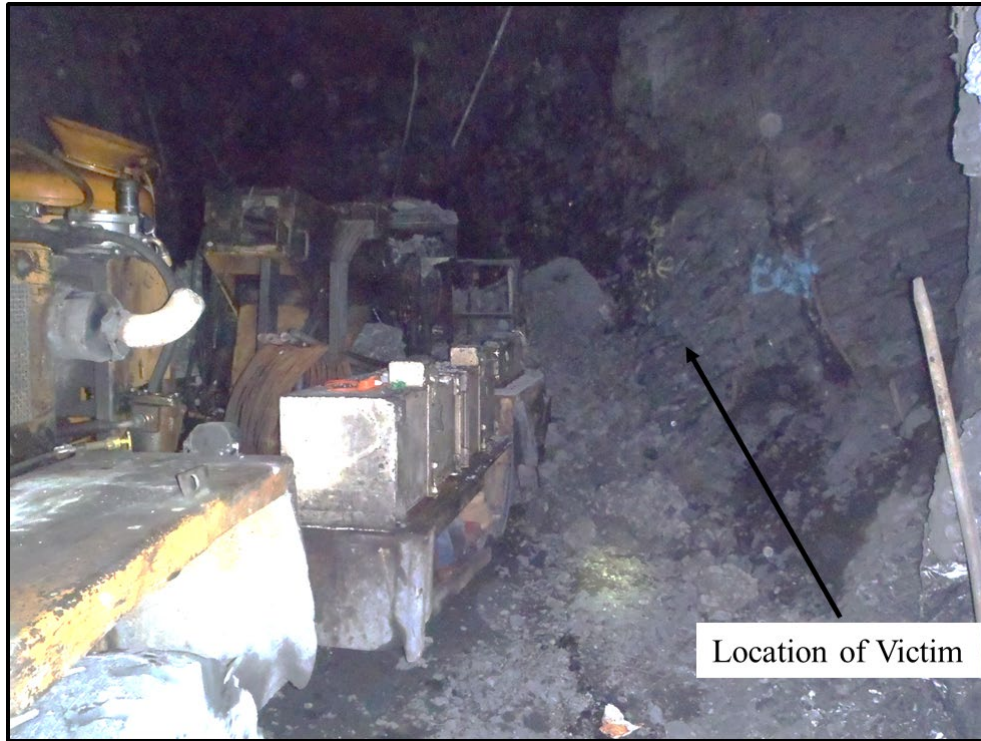
Jason M. Holman, a 42-year-old Powderman with eight years of experience, was fatally injured on October 25, 2018, when Cemented Rock Fill (CRF) used to backfill previously mined areas fell from the back/roof and buried him while he was loading blast holes. Mr. Holman's body was recovered from the fallen material on October 26, 2018.
