UNITED STATES
DEPARTMENT OF LABOR
MINE SAFETY AND HEALTH ADMINISTRATION

REPORT OF INVESTIGATION

Powered Haulage
May 18, 2019

Rogers Group Inc.
West Amarillo Sand & Gravel
Vega, Texas
ID No. 41-04358

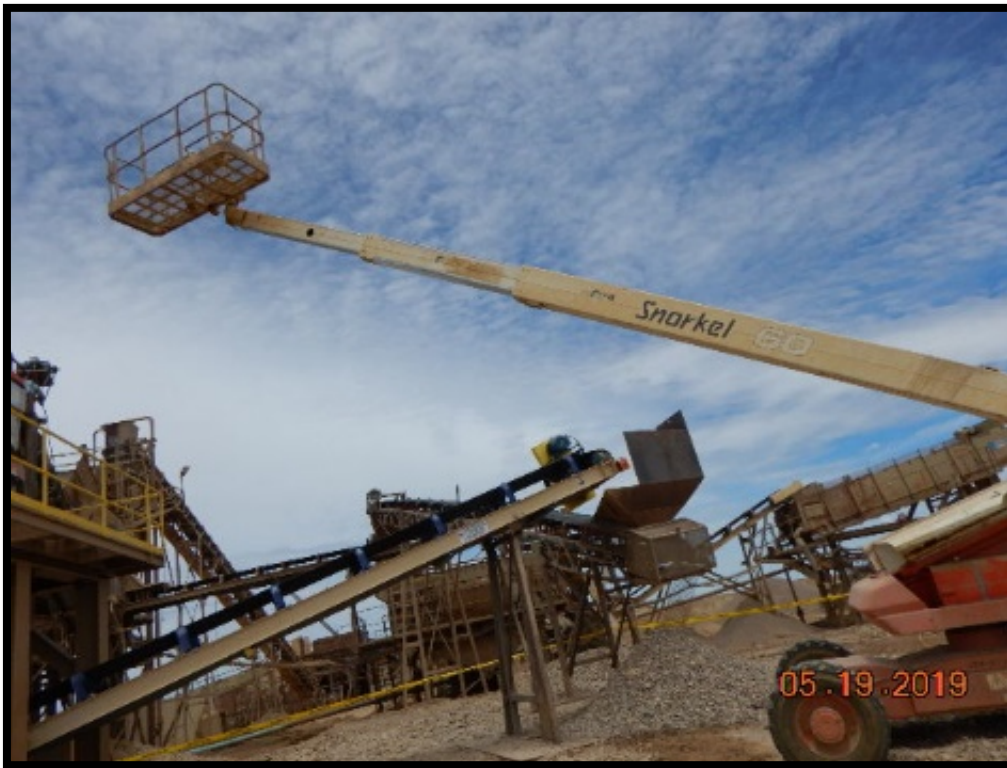
Richard E. Ramirez, a 35-year old plant operator with eight years of experience, died on May 18, 2019, at 4:25 p.m., after falling 28 feet from the basket of a personnel lift. Ramirez was using the personnel lift to access a cone crusher feed box to clear a stoppage. He was wearing a fall protection harness with a retractable lanyard, but the lanyard was not attached to the basket's tie off points.
