REPORT OF INVESTIGATION

Surface Mine
(Construction Sand and Gravel)

Fatal Machinery Accident
August 26, 2020

Portable 1
Chilton Logging Inc.
Woodland, Cowlitz County, Washington
Mine I.D. No. 45-03806

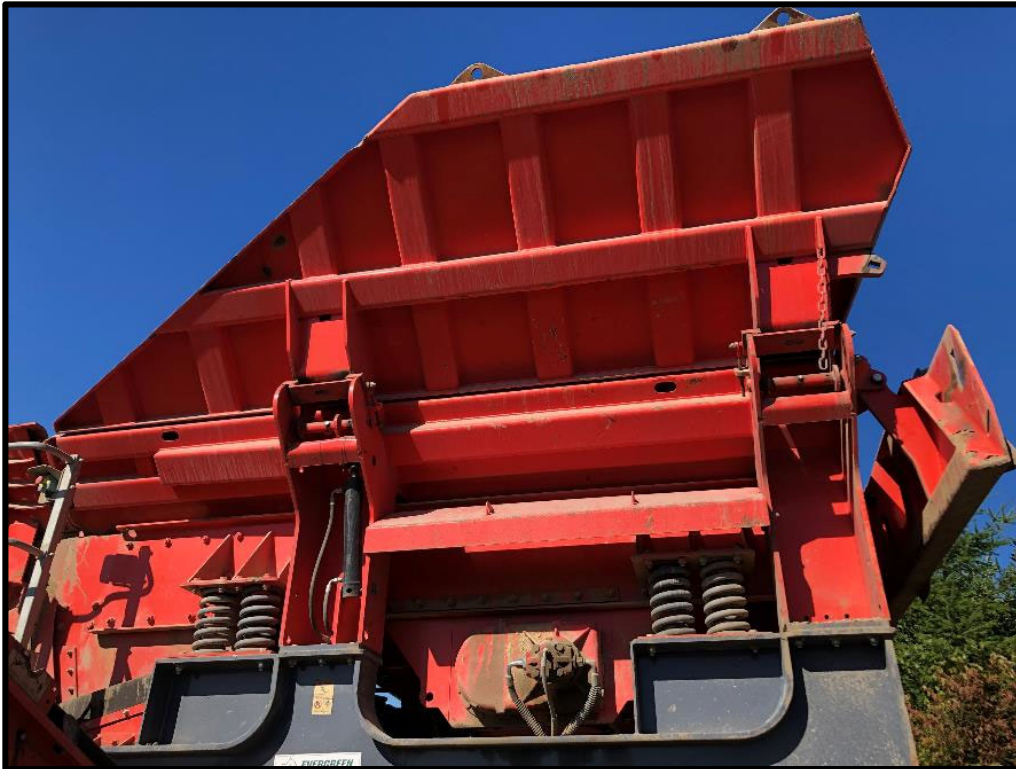
On August 26, 2020, at 12:30 p.m., Bobbie D. Skillett died when the right side hopper extension of the jaw crusher fell on him. He was a 52-year-old Crusher Foreman with more than 23 years of mining experience, including approximately four weeks of experience with Chilton Logging Inc. Skillett was preparing the jaw crusher for transport by removing both wedges that held the right side hopper extension in a raised position.

On the day of the accident, a hydraulic cylinder was not attached to the right side hopper extension. A metal wrist pin, which normally holds these components together, was missing (see Appendix C). Therefore, when Skillett removed the second of the two side wedges from the right side hopper extension, the hydraulic cylinder did not hold the hopper extension in the raised position. Instead, the right side hopper extension fell onto Skillett, crushing him against the top of the hydraulic excavator.

On the day of the accident, the miners did not follow the manufacturer's recommended procedure. Instead, they removed both rear wedges first, and then lowered the rear hopper extension. Then, they proceeded to remove both of the side wedges that held the right side hopper extension in the raised position. If they had followed the procedure properly by removing the side wedges before lowering the rear hopper extension, the right side hopper extension (and left side hopper extension) would have been mechanically blocked against motion by the rear hopper extension while they were removing the side wedges (see Appendix D). Thus, the right side hopper extension could not have fallen on Skillet, even though the hydraulic cylinder was not attached to the right side hopper extension.
