REPORT OF INVESTIGATION

Surface
(Sand and Gravel)

Fatal Handling Material Accident
February 27, 2020

Patterson Road Mine
Michigan Materials and Aggregates Company
Middleville, Allegan County, Michigan
Mine ID No. 20-02995

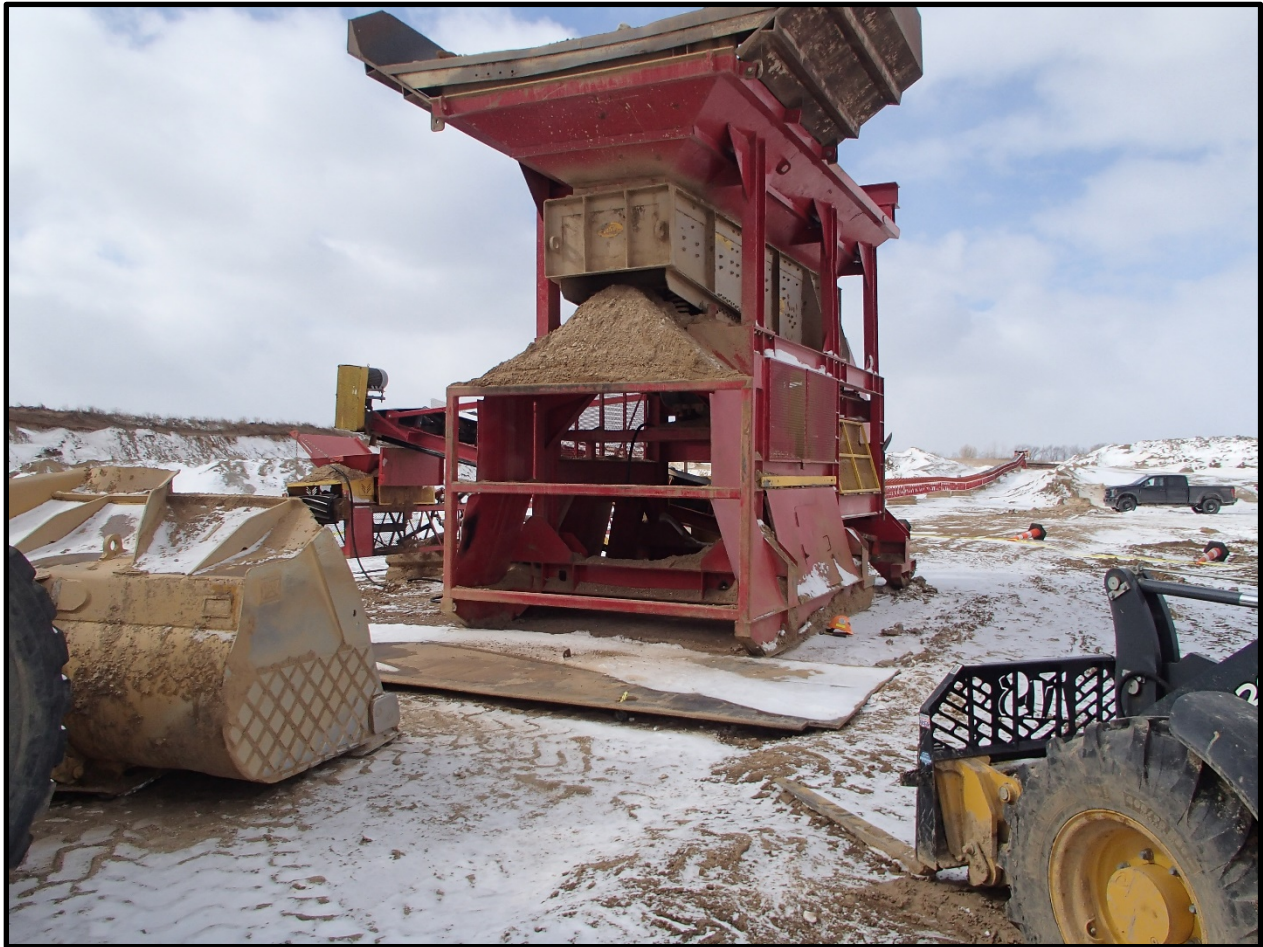
Ronald A. Baughman II, a 29-year-old equipment operator with two years of total mining experience, died on February 27, 2020. While working with other miners to set a steel plate vertically against the frame of a feed hopper, the plate fell on him.

The accident occurred because mine management did not follow their procedure for securing the steel plate prior to removing the rigging.

The weather at the time of the accident was 21 degrees with a 16 mph wind from the west. Cold, dry weather conditions created hard packed and frozen ground in the immediate area of the hopper at the time of the accident. Investigators believe that weather may have been one of the factors contributing to the accident as the wind was blowing in the same direction the steel plate tipped over.

Root Cause: The mine operator's feed ramp construction procedure did not explicitly require that the steel plate be securely fastened to the frame of the feed hopper prior to persons removing rigging, or prevent miners from working near an unsecured load.
