**United States  
Department of Labor  
Mine Safety and Health Administration  
Coal Mine Safety and Health**

**Report of Investigation  
Underground Coal Mine Explosion  
Dutch Creek No. 1 Mine – I.D. No. 05-00301  
Mid-Continent Resources, Inc.  
Redstone, Pitkin County, Colorado  
April 15, 1981**

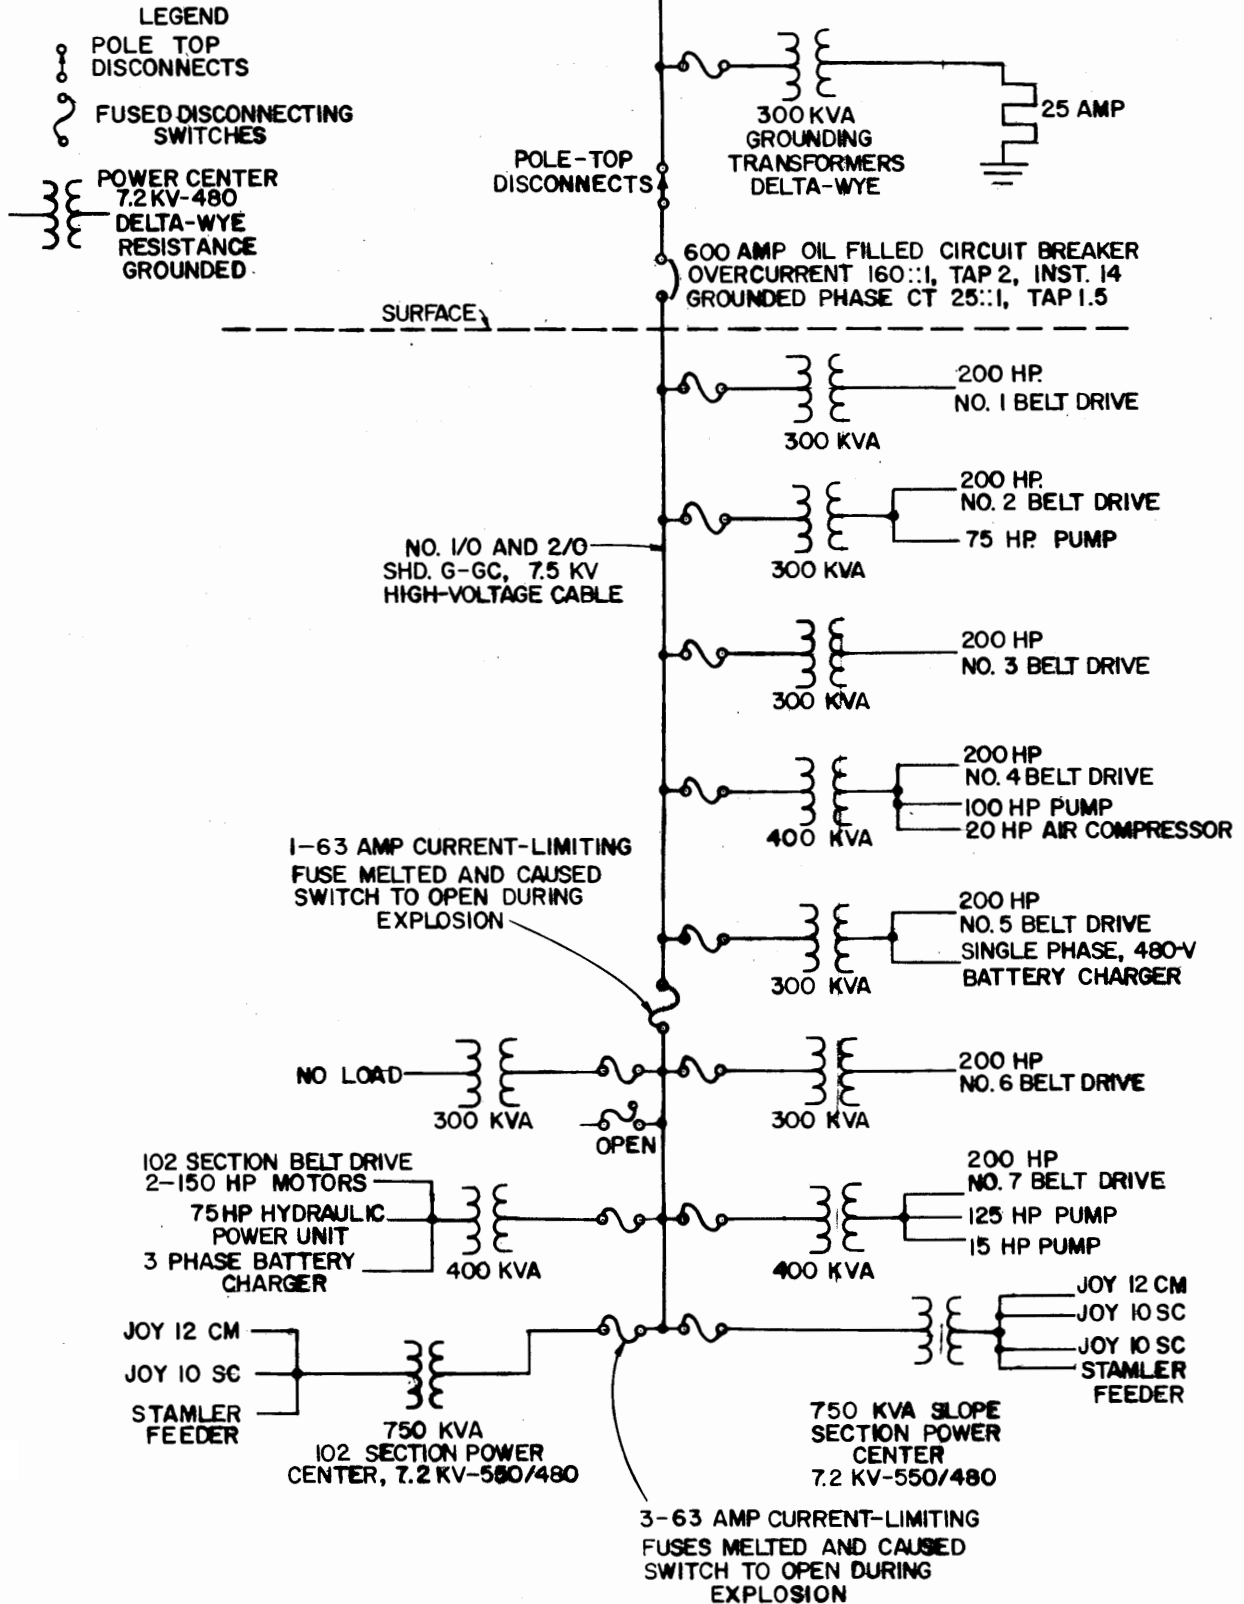
**APPENDIX J**  
**DUTCH CREEK NO.1 MINE, ID 05-00301**  
**MID-CONTINENT RESOURCES, INC.**  
**SCHEMATIC DIAGRAM OF MINE**  
**POWER SYSTEM**

**ENERGIZED POWER CIRCUITS**  
**AT TIME OF EXPLOSION**

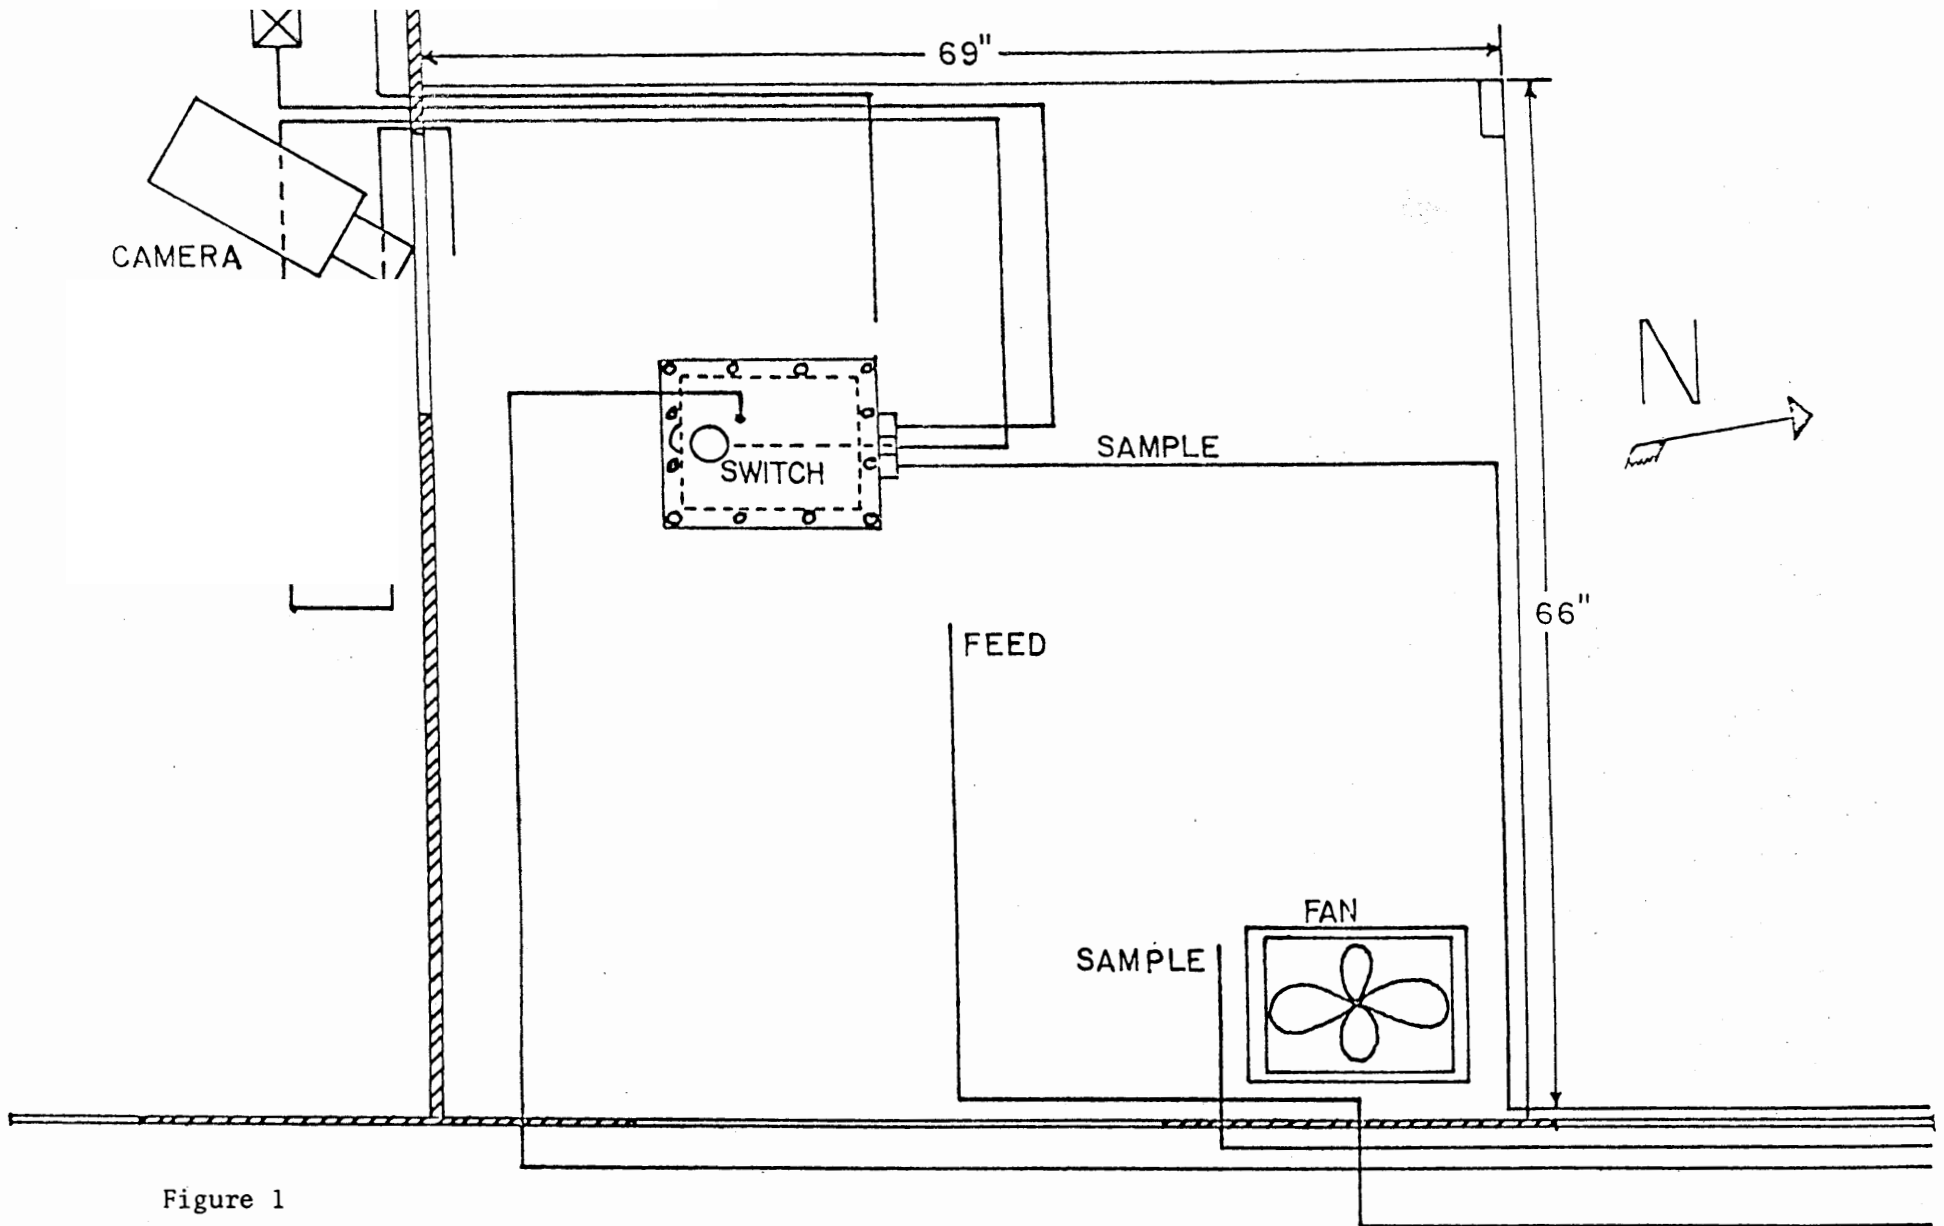
Figure 1  
SWITCH BOX EXPLOSION STUDY  
TEST SET-UP  
SCALE: 1"=1'  
6-2-81  
TMF

A small partition was assembled in the Division's Gas Gallery and used for both regimes. Details of the partition are shown in Figure 1. The height of the

Regime 1: Ignition of the mixture within the box was achieved remotely by either an electric squib or capacitively discharged high-energy spark. Tests were conducted with both original and duplicate boxes. A section of No. 14 stranded wire was placed on the box between the cover plate and box lip. The wire location can be seen in Figure 1 on the south side of the box between the second and third bolts. Gap sizes, ignition source, energy and location, percent methane, and coal dust on flange were all varied in an attempt to propagate an external ignition from an ignition inside the box. Test results are detailed in Table 1.

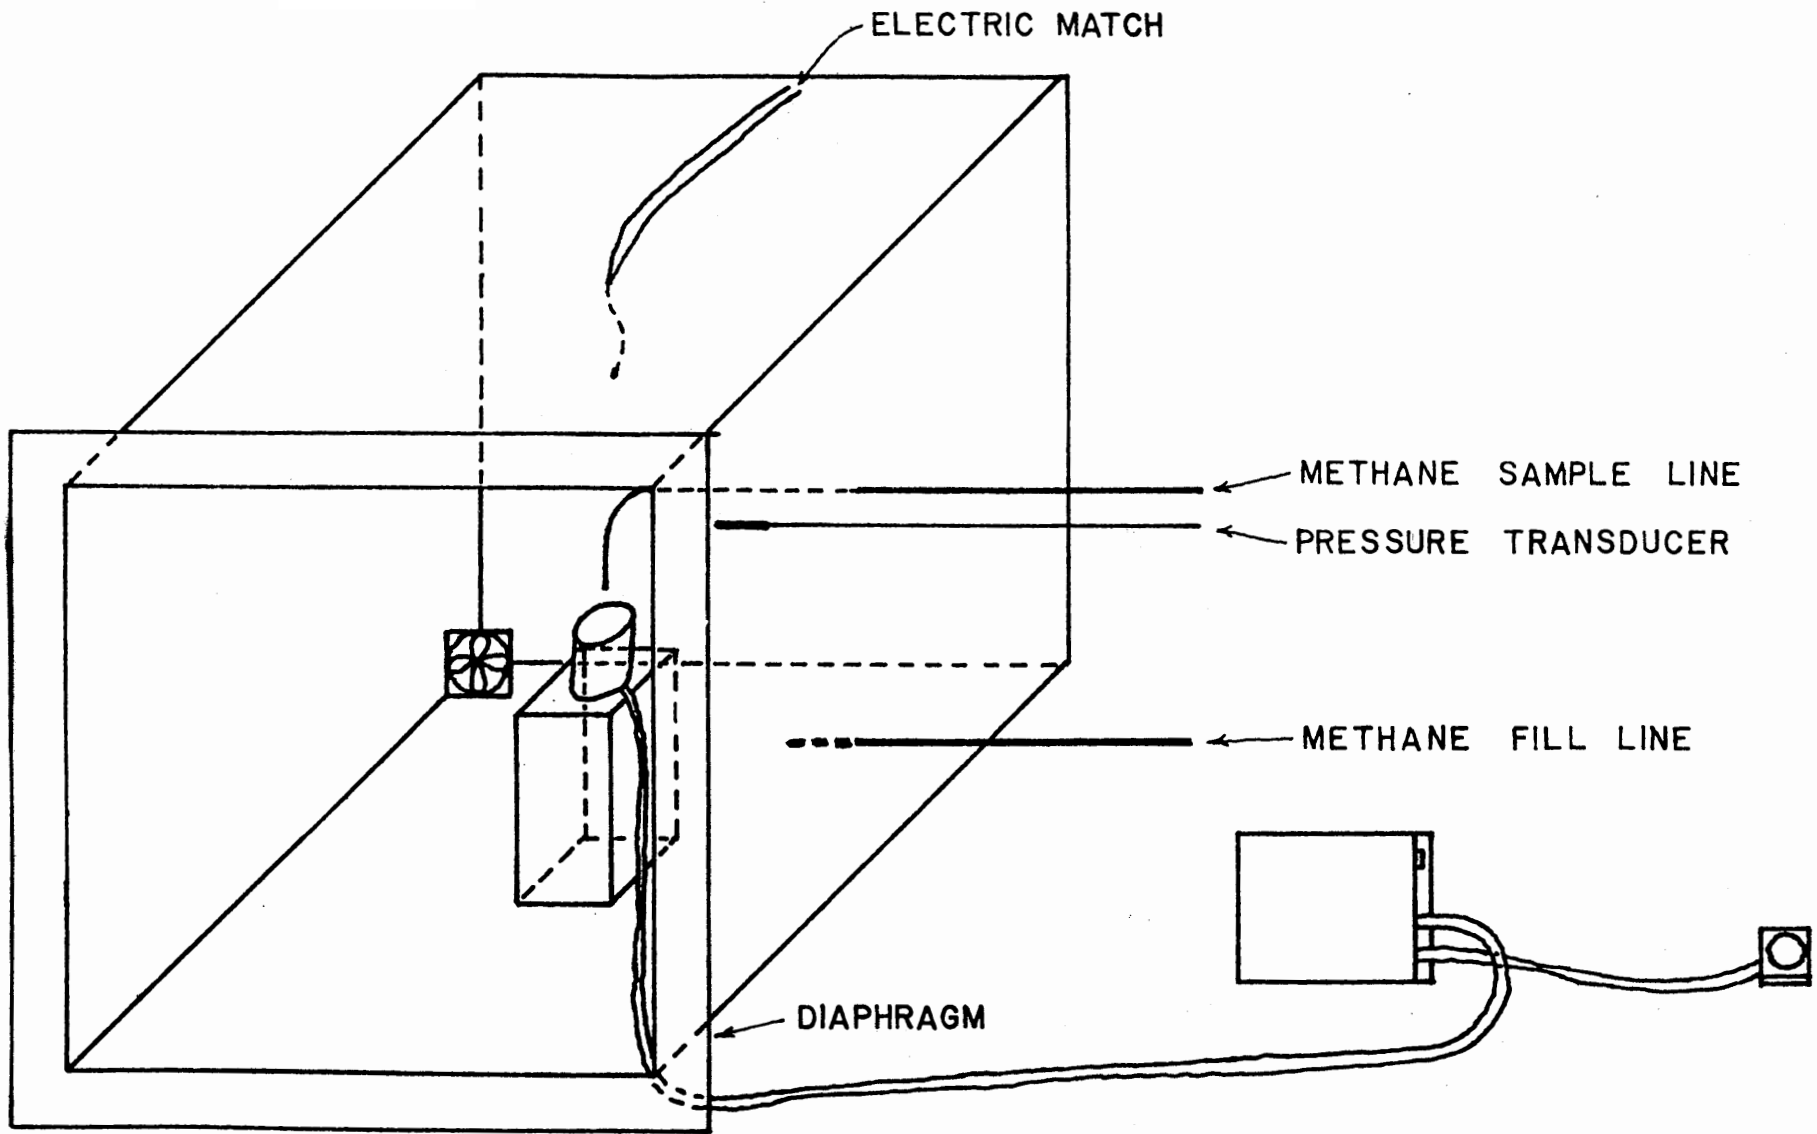
FIG. 1

plastic diaphragm was placed over the open end of the gallery to confine the flammable methane mixture. This diaphragm was 16 square feet in area and provided adequate venting so that maximum explosion pressures were reduced to below 2.0 inches water gage. Ignition was achieved by remotely igniting an electric match placed in the gallery. Figure 1 shows the test configuration.

Further testing would be necessary to determine the actual number of exposures and conditions necessary to initiate degradation. Physical wear, temperature, and humidity are also factors which may play an important part in this determination.
