FAI-2019-14

REPORT OF INVESTIGATION

**Powered Haulage
August 02, 2019**

**J R Simplot Company
Smoky Canyon Mine
Afton, Wyoming
ID No. 10-01590**

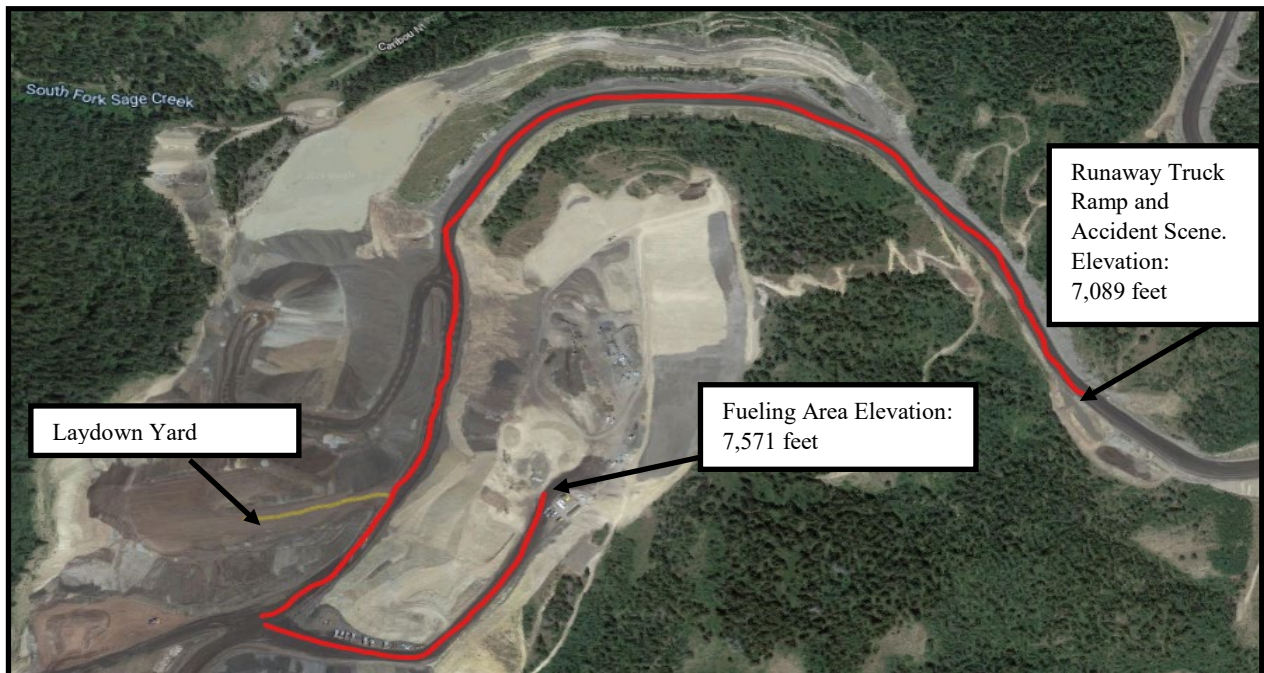
Appendix A

Aerial view of the route the haul truck drove prior to the accident. The red line is where he traveled; the yellow line shows where he intended to travel. The distance from the laydown yard to the accident scene is approximately 6,000 feet.

Brandon J. Astle, a 39-year-old contract Equipment Operator with 16 years of total mining experience, died on August 2, 2019, when the fuel/lube truck he was driving overturned. While descending the haul road, the victim called over the radio and reported that the truck's brakes did not work. The truck traveled approximately one mile down a seven percent grade haul road, struck a berm on a runaway truck ramp, and overturned.
