BUREAU OF MINES
INFORMATION CIRCULAR/1992

In-Mine Evaluation of Smoke Detectors

By G. S. Morrow and C. D. Litton

Information Circular 9311

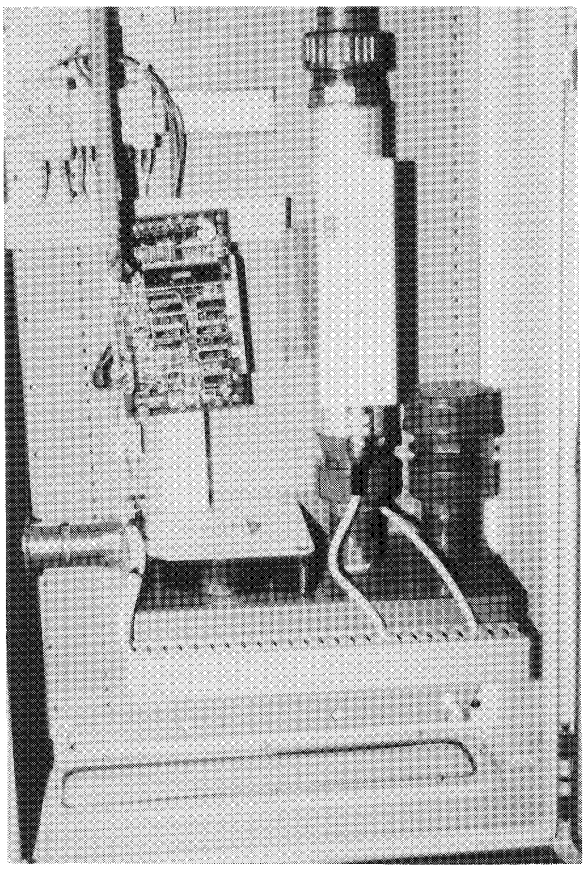
Figure 1.—HRD-2A smoke detector installed at Dilworth Mine.

The detector was installed February 7, 1990, on a main-line belt entry with an air velocity of 146 fpm. Power was obtained from a nearby CO sensor. The detector interfaced with the system via a 4- to 20-mA accessor provided by Conspec. The detector functioned properly until week 18, when the mine reported intermittent alarms lasting 10 to 20 min, but with no recurring pattern. The detector was removed, cleaned, and monitored continuously on a Conspec system at the Bureau with no alarms recorded. The mine had reported brief alarms from the detector while rock dusting. From July 30, 1990, to reinstallation in the mine on October 1, 1990, the detector was used for research purposes at the Bureau and functioned properly. The addition of a settling chamber on the sampling line, along with the insertion of honeycomb mesh at the end of the sampling tube, reduced but did not eliminate false alarms due to rock dusting. The detector remains in place to further research methods to reduce rock dust alarms.

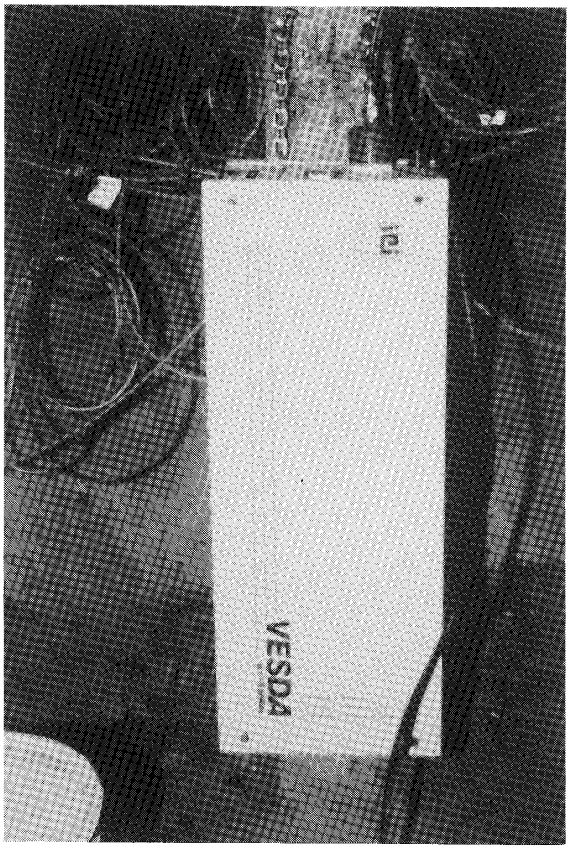
Figure 2.—VESDA smoke detector installed at McClure Mine.

During 47 weeks of operation the HRD-2A detector alarmed 488 times and the VESDA detector alarmed 4 times. Diesel contaminants accounted for 486 alarms on the HRD-2A detector and 2 on the VESDA detector. Rock dusting caused two concurrent alarms on both smoke detectors.

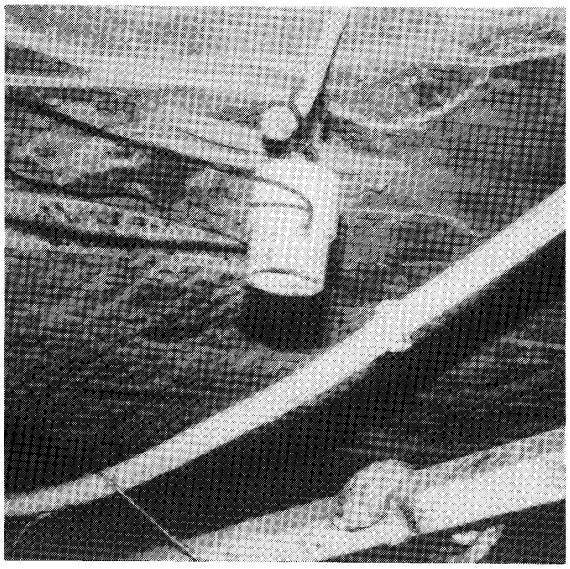
Figure 3.—End-of-line sampling port used at all test sites.

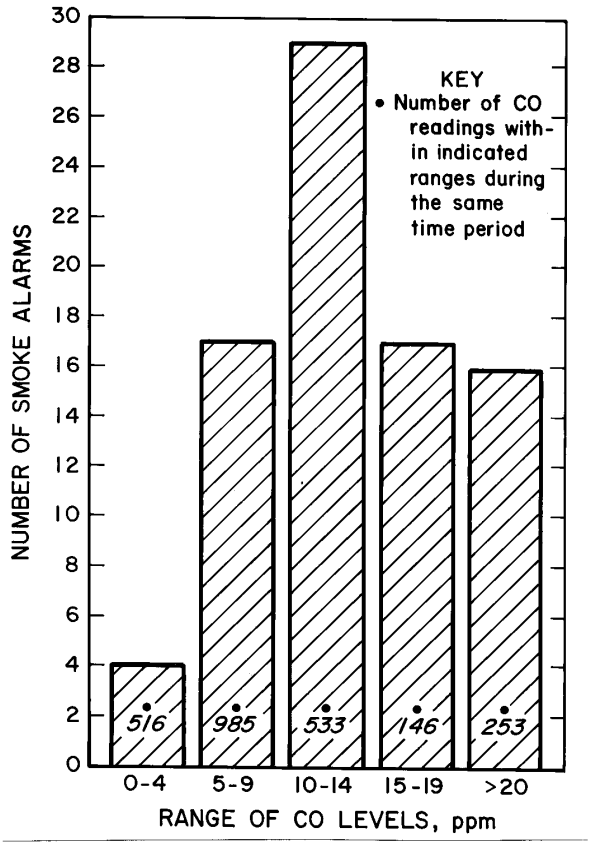
Figure 5.—Smoke detector nuisance alarms versus CO levels for 42-day period at Shoshone Mine.

The detector was installed April 5, 1990, in a two-entry section in the belt entry return air. Eighty-three alarms occurred during the period of April 28, 1990, through June 9, 1990 (42 days); all were attributed to diesel emissions. During the same period, a companion CO sensor had 516 readings of 0 to 4 ppm, 985 readings of 5 to 9 ppm, 533 readings of 10 to 14 ppm, 146 readings of 15 to 19 ppm, and 253 readings in excess of 20 ppm.

These smoke detector alarms and CO levels due to diesel exhaust allow for a direct comparison of the nuisance alarm frequency for the two types of detectors. For the smoke detector, this alarm frequency is about two per day. For CO at the 10-ppm level, the alarm frequency is 22 per day. For CO at the 15-ppm level, the alarm frequency is 10 per day. At the 20-ppm CO level, the alarm frequency is still six per day, or three times greater than the alarm frequency for the smoke detector.

While the absolute number of nuisance alarms due to diesel emissions appears high, as it was for the smoke detector at McClure Mine, the actual alarm frequency is significantly lower than that of CO sensors. It should also be noted that the smoke detector continuously operated at its maximum level of sensitivity, thus increasing its potential to respond to diesel contaminants. At this level of sensitivity, the equivalent CO detection level from a small coal fire is typically in the range of 3 to 5 ppm. As a result, the smoke alarm frequency should be compared with the CO alarm frequency at the CO level of 5 ppm. If this comparison is made, then the 5-ppm CO alarm frequency was 46 per day, or 23 times greater than the smoke alarm frequency.

In general, the smoke alarms correlated with significant increases in the CO levels. With the exception of two alarms on May 2, 1990, and May 4, 1990, the average CO reading at the time of the smoke alarm ranged from a low of 3 ppm to a high of 34 ppm, with the average level being 17 ppm. On June 9, 1990, the sampling tube was moved into intake air and the alarms ceased. On July 27, 1990, the operator decided to remove the detector from the mine, could not be convinced to relocate it in the mine, and returned it to the Bureau.

Even though the nuisance alarms are not eliminated, their frequency is reduced significantly. It is possible that by decreasing the smoke detector sensitivity by a small amount, these alarms could be reduced even further.
