REPORT OF INVESTIGATION

Fatal Powered Haulage Accident
April 19, 2021

Mobile Crusher #3
Frontera Materials Inc
La Joya, Hidalgo County, Texas
MSHA ID No. 41-04292

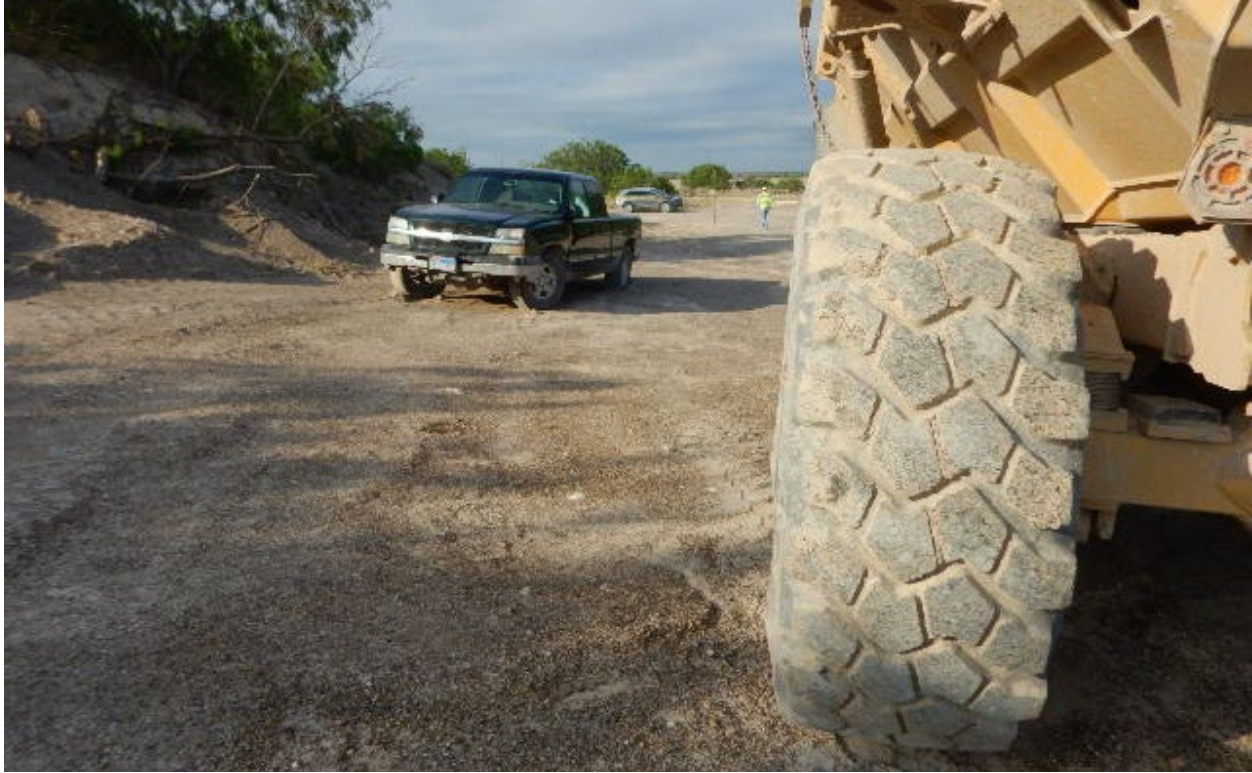
At 11:45 a.m., Olivera went back to the parking area to eat lunch when he observed Garcia Jr. pinned between the left front bumper of the haul truck he had been operating and the driver's side door of Garcia Jr.'s personal pickup truck. The haul truck was still running. Olivera immediately called Martinez and Sergio Garcia. Sergio Garcia arrived at the accident scene and called Stephen Forshage, Vice President.

Investigators found uneaten portions of Garcia Jr.'s lunch on the hood of his pickup truck. Based on the examination of the accident scene and information obtained during interviews, investigators determined that Garcia Jr. stopped his haul truck on the two percent grade in the parking area and exited his haul truck to get his lunch from his personal pickup truck and eat. Martinez observed Garcia Jr. at 10:30 a.m. and Olivera observed Garcia Jr. at 10:35 a.m. However, there were no witnesses in the parking area from 10:35 a.m. to 11:45 a.m.
