REPORT OF INVESTIGATION

Surface Metal Mine  
(Copper)

Fatal Electrical Accident  
April 09, 2016

Freeport-McMoRan Safford, Inc.  
Freeport-McMoRan Safford, Inc.  
Safford, Graham County, Arizona  
ID No. 02-03131

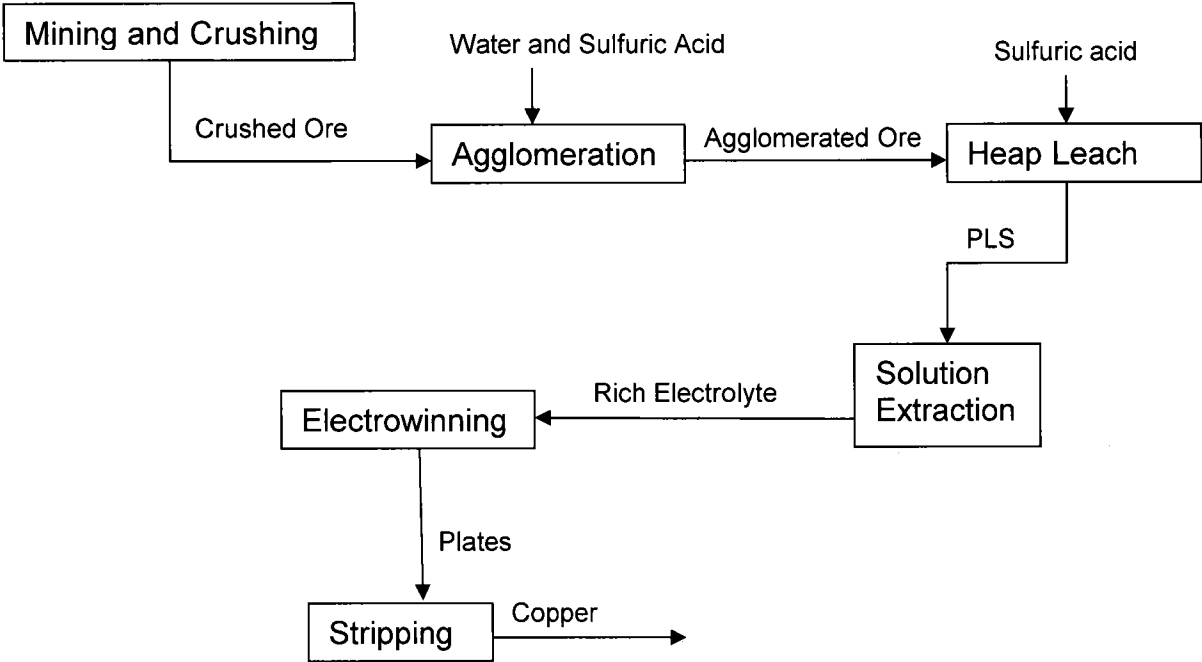
# Appendix C

## Process Flow Charts

- 3. Electrolyte Piping:** Electrolyte for the SX process is provided to the cells through a series of HDPE piping. The HDPE piping is connected in pipe sections with flange-fitting endcaps made of stainless steel. After flowing through cells, the depleted electrolyte free-falls through a pipe to provide air break, to minimize current transfer. Depleted electrolyte is then pumped back to SX.
