REPORT OF INVESTIGATION

Open Pit Magnesite

Fatal Slip/Fall of Person Accident 9/15/2016

Premier Magnesia LLC Premier Magnesia LLC (Gabbs, Nye County, Nevada) Mine ID No. 26-00002

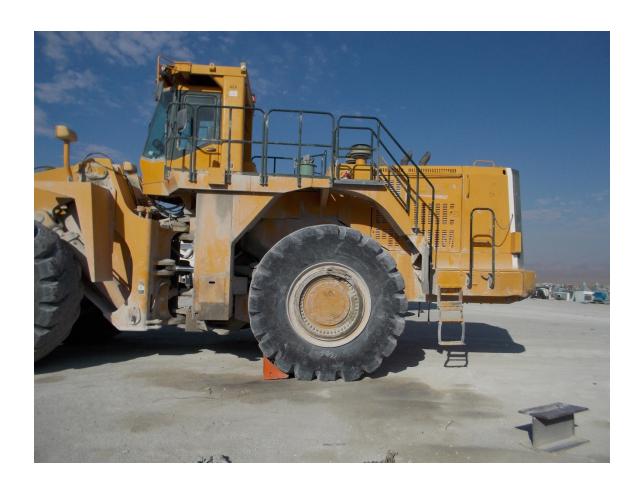
The equipment involved was a Kawasaki 135ZV front end loader. It was located outside of the lower shop for repairs.
