MNM Fatal 2013-21

Falling/Sliding Material
December 13, 2013 (Georgia)
Industrial Sand Mine
Water Cannon Operator
53 years old
19 years of experience

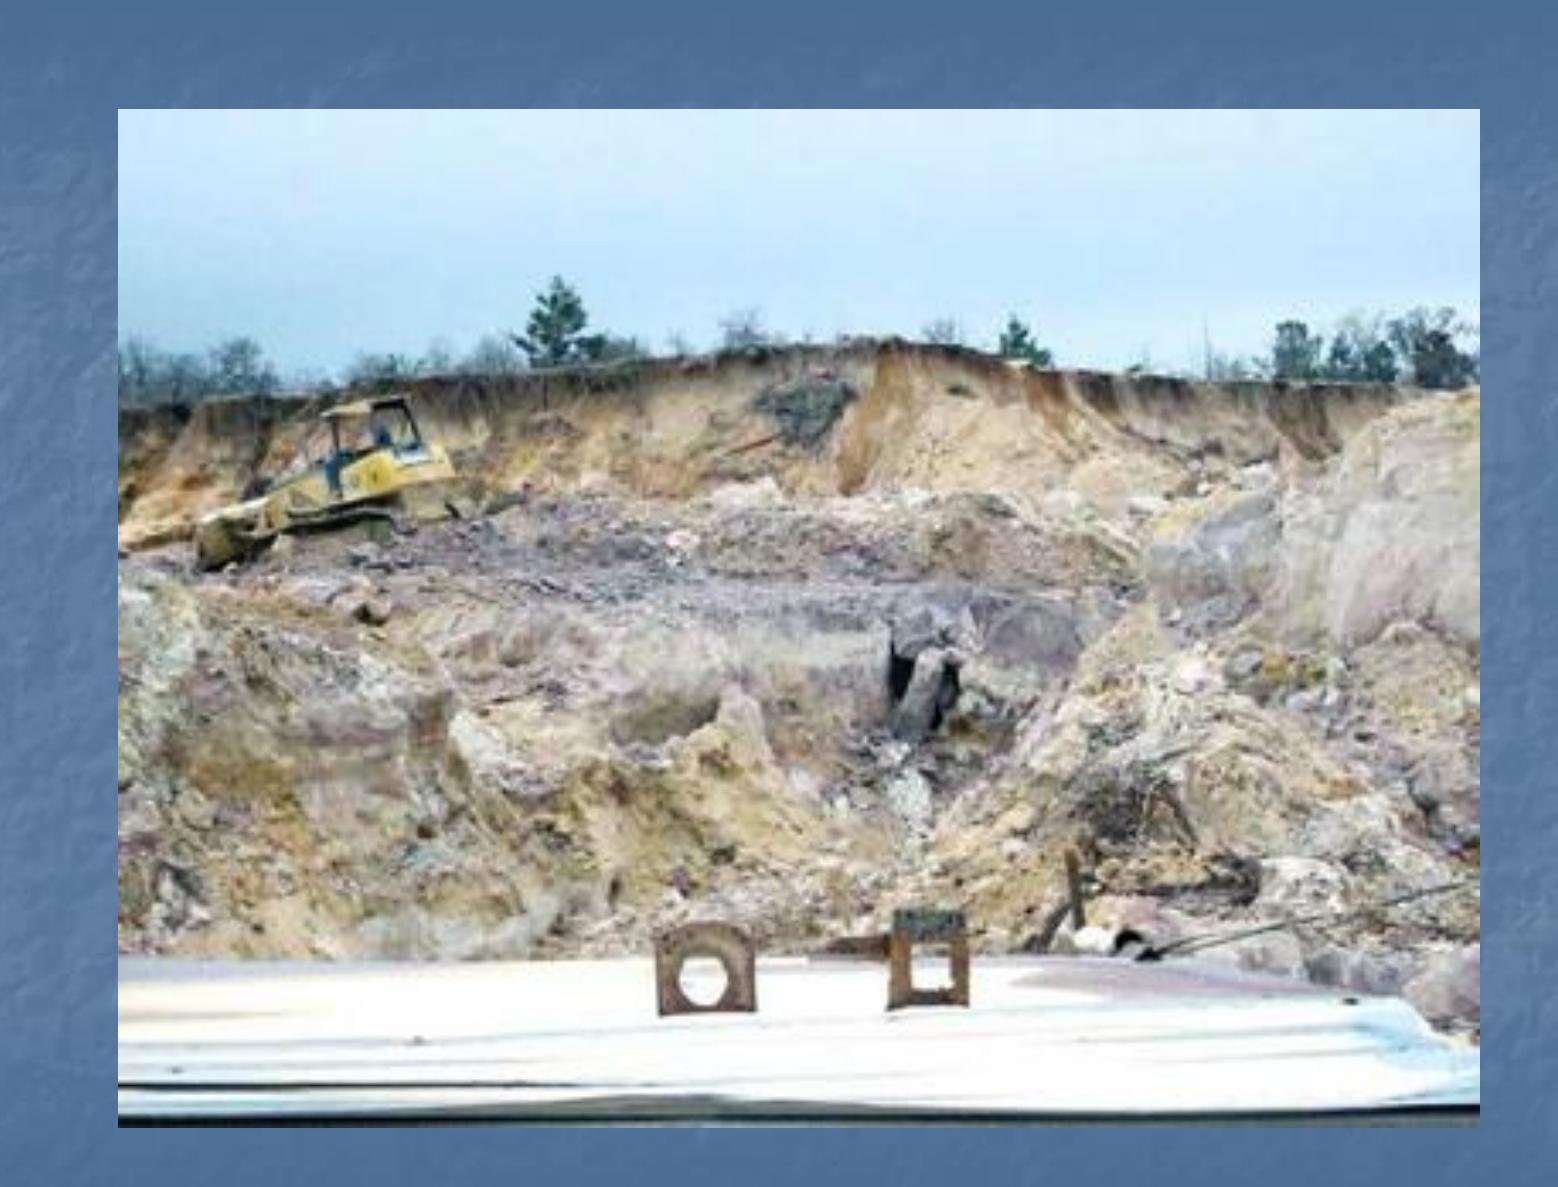
The victim was killed when the bank of a trench collapsed engulfing him in the falling material. He walked near the edge of a trench, 27 feet in depth, to observe an excavator working below.

The accident occurred because the hydraulic mining system used at the mine did not maintain the wall and bank stability in places where persons work or travel while performing their assigned tasks. The ground conditions that created the hazard to persons was not taken down or supported before other work or travel was permitted in the affected area. The area was not posted with a warning against entry and/or a barrier was not installed to impede unauthorized entry.

Corrective Action: Management established a new mining method that eliminates the use of deep trenches. Persons experienced in examining and testing for loose ground have been designated to conduct examinations at the pit.

Corrective Action: Management established a new mining method that eliminates the use of deep trenches. All miners were task trained regarding the health and safety aspects of the new mining method.
