MNM Fatal 2015-13 Falling, Rolling, or Sliding Rock or Material August 03, 2015 (North Dakota) Construction Sand and Gravel Loader Operator ■ 64 years old 44 weeks of experience

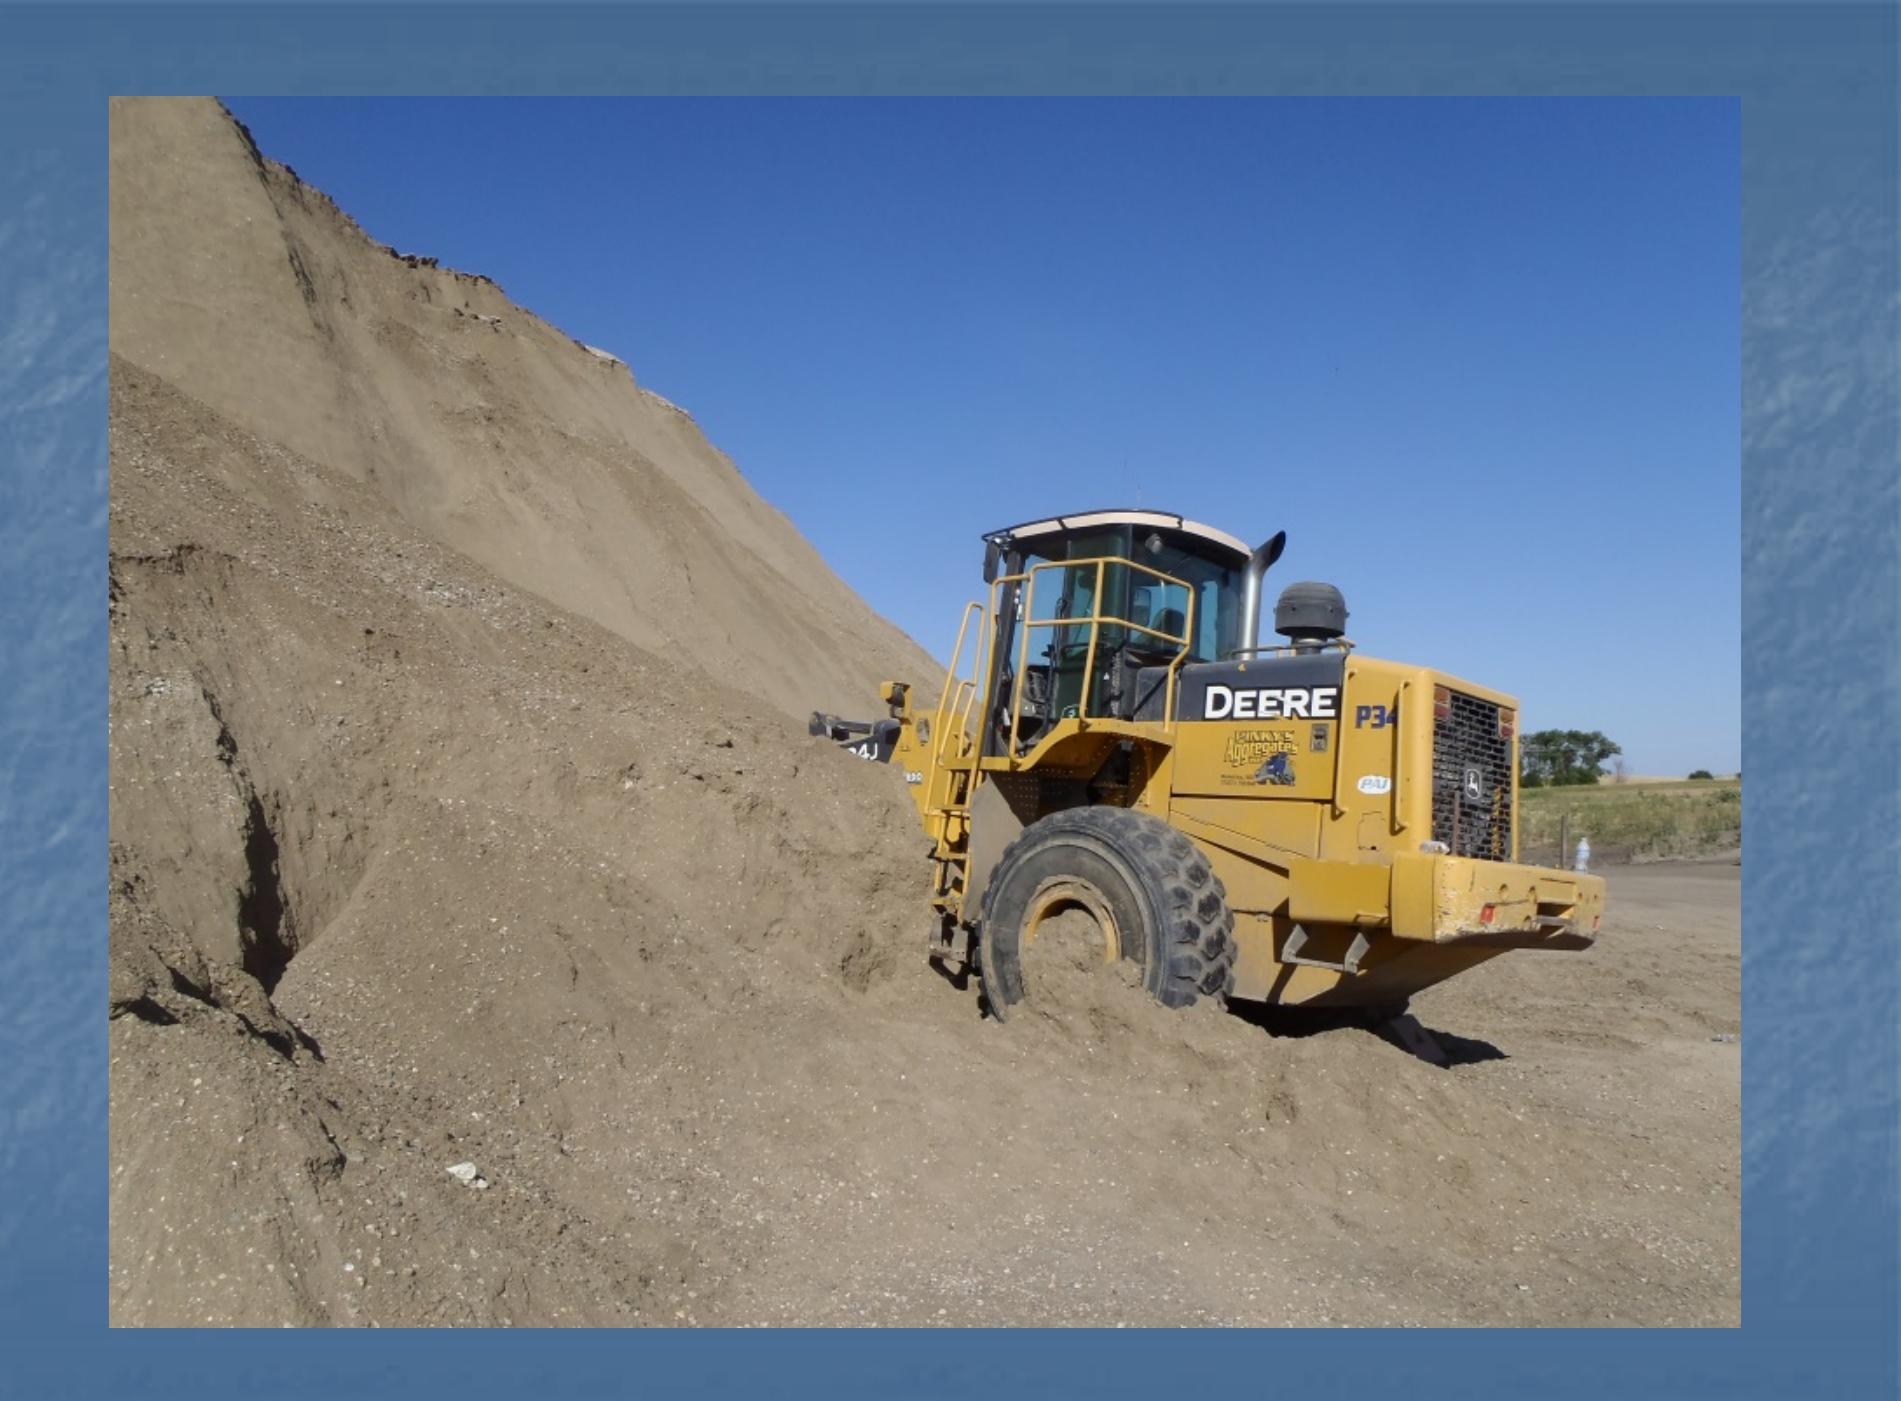
William G. Makela, front-end loader operator, age 64, was killed on August 3, 2015, when he was engulfed by a slide of material from the stockpile. Makela had exited the frontend loader and was standing beside the loader prior to the slide.

The accident occurred due to management's failure to identify possible hazards and establish safe procedures associated with work or travel near stockpiles. The stockpile ground conditions created a fall of material hazard from lack of maintenance and trimming. Failure to recognize the hazard of working near the stockpile face contributed to the accident.

- Root Cause: Management failed to correct the hazardous stockpile ground conditions. The stockpile was constructed 39 feet high, and the slope was greater than the angle of repose despite not having equipment able to safely trim the pile to the angle of repose. The stockpile ground conditions created a fall of material hazard from a lack of trimming or maintenance.
- Corrective action: The stockpile was trimmed to the angle of repose. Management retrained miners in identifying and controlling areas of the stockpile where hazardous slips can occur. Additionally, a Standard Operating Procedure was adopted that load out is only allowed when equipment is on site that is able to trim the 35 foot high stockpile to the angle of repose.

Root Cause: Management failed to ensure that all persons could recognize the fall of material hazards associated with working near the stockpile and traveling between the stockpile and equipment. Makela did not recognize the hazard imposed by the stockpile and exited the front-end loader between the loader and the stockpile, hindering escape.

Corrective action: Miners were trained to evaluate the potential hazards of falling material and the dangers of work or travel between stockpiles and equipment.
