MSHA's Accident Prevention Program Safety Idea

Avoiding Surface Drill Entanglements

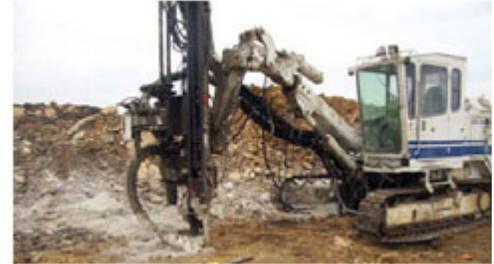
Many accidents have occurred when miners have come into contact with rotating drills. They had tried to manually thread drill steels on, unplug clogged suction hoses, or just got too close to the rotating steels when the accident occurred. Whatever the reason, these accidents can be avoided if you follow these Best Practices.

- Train personnel to follow the manufacturer's procedures when adding drill steels.
- Never manually thread drill steels when the drill head is rotating.
- Do not wear loose fitting clothing when working around drills. Also be careful of long hair that can become entangled.
- Never over-ride or bypass the safety features on the equipment.
- Know where your emergency stop switches are and ensure they are functional.
- Provide safe routing of hoses and cables so they are not close to the rotation of the drill.
- Shut down the drill when making any repairs to the drill head.
- Make the drill operator aware of your presence when approaching.
- Provide adequate lighting at night when drilling.
