## MSHA's Accident Prevention Program Safety Idea

### Shrapnel From Miners' Bits

Mine Type: **All Underground**  
Category: **Longwalls and Section Face Equipment**

Issued: 09/05/2003  
Tag # AP2003-M095

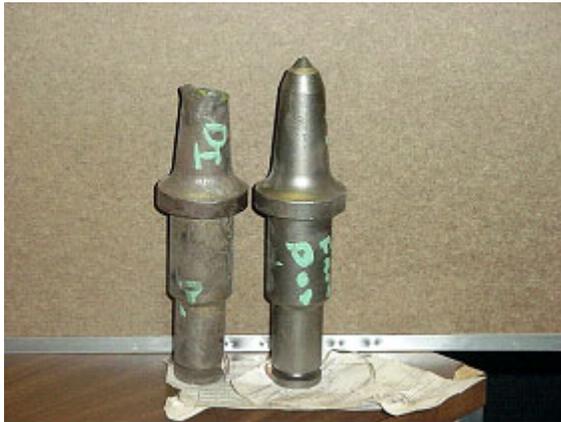
A continuous mining machine operator was fatally injured when a piece of shrapnel from a miner bit flew back from the face. A sharp, lethal piece of steel, traveling at a high speed struck him in the neck.

Hard carbonate nodules had been encountered in the cut resulting in a large amount of sparking at the face. The accident investigation revealed the shrapnel came from a miner bit which had lost its tungsten carbide cutting tip.

- Replace dull, cracked or burred miner bits every cut and more often when hard cutting conditions are encountered. When in doubt follow the bit manufacturers' replacement recommendations. Once the tip is lost the bit body becomes a blunt pick pounding on the face.
- Wear appropriate personal protective equipment such as ANSI Z87.1 eye and face protection when near the active mining face.
- Read, know and follow manufacturers' recommendations and company safety policy.
