MSHA's Accident Prevention Program Safety Idea

Hydraulic Hose Life

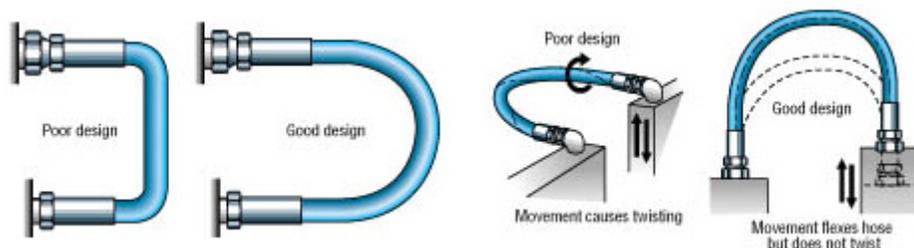
- **Environment** - Temperature extremes, UV light, chemicals, ozone, etc. will degrade the rubber used in hydraulic hoses.
- **Abrasion and Cuts** - Wear against other hoses or objects will wear off the outer cover and lead to corrosion of the reinforcing mesh.
- **Extreme Pressure Fluctuations** - Pressure surges above the hose working pressure will damage hose components.
- **Vibration** - Cyclic loading of hoses can damage hose components even when motion seems relatively small.
- **Improper Length/Routing** - Forcing a hose into an improper geometry causes high stresses in the hose components that may also reduce pressure capacity (avoid multi-plane bending, small bend radii, tension in hose, etc.). Hose life can be reduced by 90% when subject to these type of stresses.

That piece of used equipment you just bought might have been a deal, but make a thorough inspection of the hydraulic hoses before it is placed in service. The rubber in hydraulic hoses ages and deteriorates. Hoses that have been in service for several years may need to be replaced.
