MSHA's Accident Prevention Program Safety Idea

"Know Your Ropes" (A Sequel to "Wire Rope Safety")

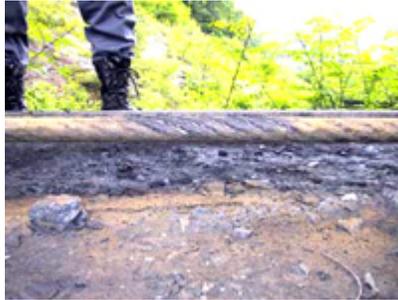
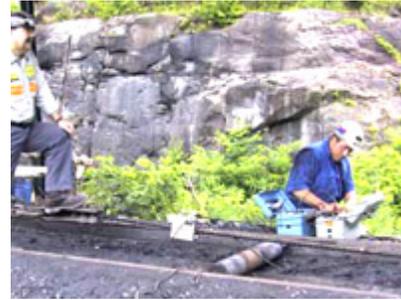
A wire rope may look good on the outside but could be hiding corrosion on the inside. Internal corrosion of a wire rope is a dangerous condition. It diminishes the rope strength and leads to premature failure. Mine operators often use rock salt and calcium chloride to remove ice buildup from the slope. When these salts dissolve, the brine created can penetrate the rope and accelerate corrosion.

- Use an ice melter such as Calcium Magnesium Acetate (CMA) or Sodium Acetate, instead of rock salt or calcium chloride, to minimize the corrosive impact of deicing.
- Apply a wire rope lubricant with a corrosion inhibitor to protect your slope rope from environmental attack.
- Drain water accumulations in the slope so the rope is not dragged through it.
- Enhance your wire rope inspections with electromagnetic nondestructive testing (NDT). NDT examines the entire rope whereas the caliper method only tests specific points.
