MSHA's Accident Prevention Program Safety Idea

Falling Through the Roof

Category : **Fall Protection & General Safety**
Mine Type: **All Mines**

Issued:	11/21/2003
Tag #	AP2003-S091

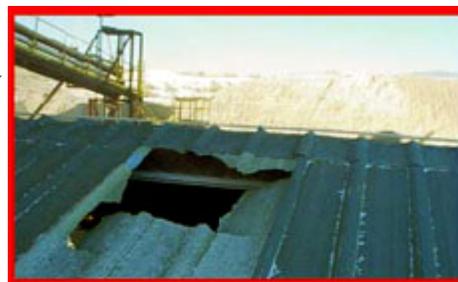
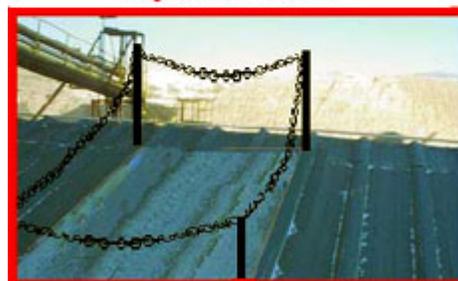
Unguarded vs. Guarded

A miner sent us this safety idea after reviewing a Fatalgram where a maintenance worker fell through a roof skylight. He noted *"there should have been a guard around the skylight. I know where I work, we have guards around every one of our skylights. I believe they are about 42 inches in height. This keeps a person from walking out onto the skylight or backing onto the skylight. The skylights have a way of getting dirty and then you don't notice them. They can be mounted even on a pitched roof. They can be bolted down to the roof or if the roof isn't strong enough a frame can be built that is strong enough to hold the skylight."*

This is good advice. Another idea is to raise the skylight so it is not flush with the roofline. Not everyone who goes into an area will be aware of the hazards. This is especially true if the area is seldom used or if that person has never been on that site.

If a surface is not specifically engineered and constructed to serve as a walkway, access should be restricted, and warning signs posted. Also, if access is possible, provide proper fall protection for workers that will be exposed to the hazards of elevated work areas.
