U. S. Department of Labor MSHA's Accident Prevention Safety Idea

Staple Lock Hydraulic Fittings

AP2007- 93385

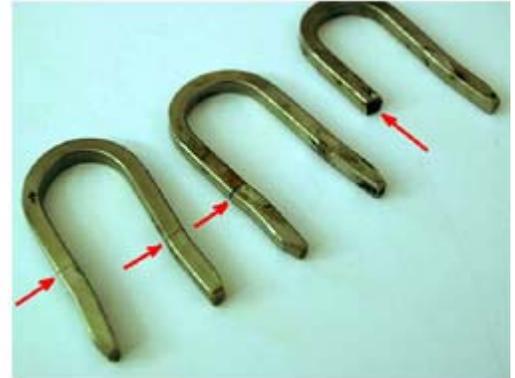
Cracked, corroded, worn, or incorrect staples on staple lock hydraulic fittings are not detectable by visual inspection. Avoidance of staple lock failure can only be accomplished through routine preventative maintenance. Staples have a limited service life, and should be replaced at manufacturers' recommended intervals.

Staples that have migrated out of position are visually identifiable, as are fittings that are locked by only one leg of the staple. Routinely inspect for these conditions, and replace these staples with new ones. Before replacing any staples, always remember to follow MSHA's best practices for hydraulic hose maintenance.
