**MSHA's Accident Prevention Program
Innovative Products**

**“Non-Sparking, Conveyor
Roller Bearing Isolators”**

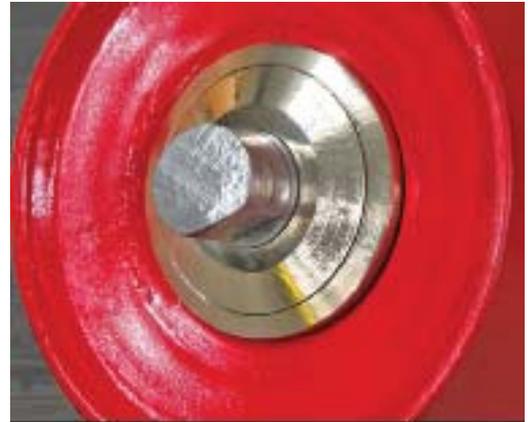
Belt conveyor roller bearings are subjected to severe duty service. They are constantly exposed to dust, dirt and moisture. Plastic end caps and rubber contact seals installed to protect the bearings quickly wear and deteriorate, resulting in seized bearings. When a bearing seizes, it throws off sparks, melts and eventually causes the roller to seize. In addition to the fire and smoke hazards, the frictional drag on the belt creates a large amount of electrical energy consumption, worn or torn belts and downtime.

Bearings are typically designed to last 20 years or more, but very seldom do, mostly because they are not adequately protected. Bearing isolators made of bearing bronze, brass, other non-sparking metal or sintered materials last much longer than those of rubber or plastic and can act as emergency sleeve bearings for a short time. The main bearing meltdown is therefore delayed until temperature rise is detected. The use of a temperature gun during examination exponentially increases the detection of failing bearings. There are isolator replacements available for the plastic protectors that can be installed by mine maintenance personnel with a press or a soft hammer.
