CLOSE CALL ELECTRICAL FLASH BURN

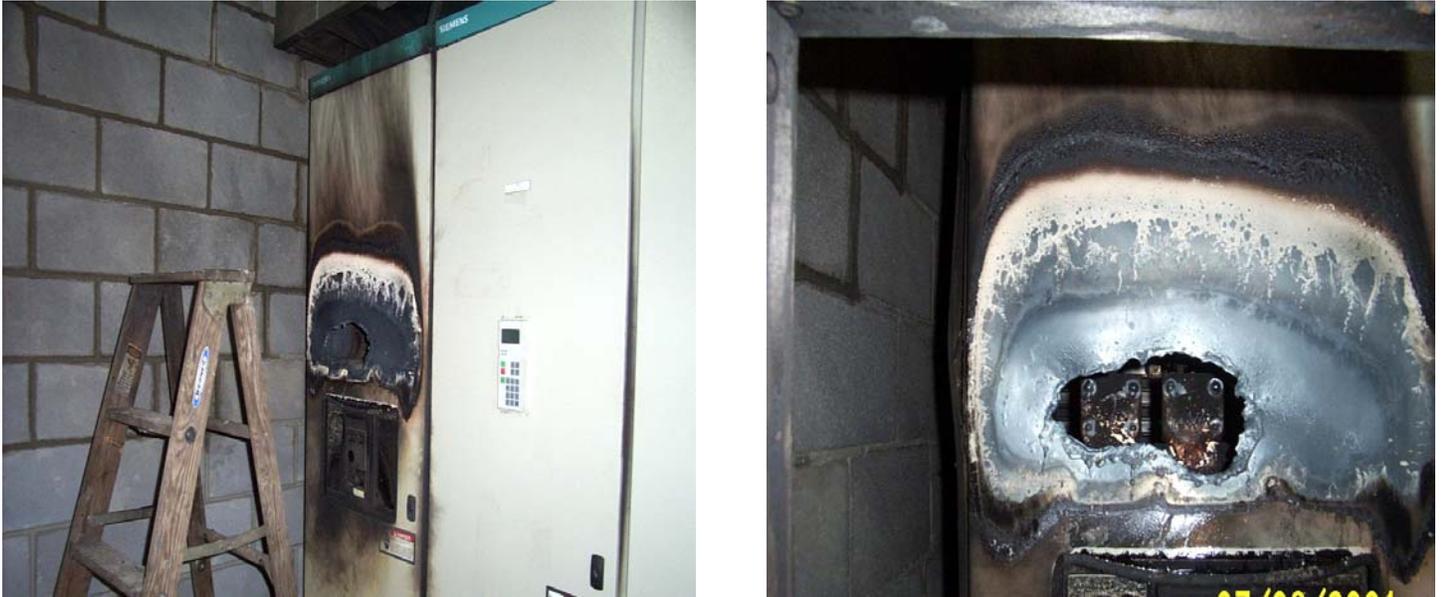
On April 14, 2006, a miner was injured while laying block for a surface electrical installation. He was cleaning the mortar joints with a piece of metal conduit when the conduit fell through the top of a 660 VAC panel, causing a short. The ensuing arc burned through the panel access door, the flash inflicting 1st and 2nd degree burns to the miner's arm, face and neck.

1. When working around electrical installations, use non-conducting tools if possible.
2. Make a thorough visual examination of the work area. Guard/cover any potential access ways to energized panels.
3. Take the time to stop, look, analyze, and manage the job before beginning work.
