CLOSE CALL

Surface Mine-Track Hoe Rollover/Fire

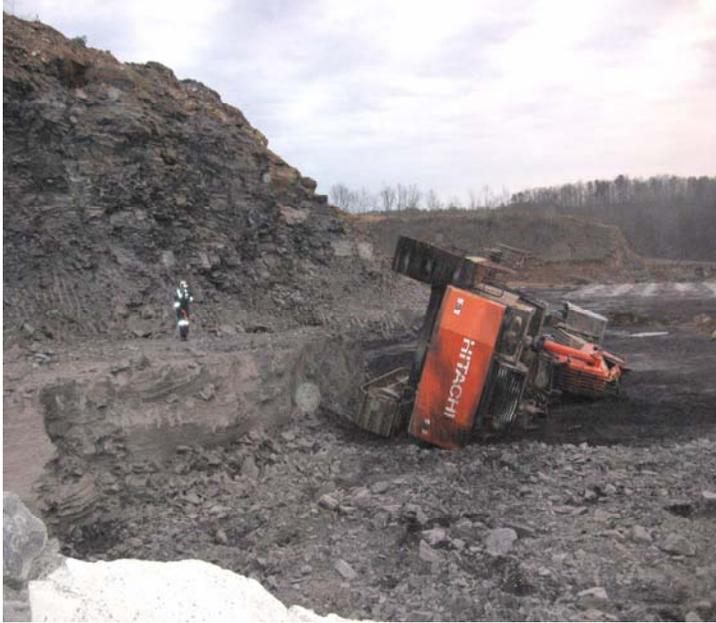
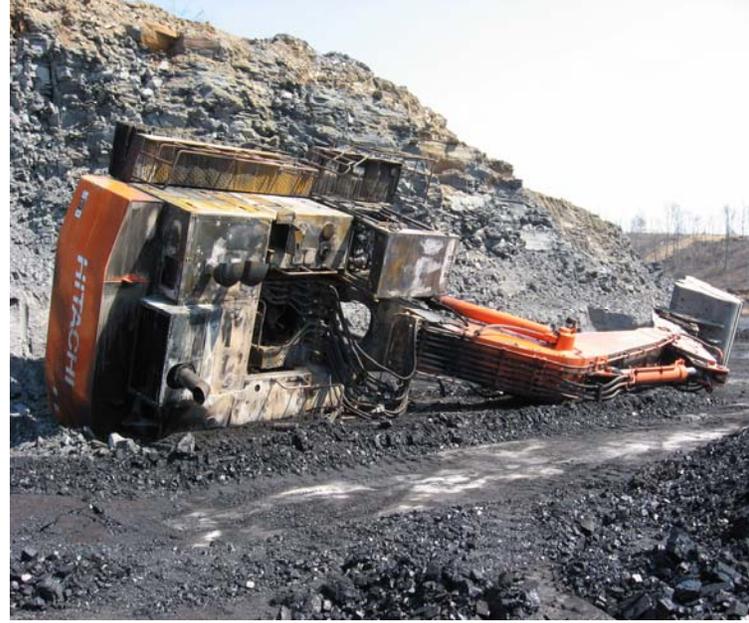
On March 10, 2008, a track hoe operator received minor injuries when the machine he was operating rolled off the ledge of the pad as he was loading trucks. As the operator exited the cab, the machine caught fire, and was subsequently extinguished by the mine crew and local fire department personnel. The operator was taken to a local hospital and treated for minor bumps/bruises and released that day. The operator was in the process of breaking off the edge of the pad with the teeth of the bucket and pulling up the loosened rock. While pulling up on the rock and swiveling the machine, the track hoe frame was raised and rotated over the edge of the pad. The release of the pressure and lowering of the machine caused it to roll off the pad.

1. Always know where you and the machinery you are operating are located with respect to your surroundings.
2. Make a thorough visual examination of your work area, recognizing areas of tight clearance.
3. Design your mining method to eliminate the hazard posed by leading edges.
