Metal/Nonmetal Northeast District

Mobile Accident

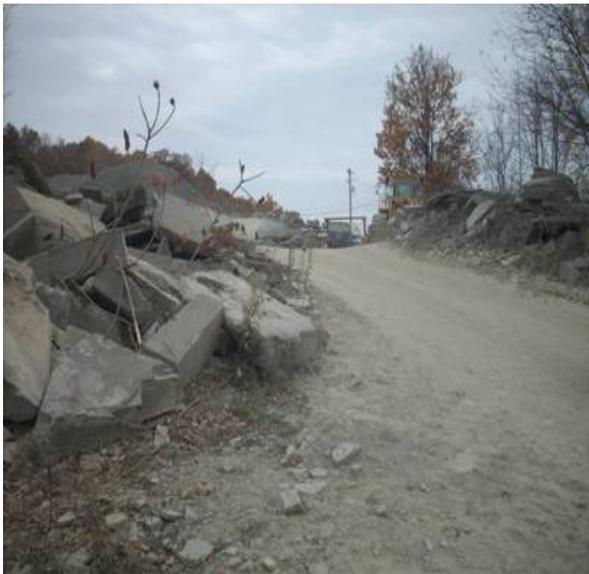
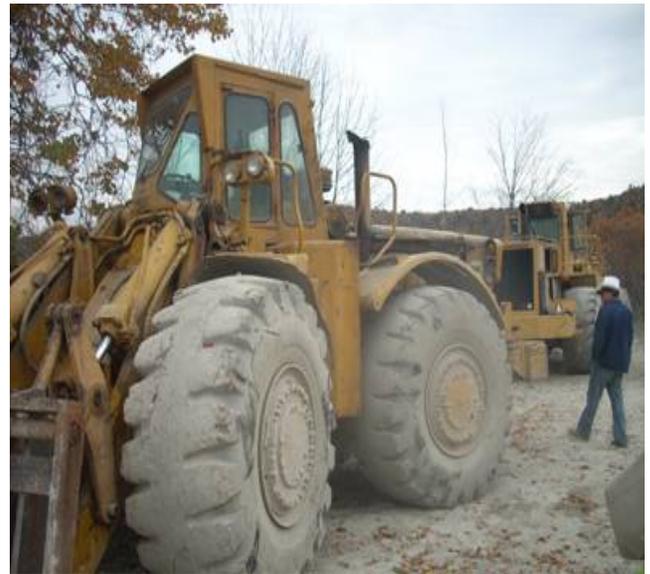
On October 21, 2009 a miner was seriously injured when carrying a 9 ton block of bluestone up an inclined roadway using a CAT 988A FEL with forks. The loader stalled near the crest of the hill and started to roll backwards. The equipment operator was unable to stop the machine. He jumped/fell head first from the left side of the cab and was run over by the equipment suffering a crushed pelvis, broken sternum and severe internal injuries. The equipment operator was not wearing the provided seat belt.

- Always wear the provided seat belt.
- Always examine the seat belt during the mobile equipment pre-shift examination.
- Test all braking systems on level ground, then on an incline before carrying the first load.
- Ensure all safety defects are reported.
