# MNMM Fatal 2004-27

- Other (Drowning)
- December 13, 2004 (Texas)
- Limestone
- Laborer – 56 years old – 4 years experience

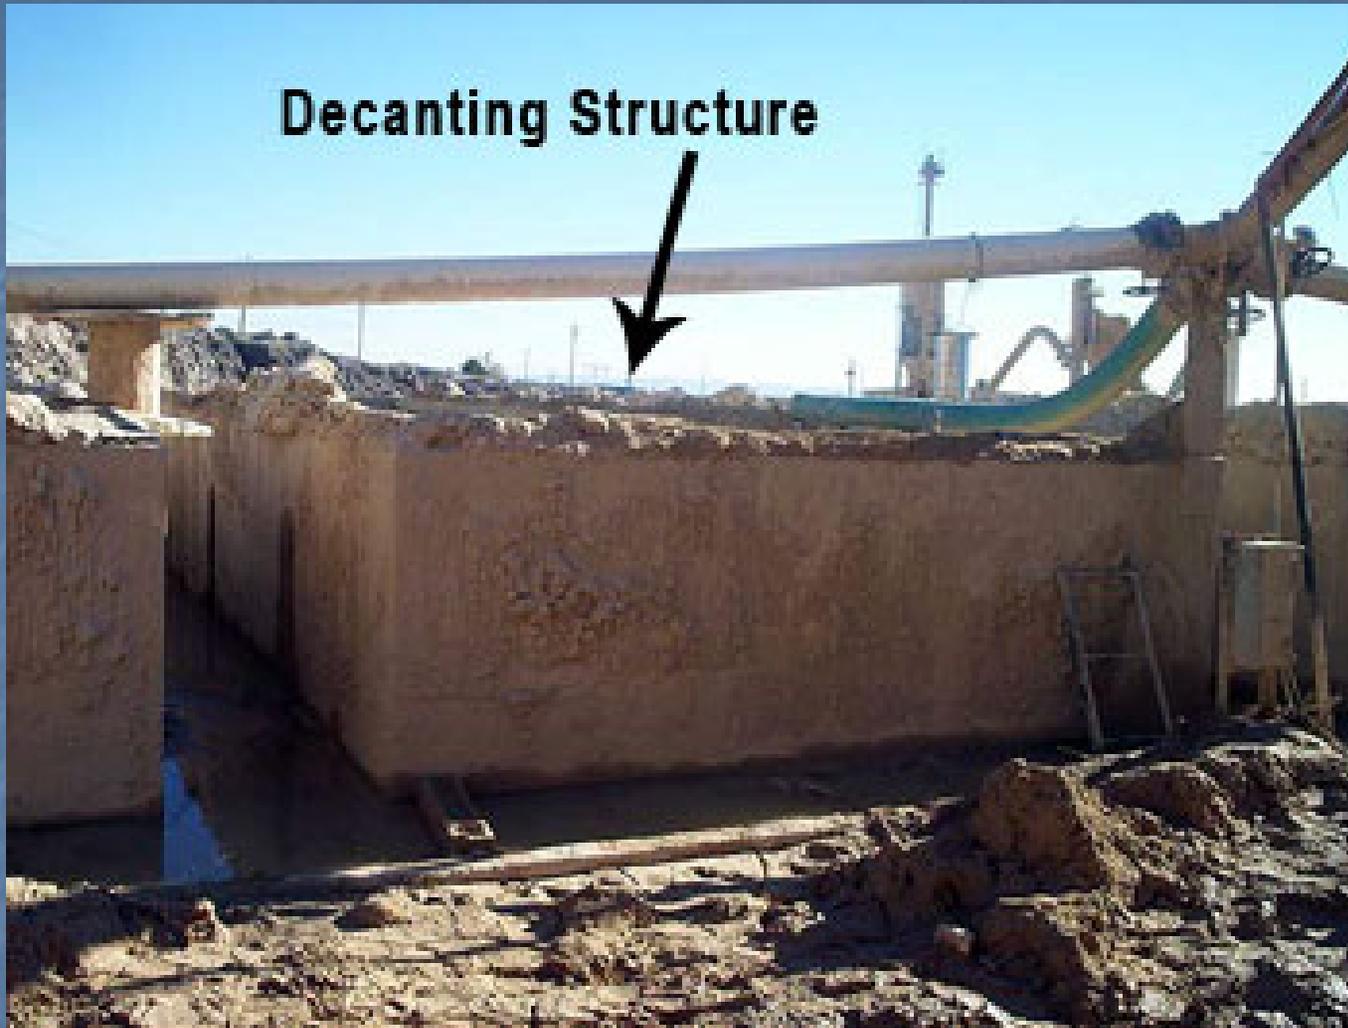
**Decanting Structure**

- The victim fell into a 5-foot high concrete decanting structure and drowned. The decanting structure contained about 4 feet of sand and water. He was found floating near the overhead valve that directed the plant discharge water that was flowing into the decanting structure.

- The accident occurred because safe operating procedures were not established to ensure that persons were protected from hazards while working over and around decanting structures. Life jackets were not provided for persons who performed tasks at the decanting structures.

- Management policies and administrative controls were inadequate. Safe operating procedures were not established to ensure persons were protected from the hazard of falling into water at the decanting structures.

- Ensure that flotation devices are provided and worn by miners where there is a danger of falling into water.
- Before beginning work, miners should discuss the job tasks, identify all possible hazards, and ensure that steps are taken to safely perform the task (risk analysis).
