# MNMM Fatal 2005-22

- Falling/Sliding Material
- August 27, 2005 (Colorado)
- Crushed Stone Operation
- Front-end Loader Operator
- 26 years old
- 4 years mining experience

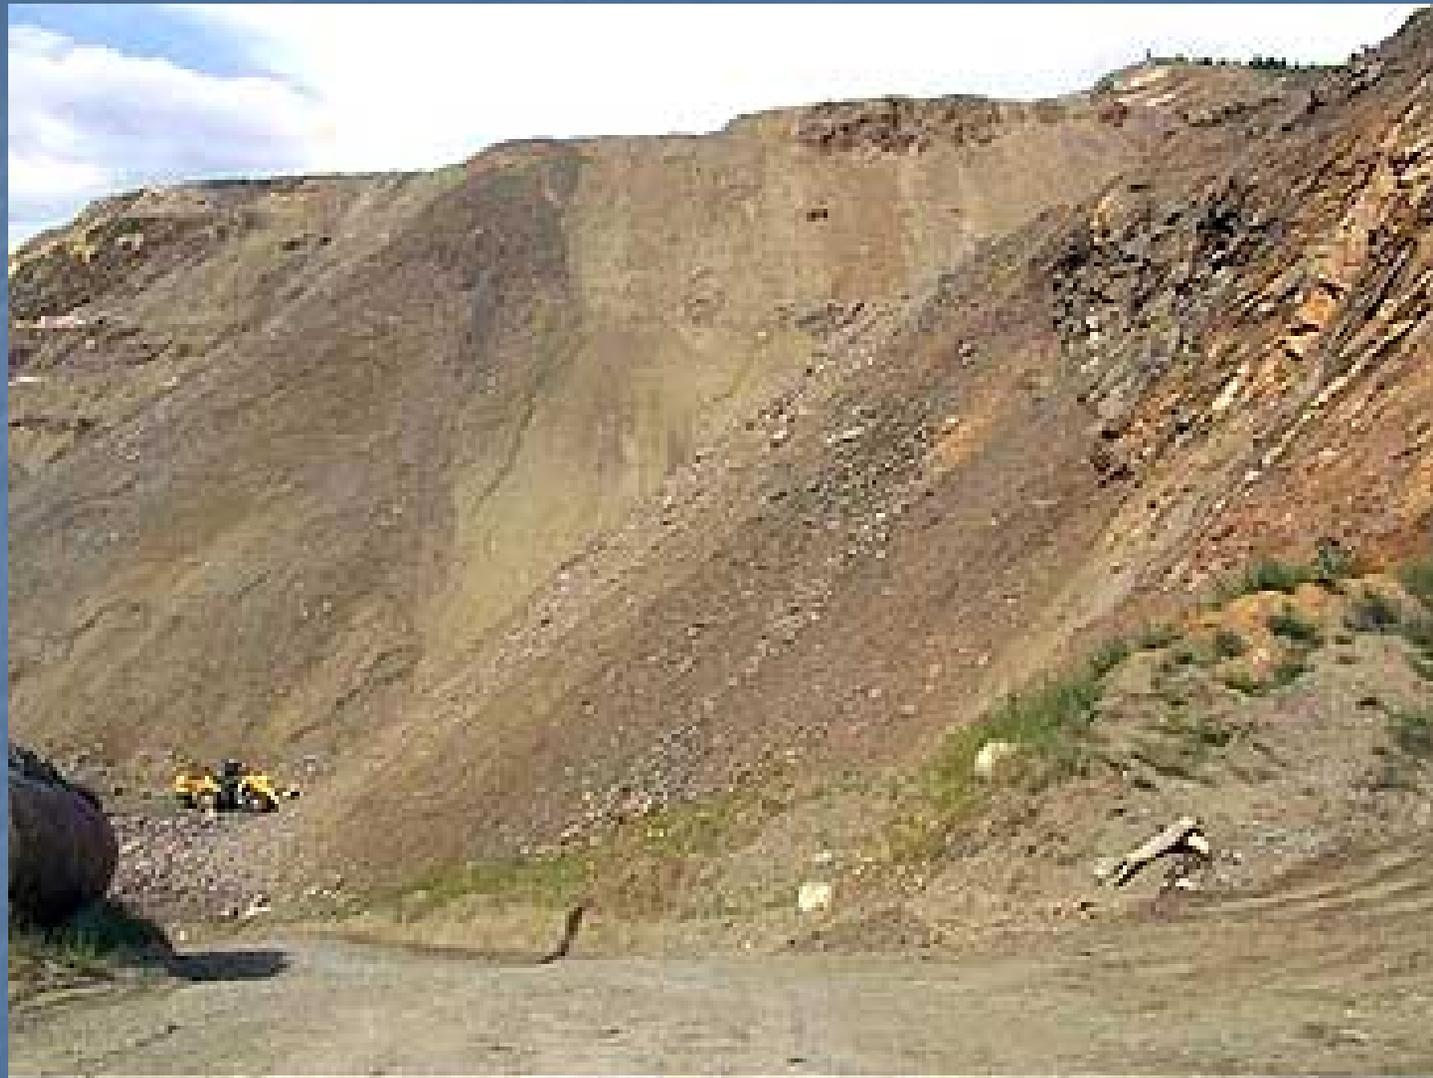
The victim was fatally injured when rocks rolled and struck the front-end loader he was operating. He was removing rock material that a second front-end loader had dumped from an upper bench.

- Procedures had not been established that isolated areas where falling or sliding materials could create a hazard.
- The victim failed to recognize the hazard associated with performing work near falling materials.

- Adopt mining methods that ensure miners are not positioned in areas where they are exposed to hazards.
- Conduct a risk analysis before starting the task. Examine work areas to identify all possible hazards. Ensure that all hazards are evaluated and eliminated so the task can be safely performed.
