# MNMM Fatal 2006-24

- Falling Material
- November 10, 2006 (Minnesota)
- Sand & Gravel Operation
- Loader Operator
- 41 years old
- 4 years experience

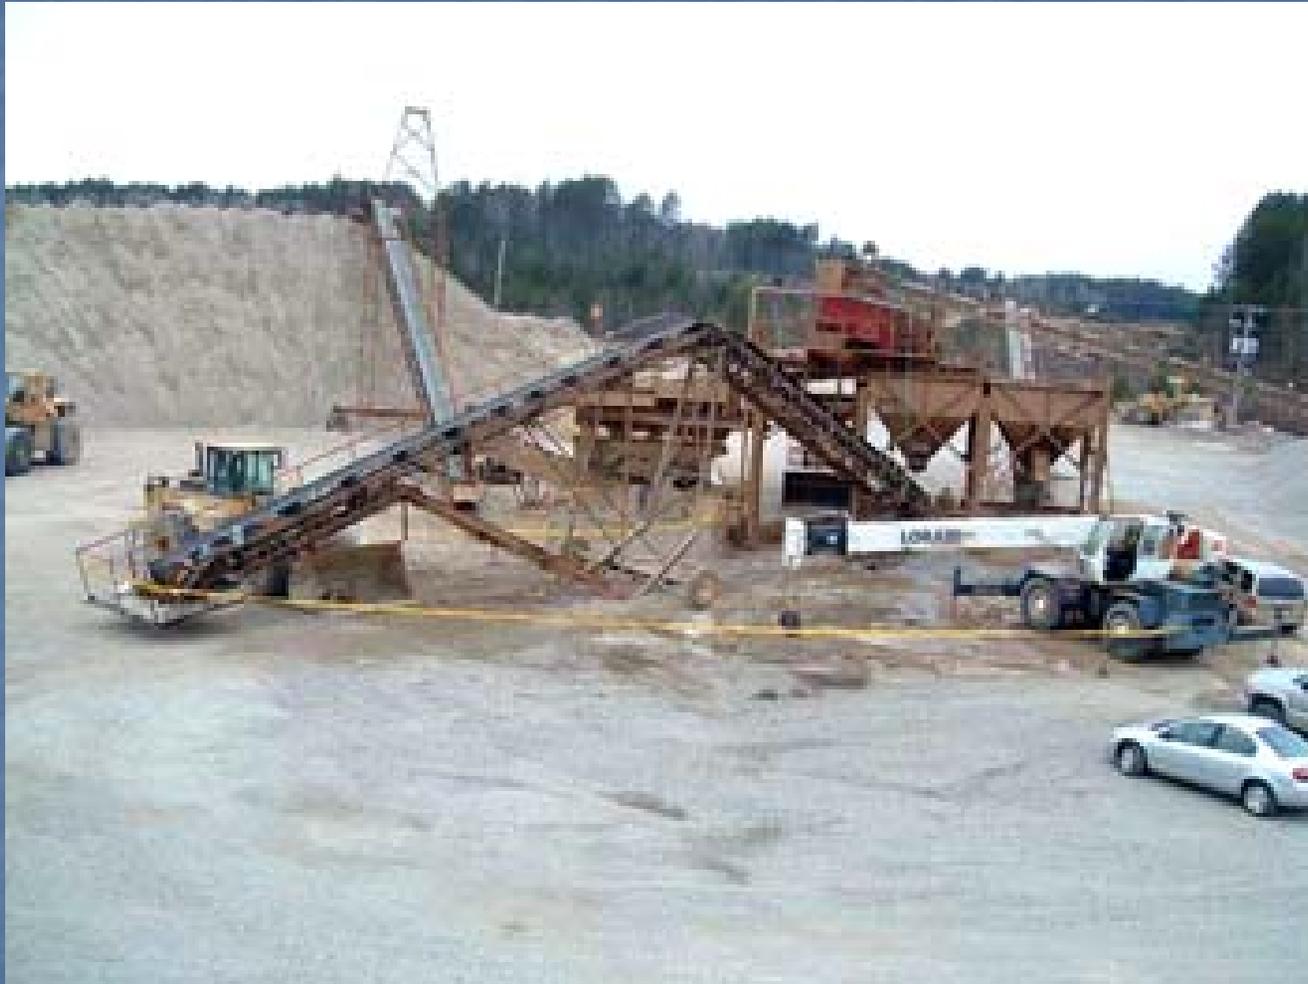
The victim was fatally injured when he was struck by the head pulley work platform of a mobile radial stacker conveyor when the main truss failed. The failure of the truss caused the conveyor to buckle, allowing the head pulley section to fall to the ground. The conveyor was being prepared for movement to another location when the accident occurred.

- Management standards and controls were inadequate. The mine operator failed to consult with the manufacturer of the conveyor or follow established engineering principles when making modifications. The modifications completed by the mine operator compromised the structural integrity of the conveyor.

- **Stop, Look, Analyze, and Manage (SLAM) each task to identify all potential hazards before performing maintenance work. Practice safe work habits during the entire task.**
- **Train miners in safe work procedures before beginning repairs.**
- **Securely block equipment against all hazardous motion at all times while performing maintenance work.**
