MNMM Fatal 2006-25

- Falling Material Accident
- December 15, 2006 (Alaska)
- Lead and Zinc Operation
- Geologist
- 51 years old
- 11 years experience

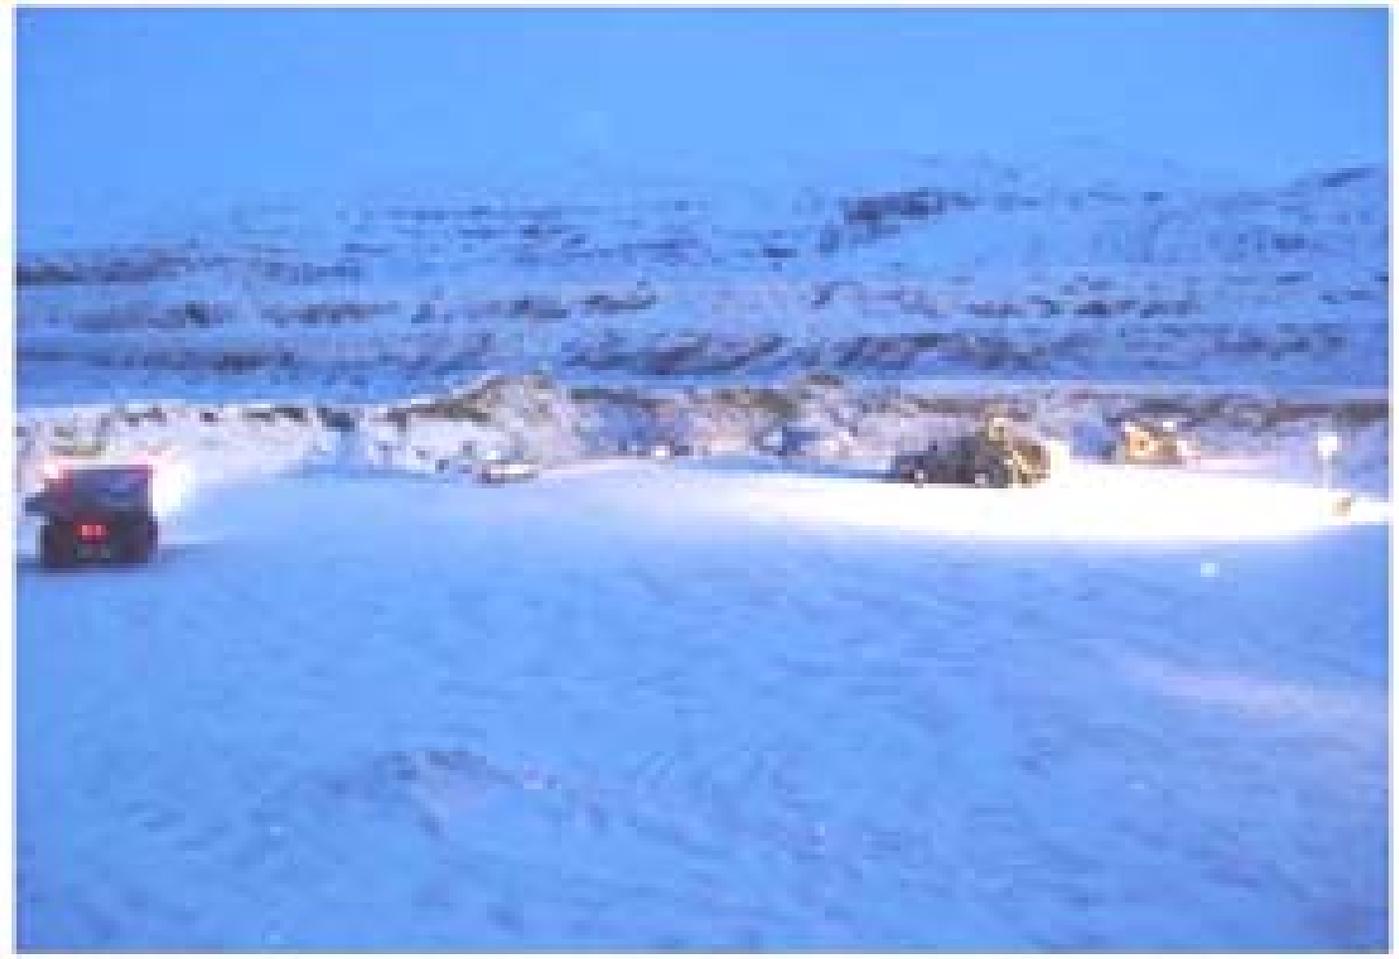
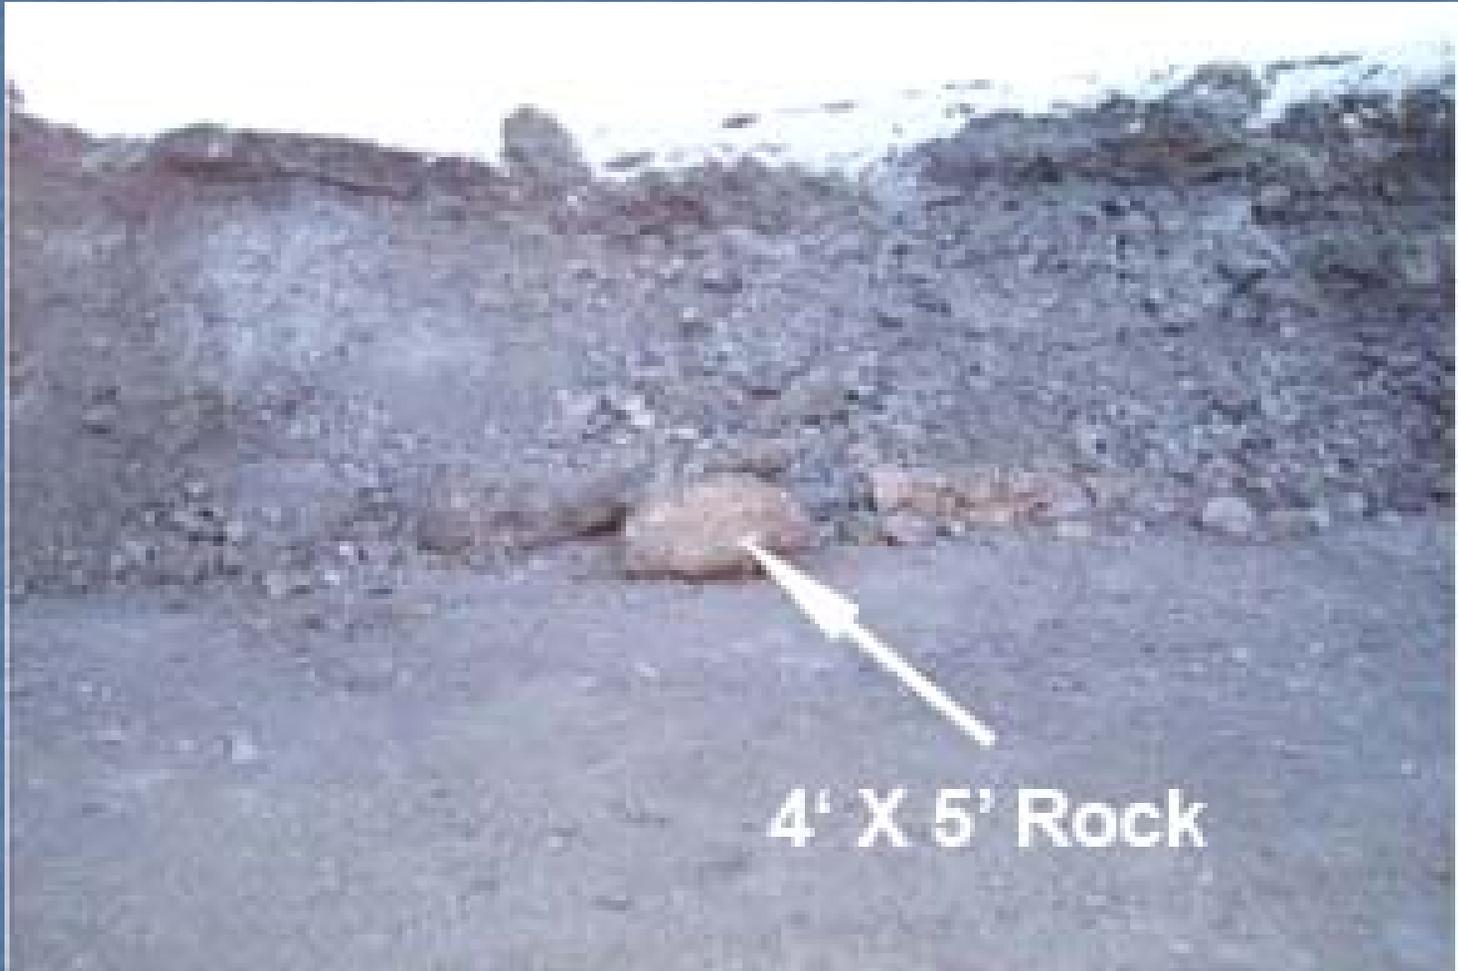
4' X 5' Rock

The victim was fatally injured when he was struck by a large piece of frozen, conglomerated material that rolled from the top of a muckpile. The victim was examining the muckpile face to determine the location of the ore-waste contact point.

- Management policies and controls were inadequate. There were no procedures requiring muckpiles to be trimmed to prevent hazards to persons and ensure that miners could safely examine muckpiles while standing near the face. Management failed to identify the blasted chunks of frozen material near the top of the muck pile as a potential hazard.

- Examine work areas to identify all possible hazards. Ensure that all hazards are eliminated so the task can be safely performed.
- Establish procedures that ensure miners always work from safe locations.
- Train miners in safe work procedures and hazard recognition, specifically to observe unsafe ground conditions while working near highwalls.
- If material needs examined, use a loader to remove it from the pile.
