**Fatality #13 - May 29, 2006**  
**Machinery - Florida - Phosphate Rock**  
**Mosaic Fertilizer, LLC - Hookers Prairie Mine**

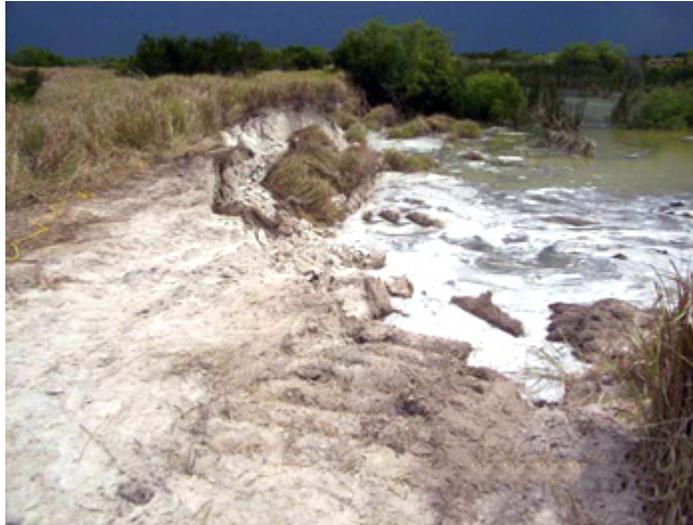
**METAL/NONMETAL MINE FATALITY** - On May 26, 2006, a 58-year-old contractor dozer operator, with 12 years experience, was fatally injured at a phosphate operation. The victim was operating a dozer to push top soil into a water filled pit that was being reclaimed. A portion of the bank and stockpile collapsed, causing the dozer and victim to slide into the water.

- Stop, Look, Analyze, and Manage, SLAM each task to identify all potential hazards. Initiate action to protect yourself when performing every task.
- Evaluate the stability of the ground prior to operating equipment near any drop off or edge.

- Use equipment (excavator) that can perform the work from a safe distance away from the edge of a pond where the stability of the ground may be unknown.

- Require that flotation devices be worn by persons performing work where there is a danger of falling in the water.
- When dozing toward a highwall edge, constantly examine the ground surface for development of cracks or fissures indicating separation, push perpendicular to the highwall face, and always keep a full blade in front of you.

- When dozing soft or unconsolidated material, be aware of changes in the feel of the footing under you and immediately back out of material that feels like it is softening up.
