**Fatality #14 – June 12, 2006**  
**Falling Material - Virginia - Sandstone (C&B)**  
**Rockbridge Stone Products Inc. - 01 Mine**

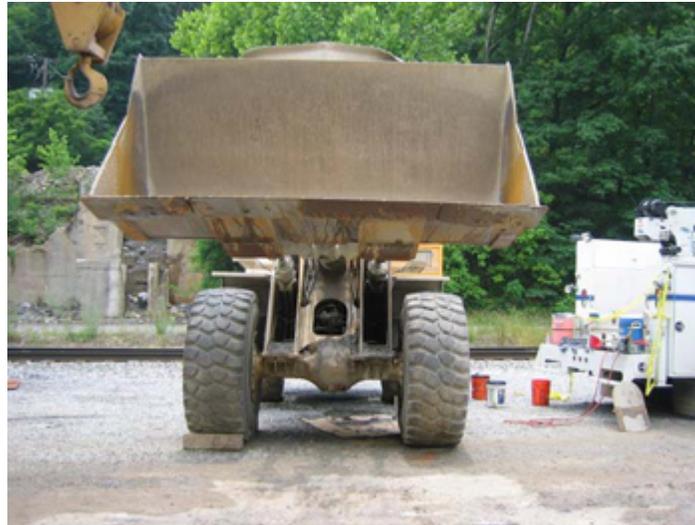
**METAL/NONMETAL MINE FATALITY** - On June 12, 2006, a 39-year-old plant operator, with 14 months experience, was fatally injured at a crushed stone operation. The victim was starting to repair a hydraulic line on a front-end loader that was parked outside of the shop. He was underneath the raised boom, loosening a hydraulic connection, when the boom arms fell, pinning him against the frame.

- Stop, Look, Analyze, and Manage (SLAM) each task to identify all potential hazards before performing maintenance work. Practice safe work habits during the entire task.
- Consult and follow the manufacturer's recommended safe work procedures for the maintenance task.
- Train miners in safe work procedures before beginning repairs.
- Securely block equipment against all hazardous motion at all times while performing maintenance work.
- Never travel or work under a raised loader bucket.
- Never loosen hydraulic hoses or components without first determining if they may be holding something up or trapping pressure.
