Fatality #19 - July 29, 2007
Fall of Person - Tennessee - Lead/Zinc Ore
East Tennessee Zinc Company, LLC - Immel Mine

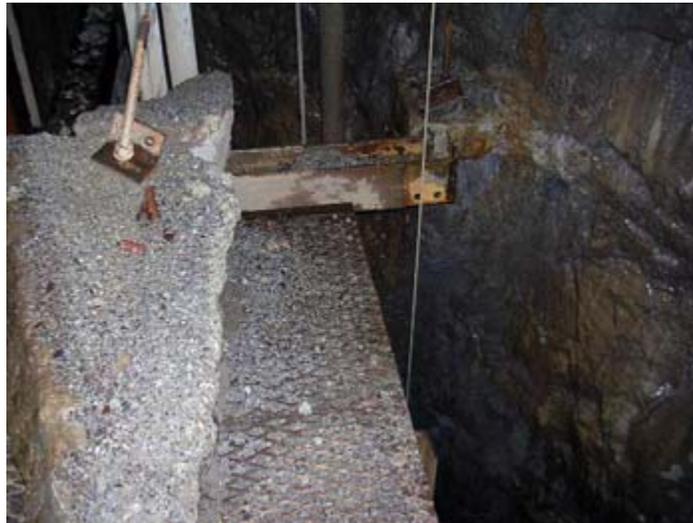
METAL/NONMETAL MINE FATALITY - On July 29, 2007, a 29 year-old contractor miner with 3 years experience was fatally injured at an underground zinc mine. The victim and two other contractor miners were working on top of a service hoist located in the main mine service shaft. He was assisting another miner who was using a chipping hammer to remove concrete from around a steel shaft set. The miners had one foot on top of the service hoist and one foot on a cross section H-beam when one side of the beam collapsed. Both miners fell into the shaft. They were both wearing safety harnesses and lanyards but the victim's lanyard was not secured. The other miner was caught by his lanyard but the victim fell 1,000 feet to the shaft bottom.

- Ensure workers are trained and understand that safety lanyards are not permitted to be unfastened while working at elevated locations.
- Provide self retracting lanyard mechanisms when workers are required to reposition themselves to perform tasks.
- Ensure safety lanyards are securely fastened at all times when workers are positioned at elevated locations.
