Fatality #6 - April 14, 2009

Slip/Fall of Person - Missouri - Limestone (C&B)

Holcim (US) Incorporated - Holcim Ste Genevieve Plant

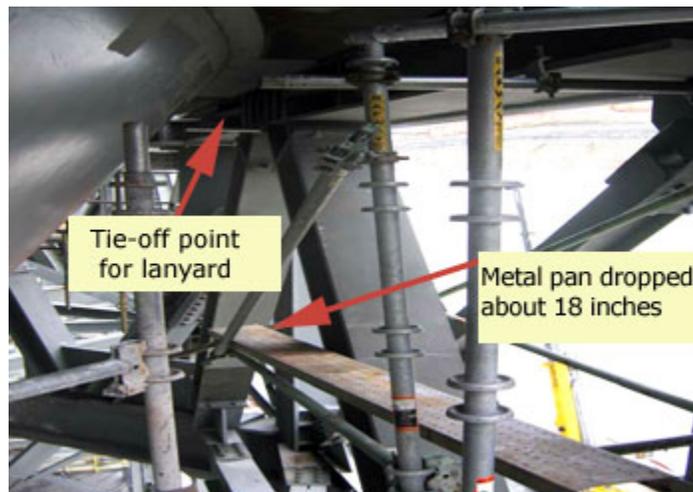
METAL/NONMETAL MINE FATALITY - On April 14, 2009, a 38 - year old contractor carpenter with 8 years of experience was fatally injured at a cement plant under construction. While dismantling a section of scaffolding, the victim lost his balance and fell when one end of the metal pan on which he was standing shifted unexpectedly. As he fell backward, the victim's safety lanyard slipped off the end of the horizontal scaffold to which he was tied.

- Train persons to recognize the hazards associated with the type of scaffold being used and how to control or minimize those hazards.
- Wear fall protection where there is a danger of falling.
- Where possible anchor fall protection to permanent support structure.
- Follow the manufacturer's procedures for assembly and disassembly of scaffold systems.
- Ensure that scaffolding is properly connected and braced to prevent side sway.
- Prior to using scaffolding, inspect the structure to ensure that it has not been altered.
